RESTORING ACTIVE BLANKET BOG IN IRELAND

Project reference: LIFE02NAT/IRL/8490

A REPORT ON THE RESTORATION OF PROJECT SITE No. 13.
CROAGHONAGH, CO. DONEGAL.

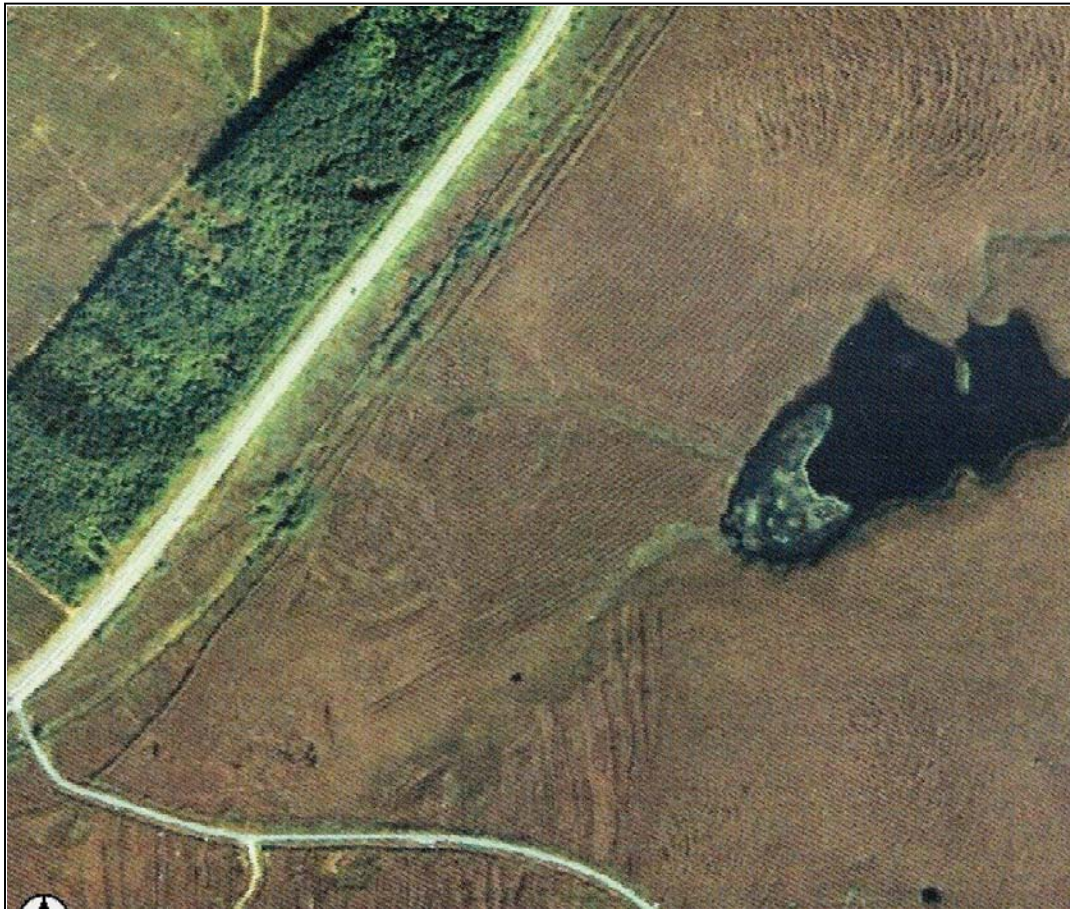
An aerial photograph of the northern portion of the site prior to restoration work taking place. Note the extensive network of linear drains to the north-west of Lough Carn. Aerial photograph taken in the year 2000.

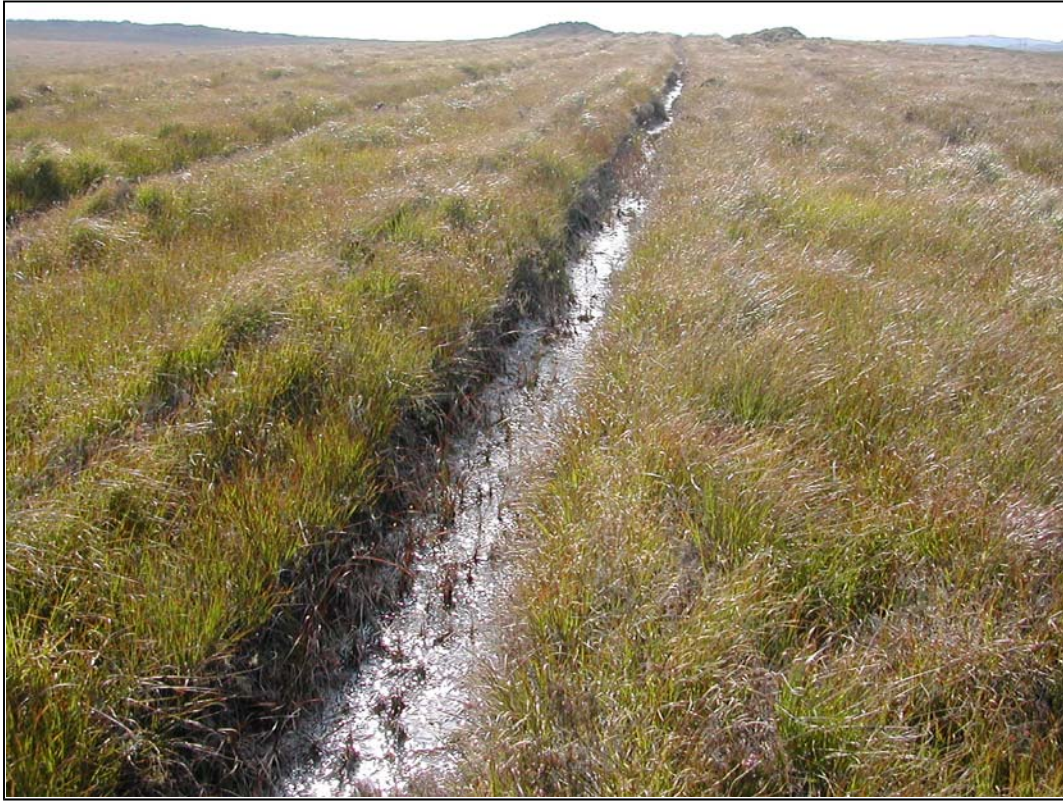
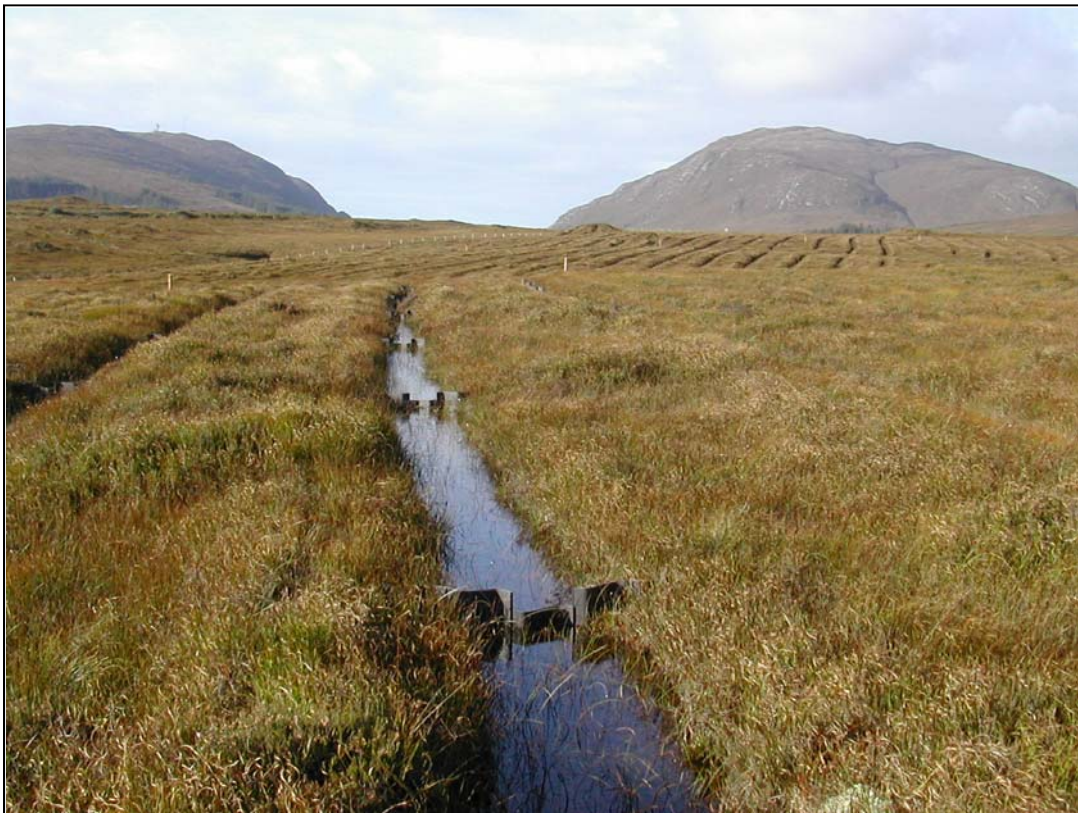
At this site an area of blanket bog was drained but not subsequently planted. These drains are

approximately 4 metres apart and are generally c. 1 metre deep. Photographs taken during 2003/2004.

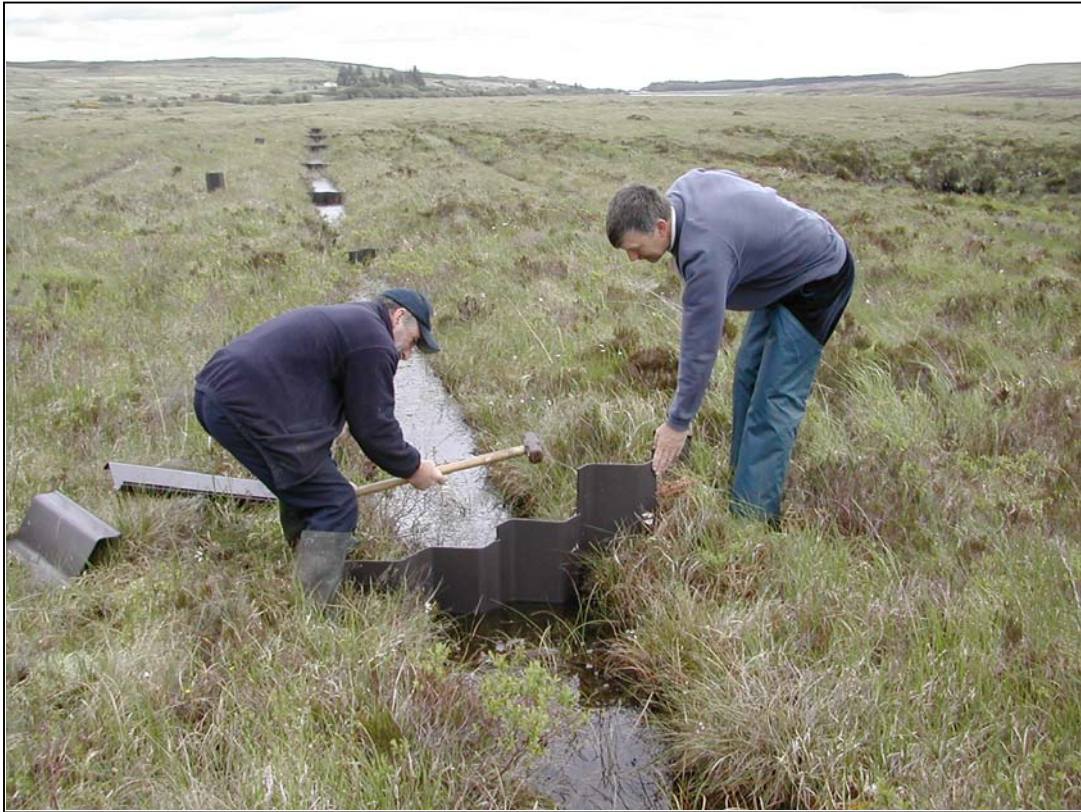
Drains were blocked during 2003/2004 using plastic piling dams.

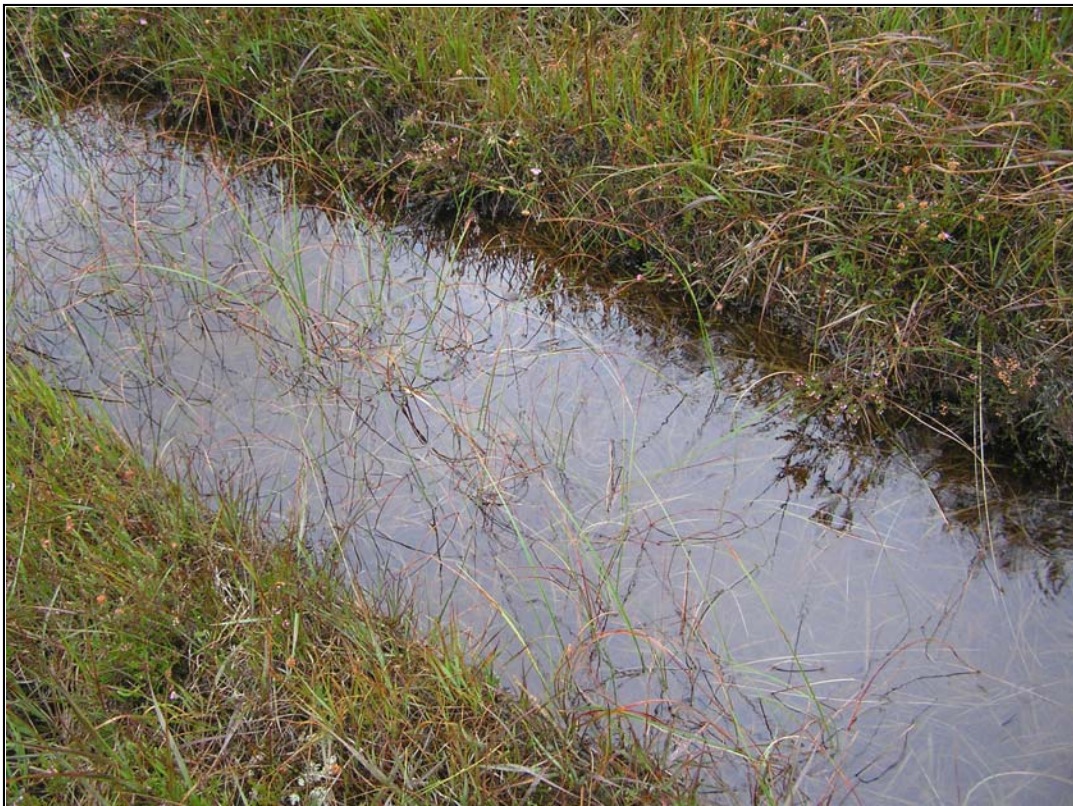
Drains tend to be dominated by a sparse growth of *Eriophorum angustifolium*.

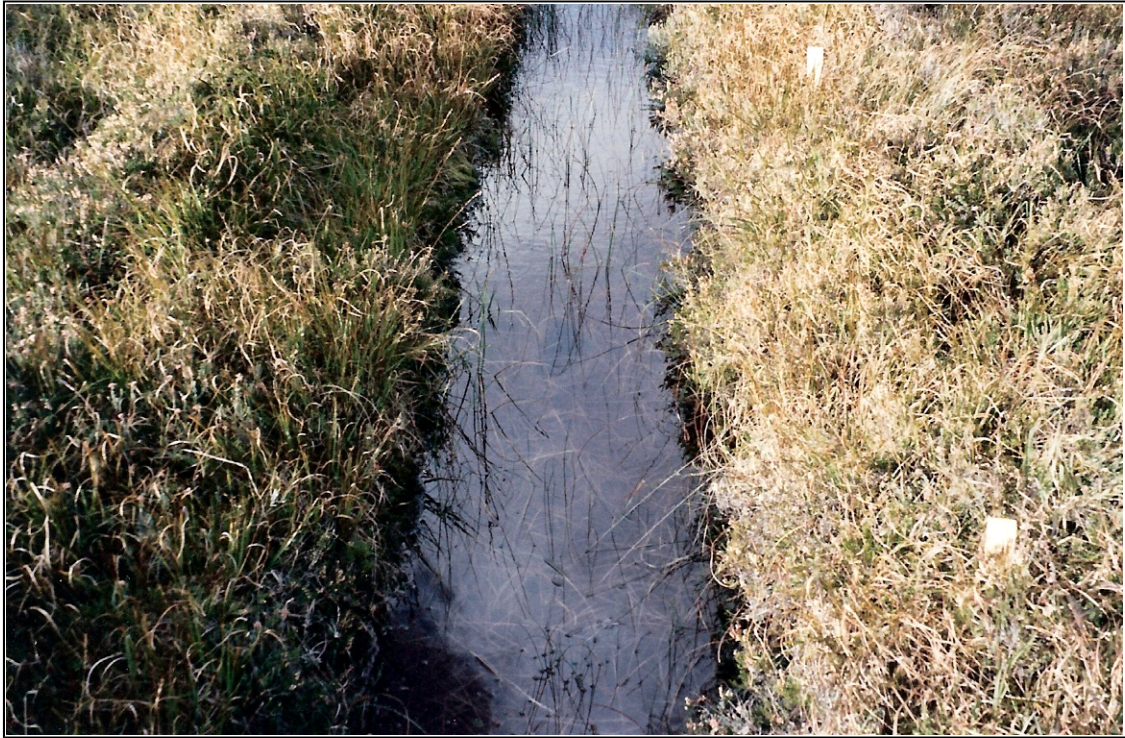
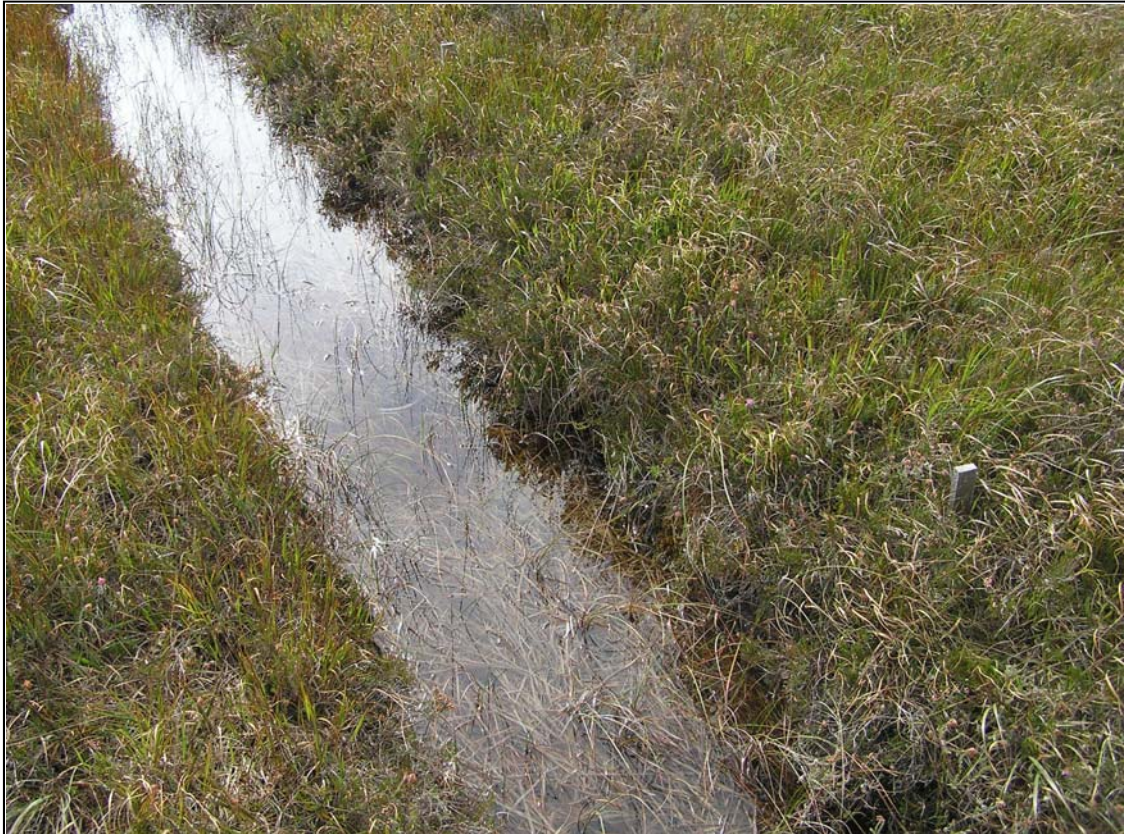
Permanent quadrat 1 – September 2004

Permanent quadrat 1 – September 2007

Site – Croaghonagh		
Perm. Quadrat No. - 1		
Near Walrag? – No		
GPS – H 05591 88774		
Size – 3m x 0.7m		
Slope – +/- 0 degrees		
Vegetation Height (m)	20 to 30	20 to 30
Vegetation cover (%)	10	10
Open water cover (%)	100	100
Dwarf shrub cover (%)	0	0
Herb cover (%)	10	10
Bryophyte cover (%)	0	0
No. of plant species	1	2
Survey date	17/9/04	13/9/07
<i>Eriophorum angustifolium</i>	4	4
<i>Molinia caerulea</i>		1
<p>History – Area drained in the early 1990's but trees not subsequently planted. Drains blocked with plastic piling in the summer of 2003.</p>

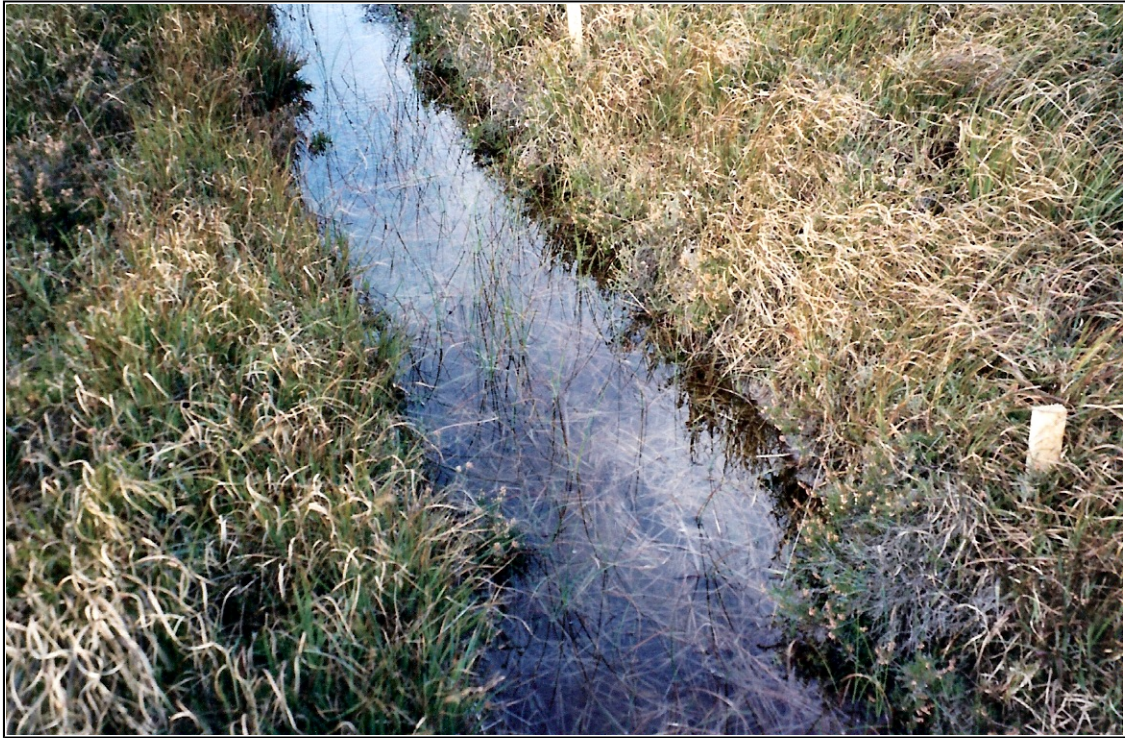
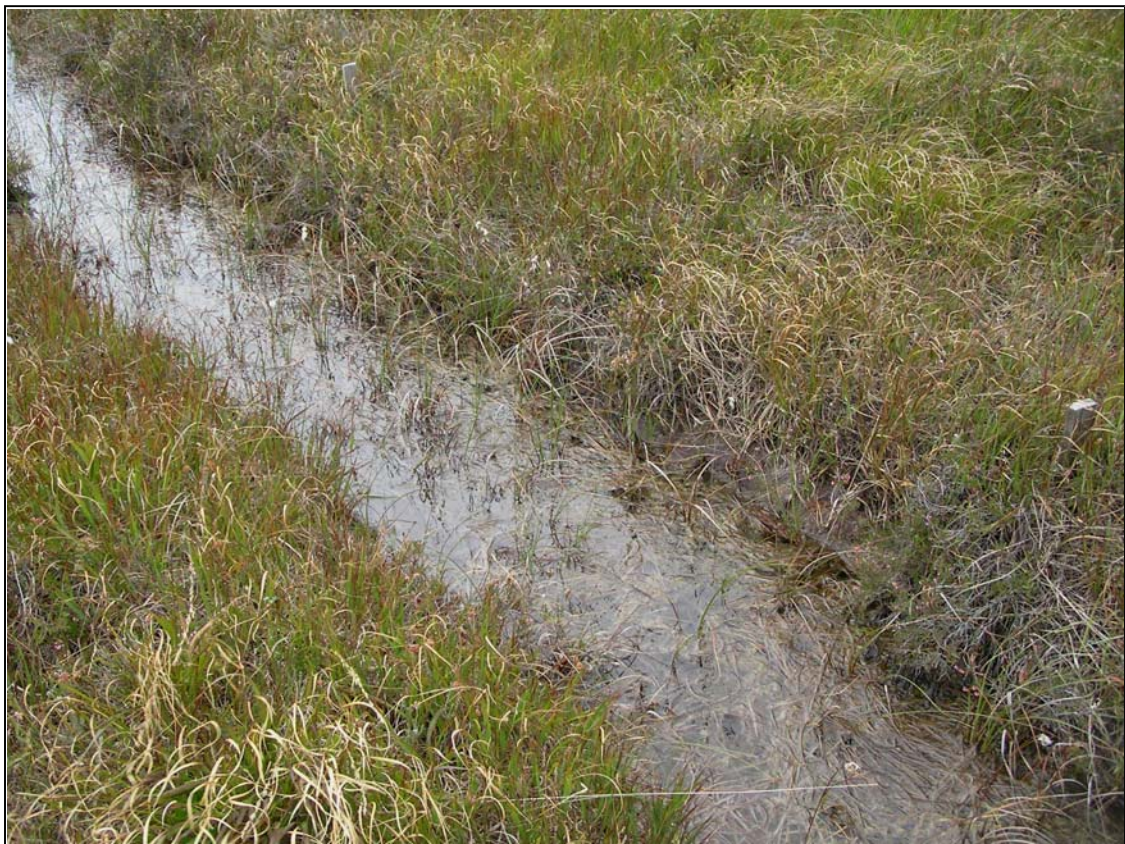
Permanent quadrat 2 – September 2004

Permanent quadrat 2 – September 2007

Site – Croaghonagh		
Perm. Quadrat No. - 2		
Near Walrag? – No		
GPS – H 05608 88741		
Size – 3m x 0.7m		
Slope – 2 to 5 degrees		
Vegetation Height (m)	20 to 30	20 to 30
Vegetation cover (%)	10	20
Open water cover (%)	100	100
Dwarf shrub cover (%)	0	0
Herb cover (%)	10	20
Bryophyte cover (%)	0	0
No. of plant species	2	2
Survey date	17/9/04	13/9/07
<i>Eriophorum angustifolium</i>	4	4
<i>Drosera rotundifolia</i>	1	-
<i>Molinia caerulea</i>		2
<p>History – Area drained in the early 1990's but trees not subsequently planted. Drains blocked with plastic piling in the summer of 2003.</p>

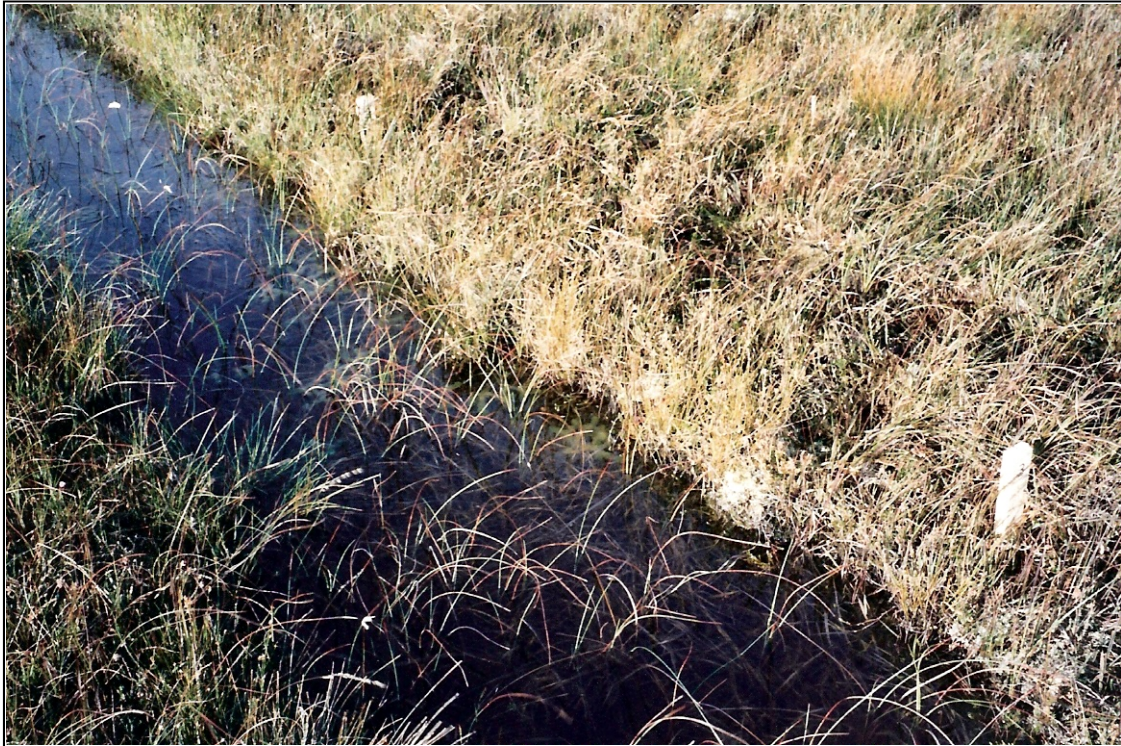
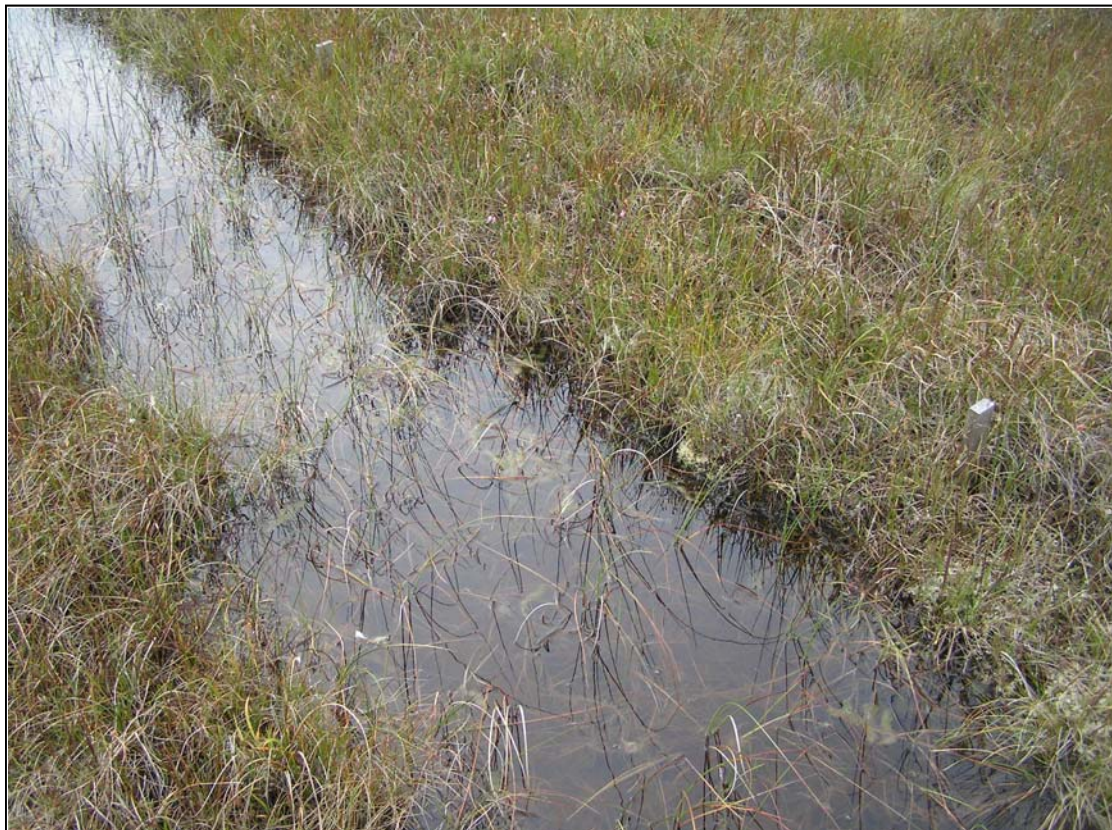
Permanent quadrat 3 – September 2004

Permanent quadrat 3 – September 2007

Site – Croaghonagh		
Perm. Quadrat No. - 3		
Near Walrag? – No		
GPS – H 05651 88757		
Size – 3m x 0.7m		
Slope – +/-0 degrees		
Vegetation Height (m)	20 to 30	20 to 30
Vegetation cover (%)	25	20
Open water cover (%)	100	100
Dwarf shrub cover (%)	0	0
Herb cover (%)	15	10
Bryophyte cover (%)	10	10
No. of plant species	3	3
Survey date	17/9/04	13/9/07
<i>Eriophorum angustifolium</i>	4	4
<i>Sphagnum cuspidatum</i>	4	4
<i>Rhynchospora alba</i>	2	1
<i>Narthecium ossifragum</i>		1
<p>History – Area drained in the early 1990's but trees not subsequently planted. Drains blocked with plastic piling in the summer of 2003.</p>

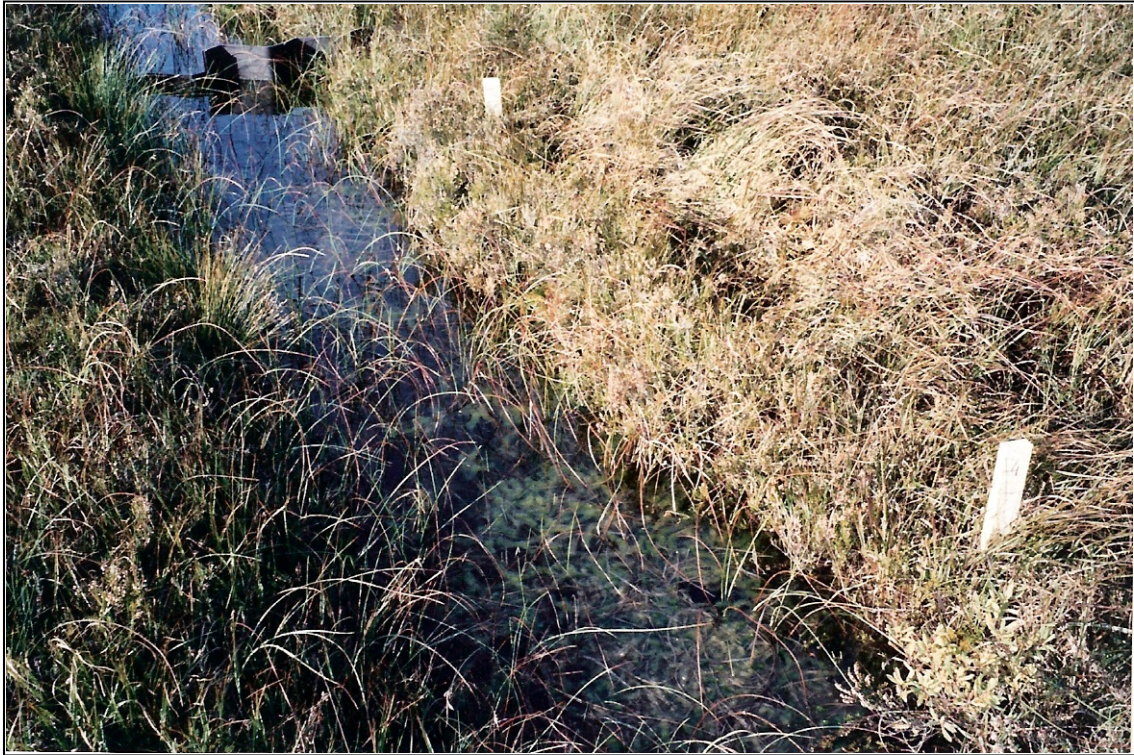
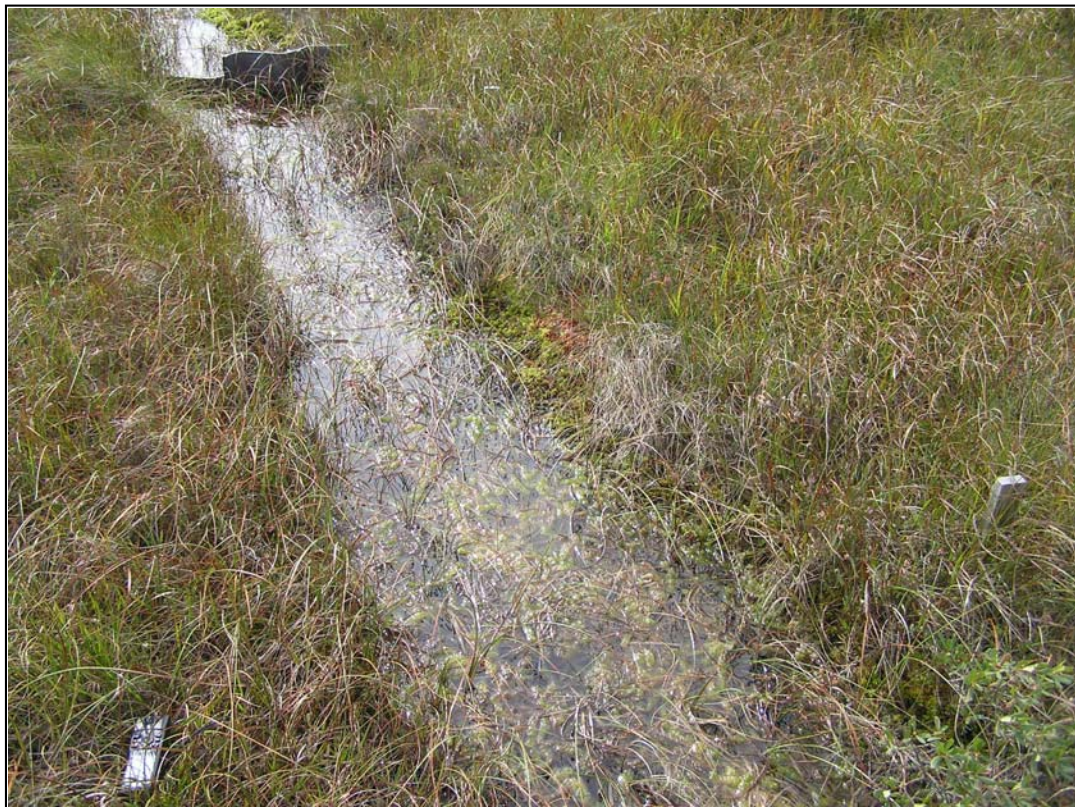
Permanent quadrat 4 – September 2004

Permanent quadrat 4 – September 2007

Site – Croaghonagh		
Perm. Quadrat No. - 4		
Near Walrag? – No		
GPS – H 05697 88771		
Size – 3m x 0.7m		
Slope – +/-0 degrees		
Vegetation Height (m)	20 to 30	20 to 30
Vegetation cover (%)	55	75
Open water cover (%)	100	100
Dwarf shrub cover (%)	0	0
Herb cover (%)	30	35
Bryophyte cover (%)	30	45
No. of plant species	4	4
Survey date	17/9/04	13/9/07
<i>Eriophorum angustifolium</i>	5	5
<i>Sphagnum cuspidatum</i>	5	5
<i>Utricularia</i> sp.	4	3
<i>Sphagnum papillosum</i>	3	3
<p>History – Area drained in the early 1990's but trees not subsequently planted. Drains blocked with plastic piling in the summer of 2003.</p>

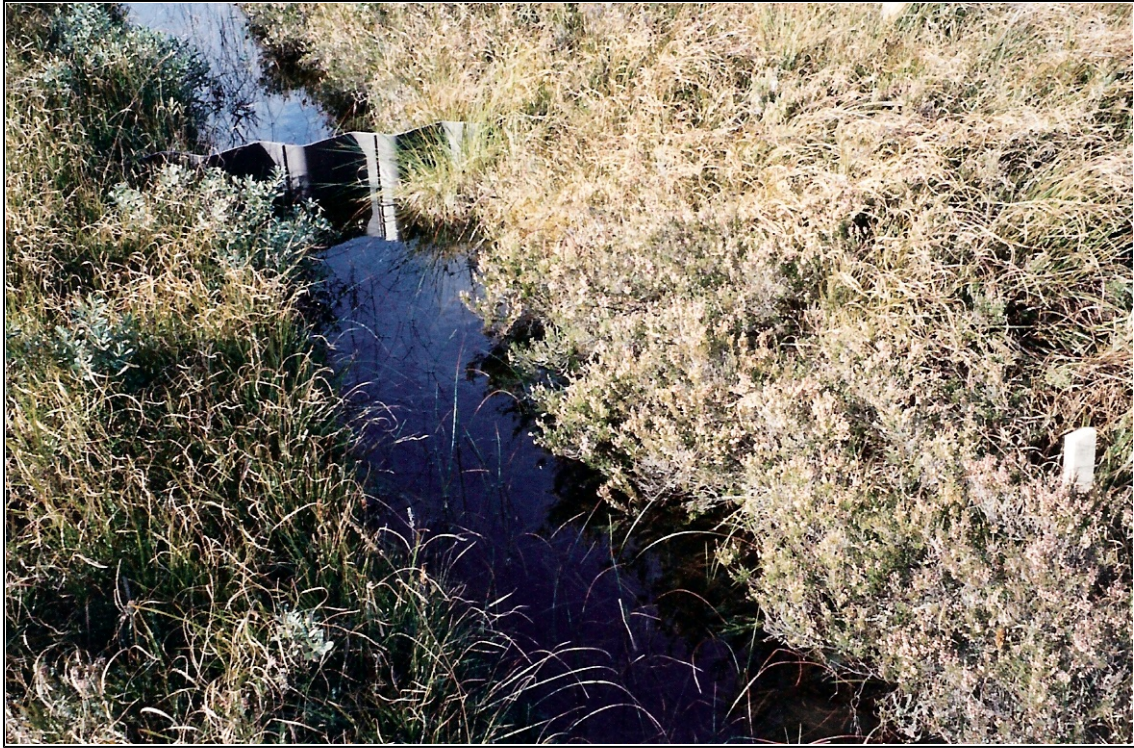
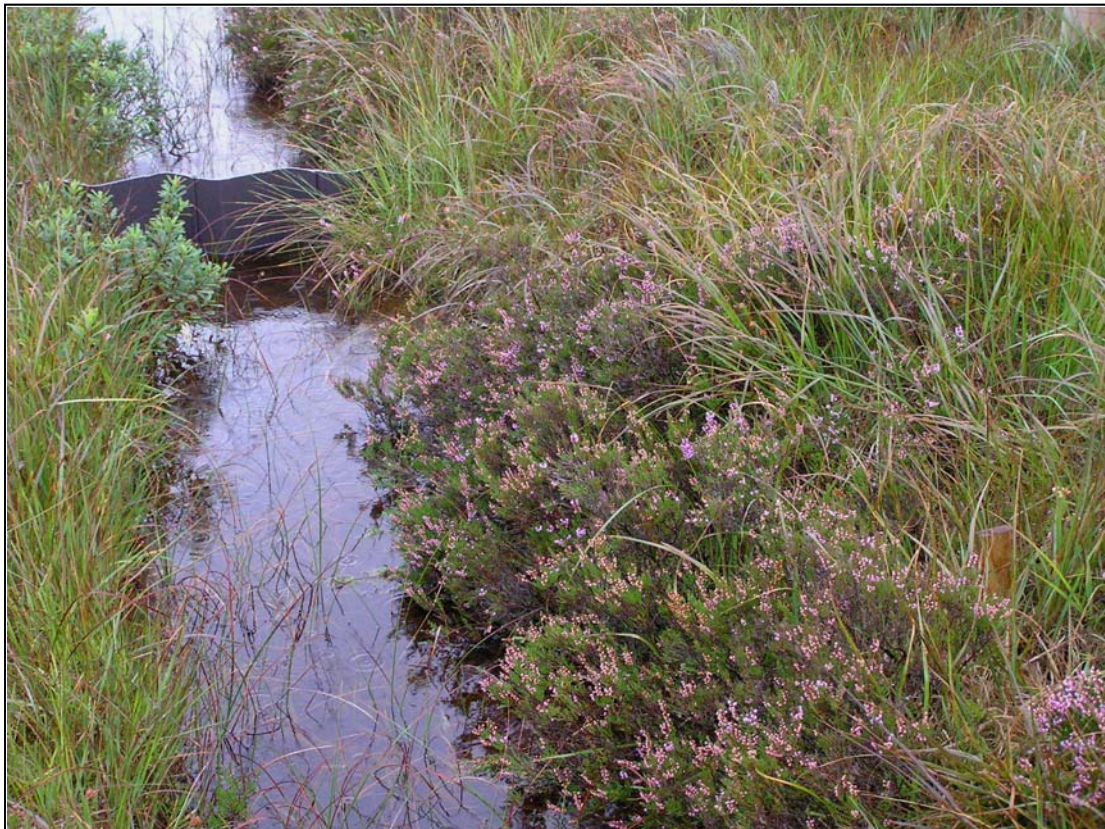
Permanent quadrat 5 – September 2004

Permanent quadrat 5 – September 2007

Site – Croaghonagh		
Perm. Quadrat No. - 5		
Near Walrag? – No		
GPS – H 05661 88709		
Size – 3m x 0.7m		
Slope – <3 degrees		
Vegetation Height (m)	20 to 30	20 to 30
Vegetation cover (%)	10	20
Open water cover (%)	100	100
Dwarf shrub cover (%)	0	0
Herb cover (%)	10	15
Bryophyte cover (%)	0	5
No. of plant species	2	3
Survey date	17/9/04	13/9/07
<i>Eriophorum angustifolium</i>	3	4
<i>Utricularia</i> sp.	2	2
<i>Sphagnum papillosum</i>		3
<p>History – Area drained in the early 1990's but trees not subsequently planted. Drains blocked with plastic piling in the summer of 2003.</p>

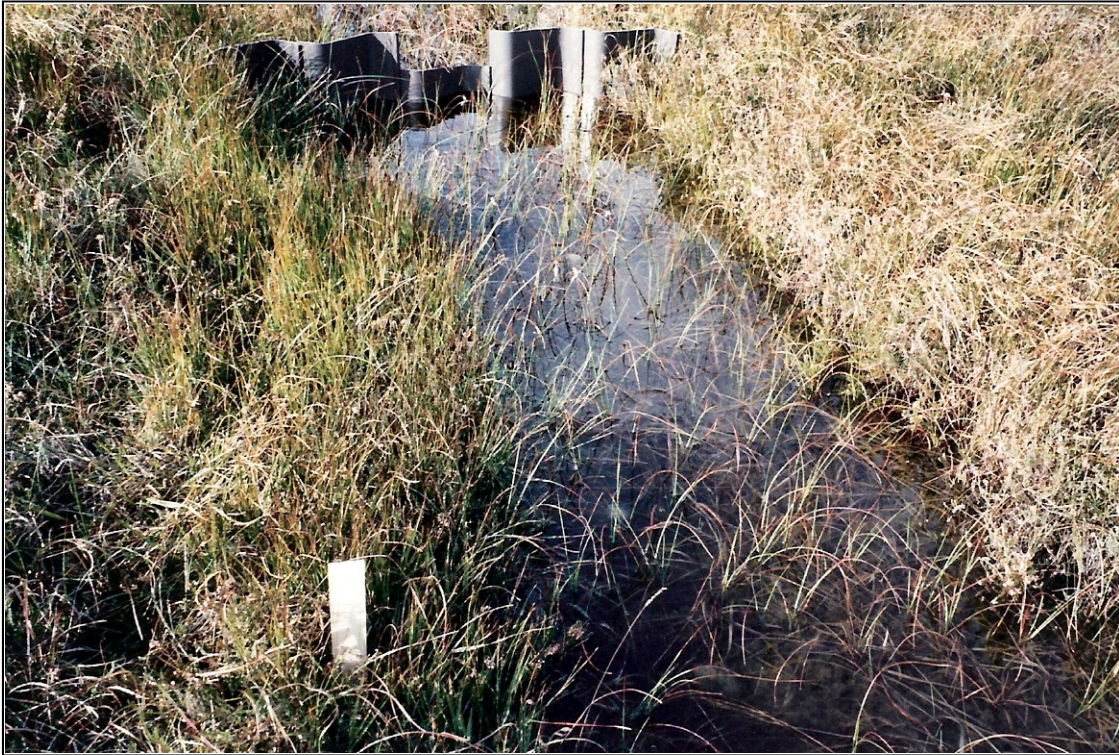
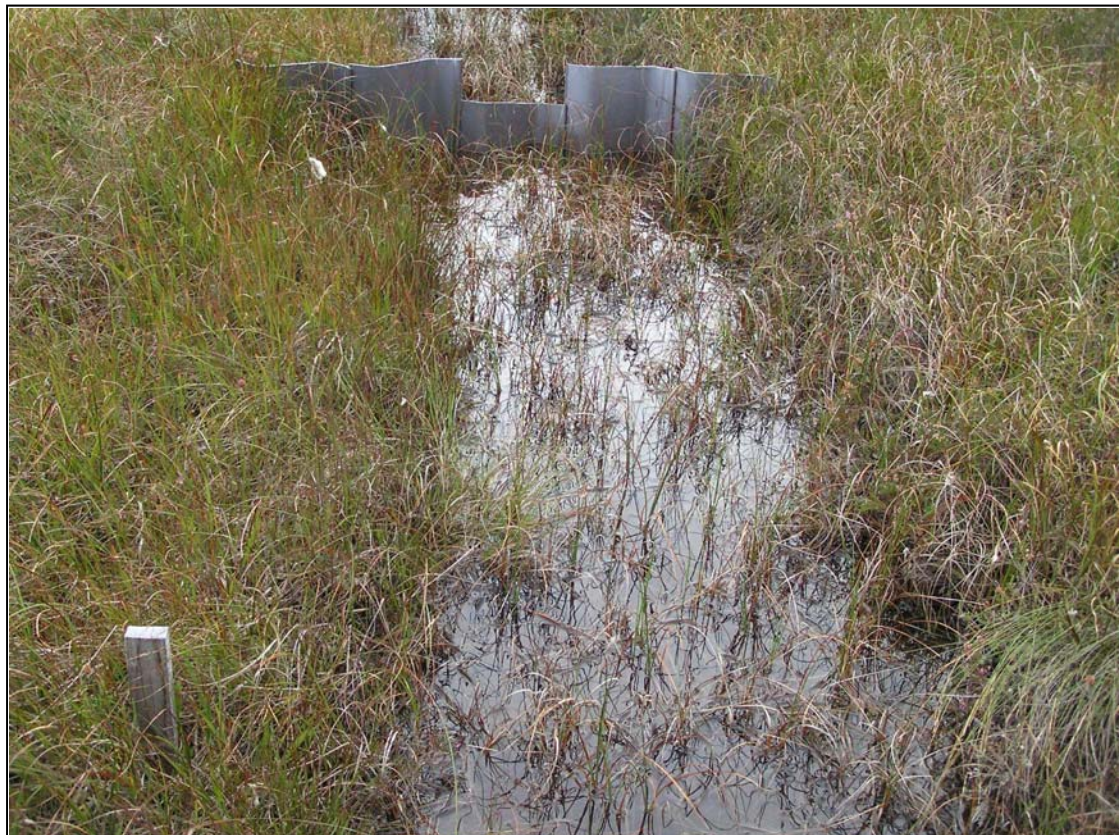
Permanent quadrat 6 – September 2004

Permanent quadrat 6 – September 2007

Site – Croaghonagh		
Perm. Quadrat No. - 6		
Near Walrag? – No		
GPS – H 05640 88708		
Size – 3m x 0.7m		
Slope – <3 degrees		
Vegetation Height (m)	20 to 30	20 to 30
Vegetation cover (%)	30	30
Open water cover (%)	100	100
Dwarf shrub cover (%)	0	0
Herb cover (%)	30	30
Bryophyte cover (%)	0	0
No. of plant species	2	1
Survey date	17/9/04	13/9/07
<i>Eriophorum angustifolium</i>	5	5
<i>Molinia caerulea</i>	2	-
History – Area drained in the early 1990's but trees not subsequently planted. Drains blocked with plastic piling in the summer of 2003.
