RESTORING ACTIVE BLANKET BOG IN IRELAND

Project reference: LIFE02NAT/IRL/8490

A REPORT ON THE RESTORATION OF PROJECT SITE No. 3.
DRUMALONHURT, CO. KERRY

Project Site No. 3 – Dromalohurt, Co. Kerry (Demonstration Site)

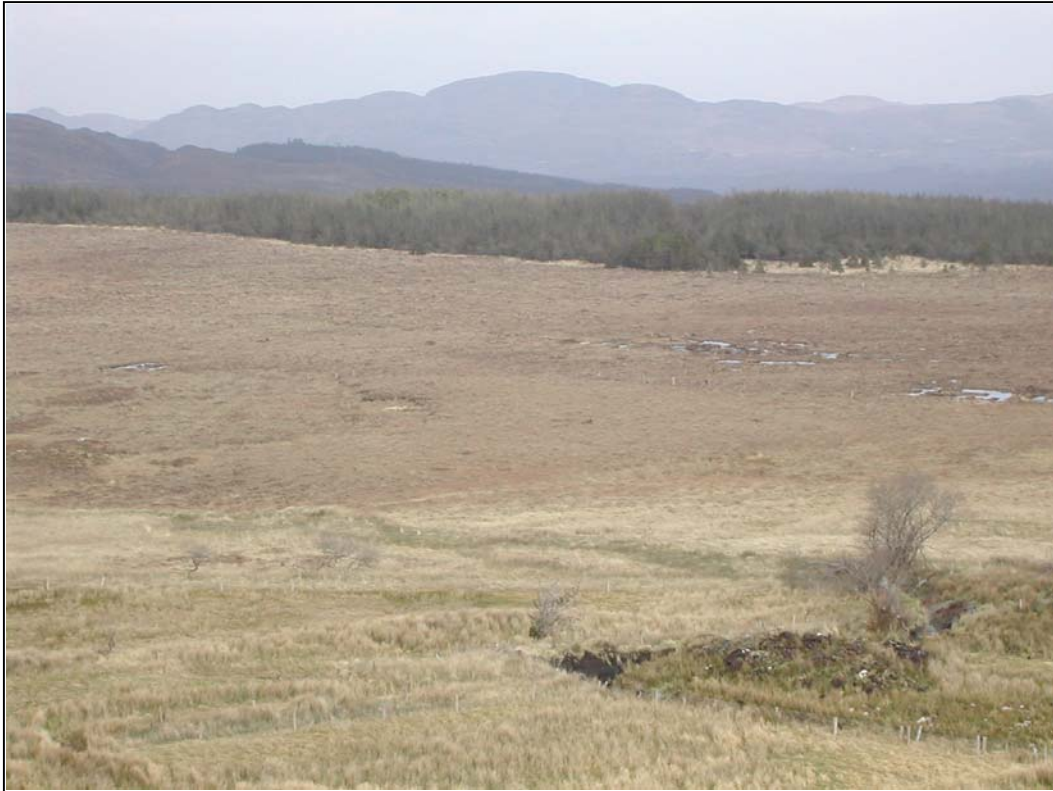
A long distance view of the site taken from high ground to the south-west. Note the pool systems on the right of the photograph. Photograph taken in March 2003.

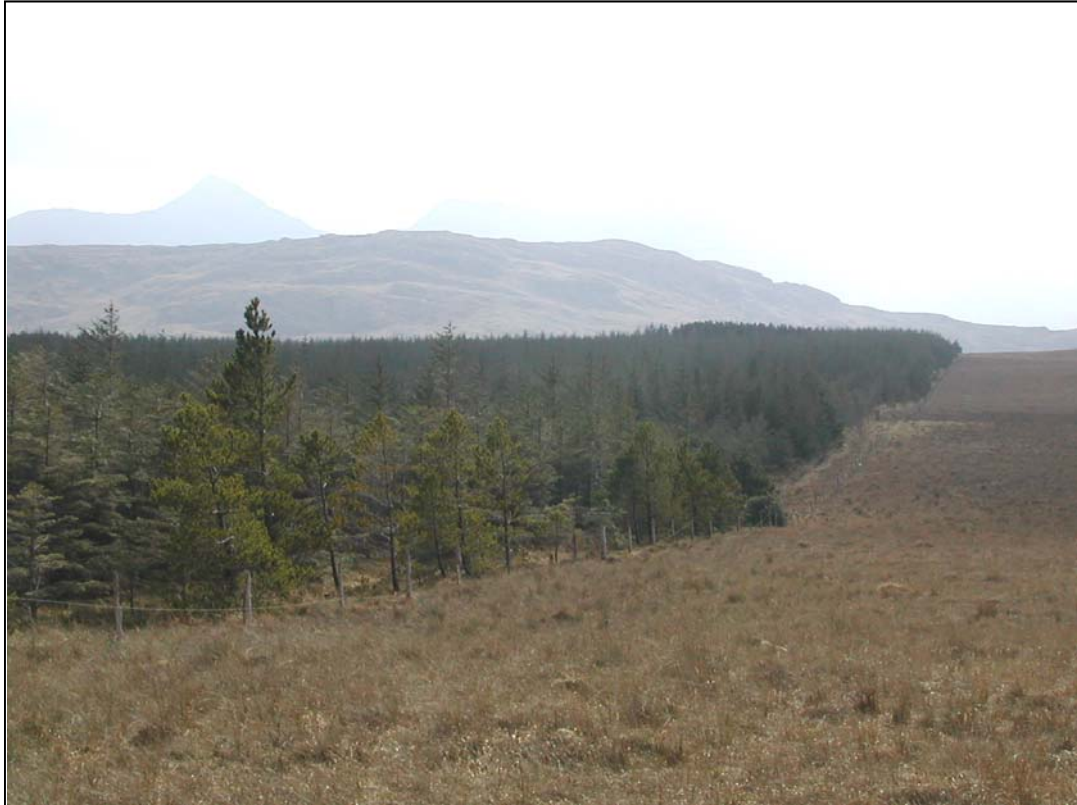
A view along the western margin of the forestry area. Photograph taken in March 2003.

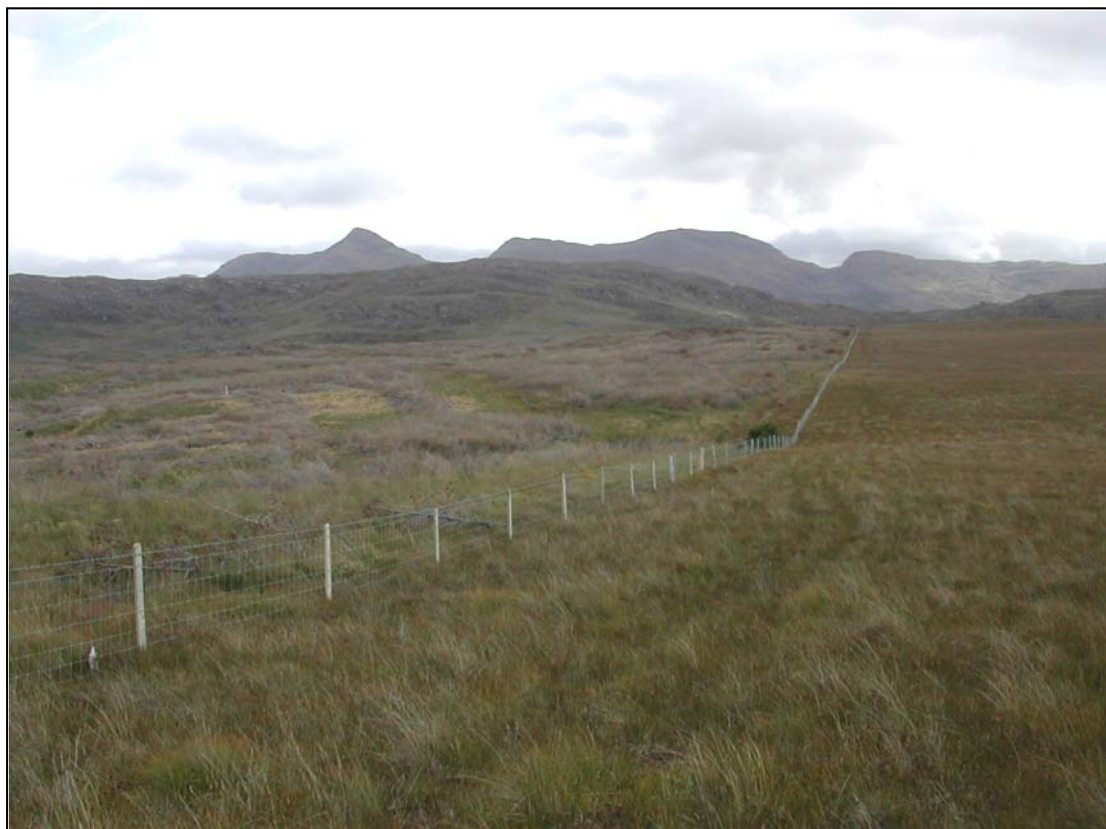
The same view taken in August 2004 with the conifer crop felled.

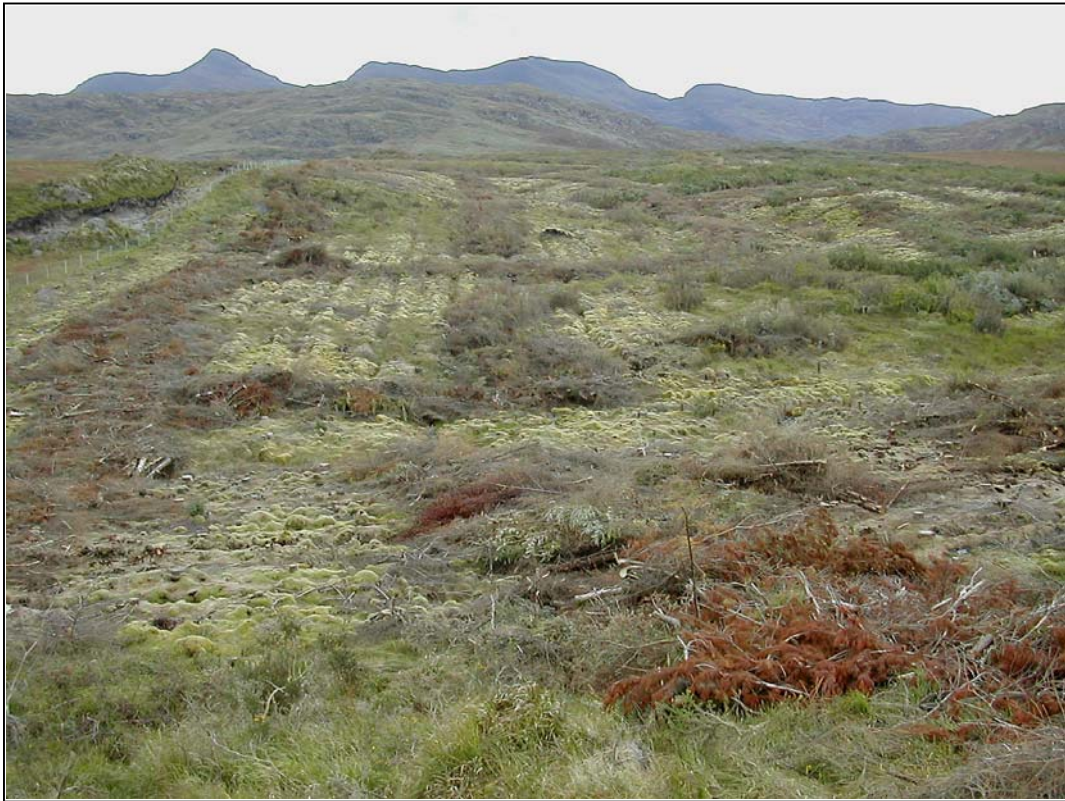
A view of felled trees in the north of the site, looking in a southerly direction. Note the moss covered bog surface between the brush tracks. Photograph taken in September 2003.

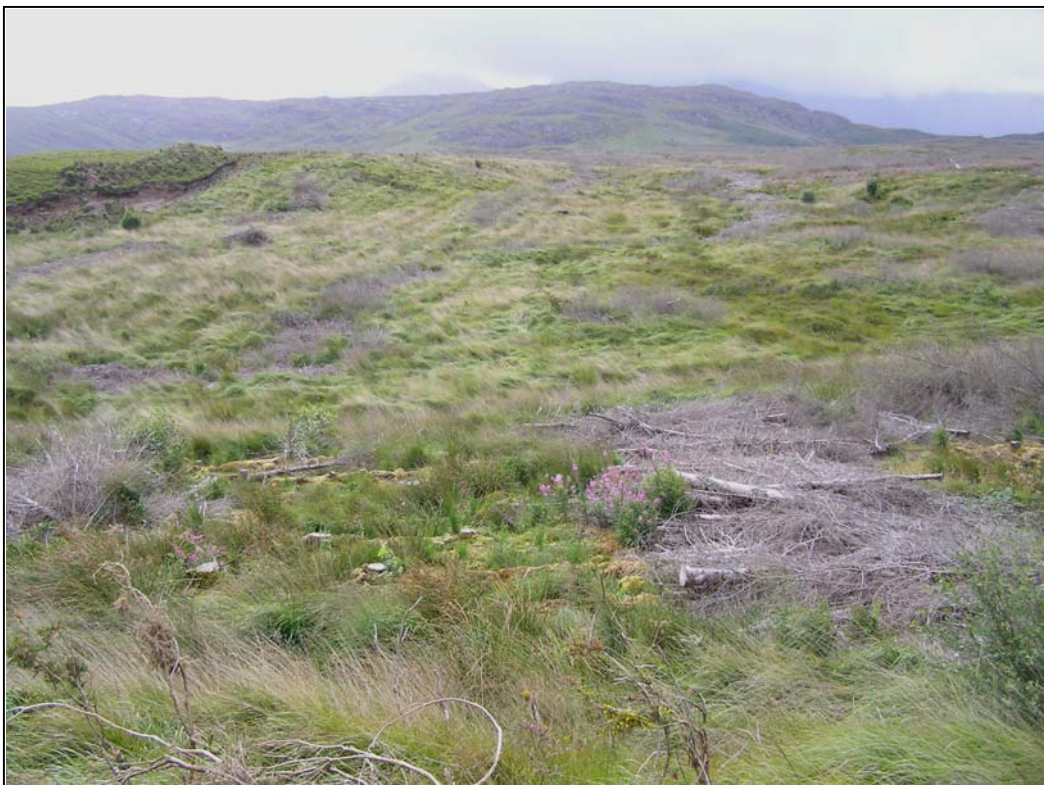
The same view taken in August 2006. Note the substantial "greening up" of the site due to the growth of *Molinia caerulea*.

In common with most sites in this restoration project the main species to recolonize rapidly following tree felling is the grass *Molinia caerulea*. In many parts of the site this species has achieved a cover of >75% within three years. Even in areas where there is a substantial cover of felled conifers present on the bog surface, vigorous tussocks of *Molinia* can be seen growing up through the dead tree branches. At present the other prominent species in the permanent quadrats tend to be the mosses *Hypnum cupressiforme*, *Sphagnum capillifolium* while *Campylopus* sp. and *Polytrichum commune* also have a high cover locally.

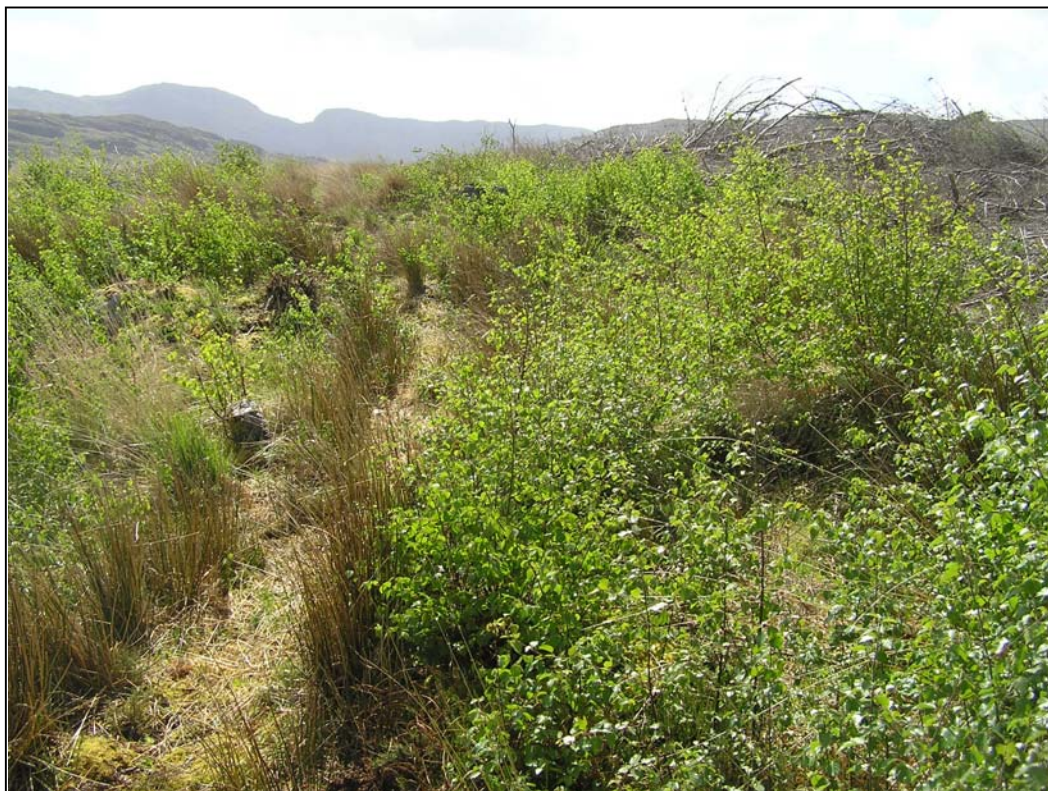
Regeneration of birch saplings is occurring over c. 2 hectares of ground at the northern end of the site. This is due to the relatively shallow peat depth in this area.

The other noteworthy feature of this site, in terms of vegetation recovery, is the natural regeneration of *Betula pubescens* evident in the felled areas close to the road which runs along the northern margins of the site. Regeneration of the species in this area has been profuse and this is due to the shallow and well-drained nature of the peat soil. Although up until now this natural regeneration has been controlled by cutting and pulling of saplings the possibility of allowing the development of a small area of birch scrub (c. 2 ha), close to the road and parking area should be considered.

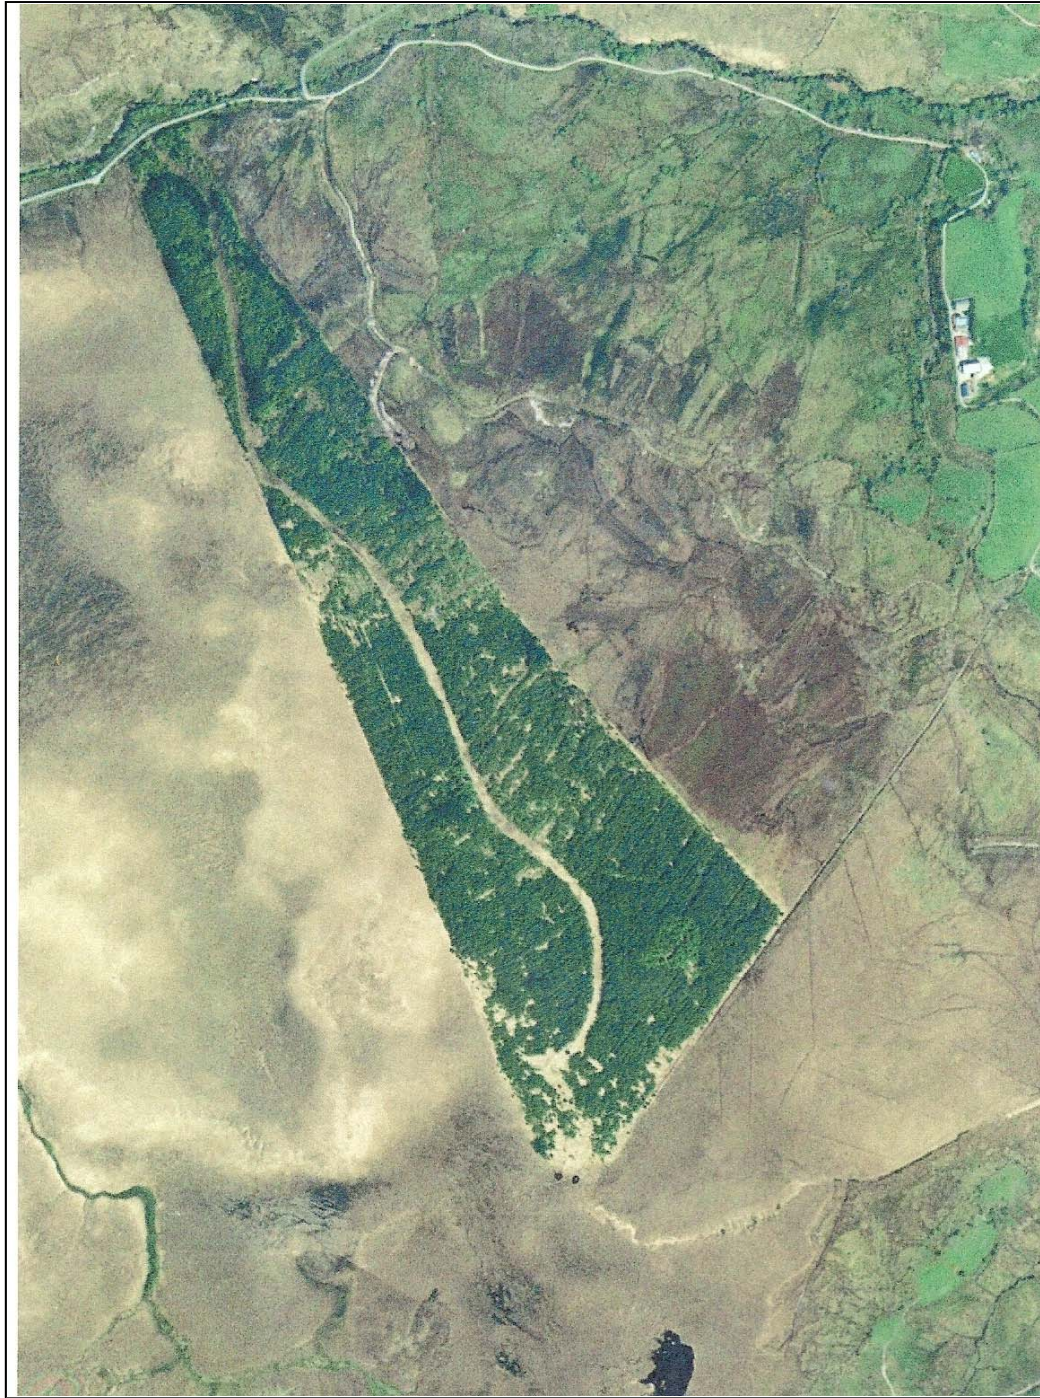
An aerial photograph of the Drumalohurt site (afforested portion only) prior to restoration work taking place.
Aerial photograph taken in the year 2000.

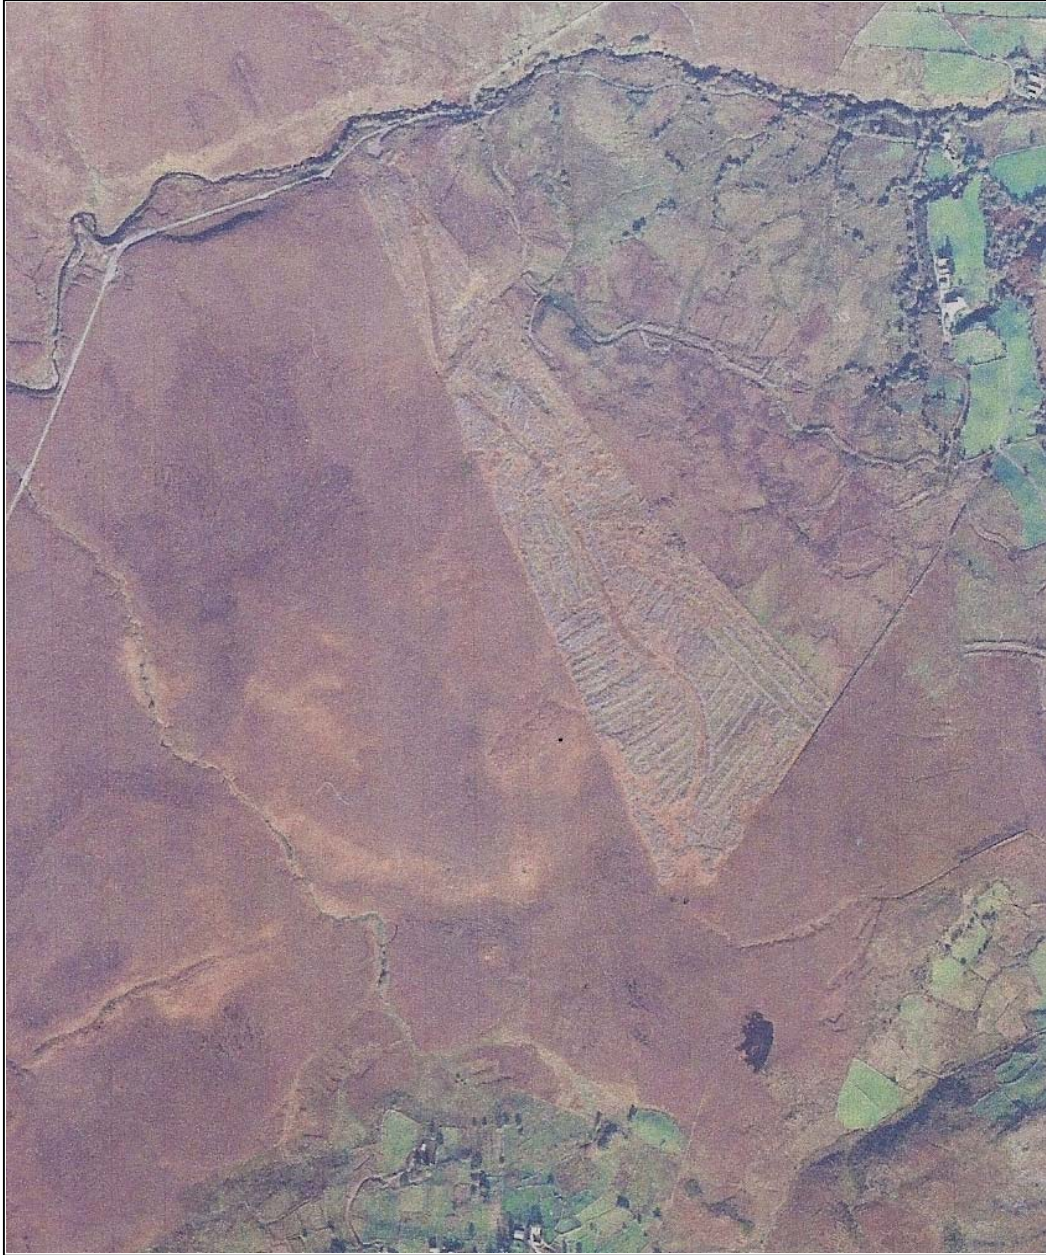
An aerial photograph of the Drumalohurt site after restoration. Aerial photograph taken in the year 2006.

At this site the main restoration measure undertaken was the felling of the young/low-yielding conifer crop by machine and the blocking of any significant artificial drains with plastic piling dams. During tree felling the machine pulled much of the felled material into brush tracks which it travelled on thus creating substantial open bog surface between the brush tracks.

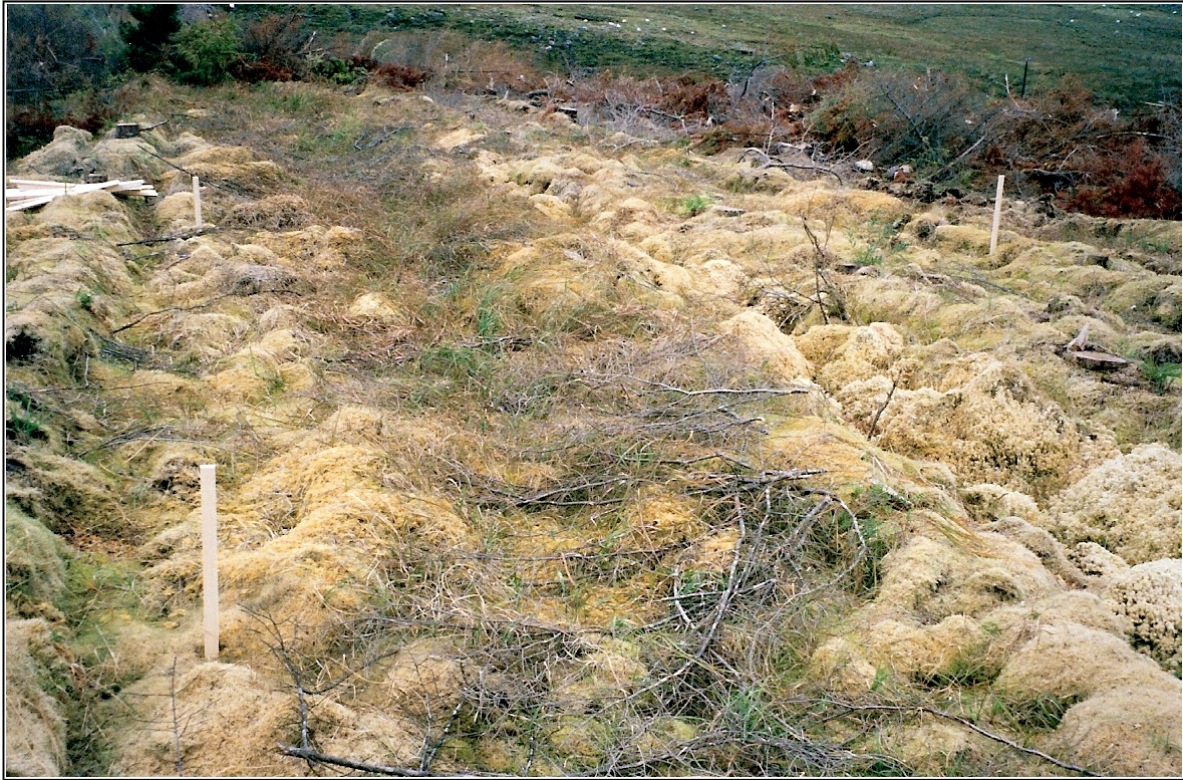
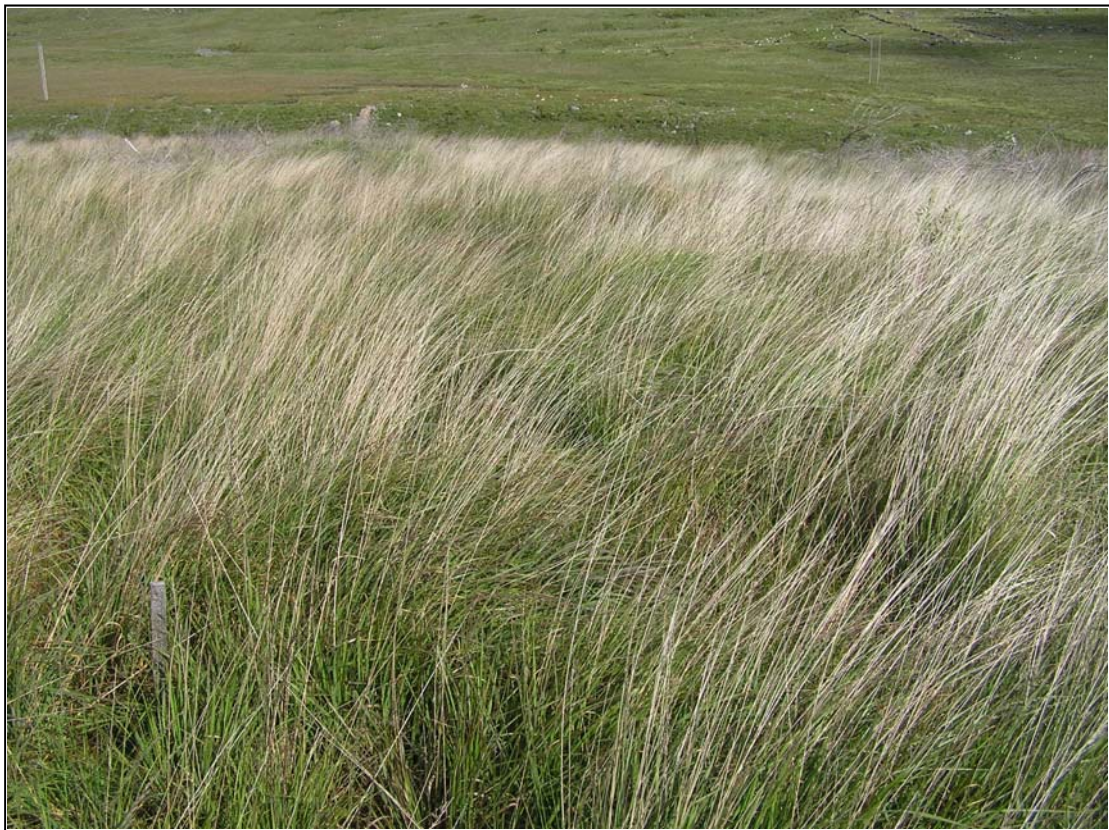
Permanent quadrat 1 – October 2003

Permanent quadrat 1 – August 2006

Code - PQ1			
GPS - V 69674 81531			
Near Walrag? - c. 5 m west of W. 5			
Size (m) - 6 x 6			
Slope (Degrees) - 3			
Vegetation cover (%)	98	98	100
Dwarf shrub cover (%)	<1	<1	2
Herb cover (%)	15	35	85
Bryophyte cover (%)	95	90	90
Needle litter cover (%)	5	<2	0
Brash cover (%)	5	3	0
No of species present	23	27	23
Date of survey	10/10/03	29/8/04	22/8/06
<i>Hypnum cupressiforme</i>	6	6	5
<i>Sphagnum capillifolium</i>	4	4	4
<i>Molinia caerulea</i>	4	5	7
<i>Sphagnum palustre</i>	4	4	3
<i>Rhytidiadelphus squarrosus</i>	3	-	-
<i>Thuidium tamariscinum</i>	3	3	3
<i>Rhytidiadelphus loreus</i>	3	3	3
<i>Hylocomium splendens</i>	2	3	3
<i>Plagiothecium undulatum</i>	2	-	-
<i>Sphagnum papillosum</i>	2	2	3
<i>Eurhynchium praelongum</i>	2	-	-
<i>Potentilla erecta</i>	2	1	1
Liverwort species	1	-	-
<i>Dicranum scoparium</i>	1	1	-
<i>Pseudoscleropodium purum</i>	1	2	1
<i>Dryopteris dilatata</i>	1	1	1
<i>Salix cinerea</i>	1	1	1
<i>Hedera helix</i>	1	1	1

<i>Erica tetralix</i>	1	1	1
<i>Ilex aquifolium</i>	1	-	1
<i>Blechnum spicant</i>	1	1	-
<i>Sorbus aucuparia</i>	1	1	-
<i>Dryopteris</i> sp.	1	1	-
<i>Polytrichum</i> sp.		2	3
<i>Pluerozium schreberi</i>		2	-
<i>Sphagnum auriculatum</i>		2	-
<i>Agrostis</i> sp.		1	1
<i>Luzula multiflora</i>		1	2
<i>Rubus fruticosus</i>		1	1
<i>Osmunda regalis</i>		1	1
<i>Betula pubescens</i> (seedlings)		1	-
<i>Pinus contorta</i> (seedling)		1	-
<i>Calluna vulgaris</i>			2
<i>Eriophorum vaginatum</i>			1
<i>Eriophorum angustifolium</i>			1
History – Previously dominated by a mixed Sitka spruce/Lodgepole pine plantation planted in the early 1980's. Trees were generally between 6 and 8 metres tall. Ground vegetation dominated by mosses (mainly <i>Hypnum cupressiforme</i>). Trees felled in the summer of 2003.

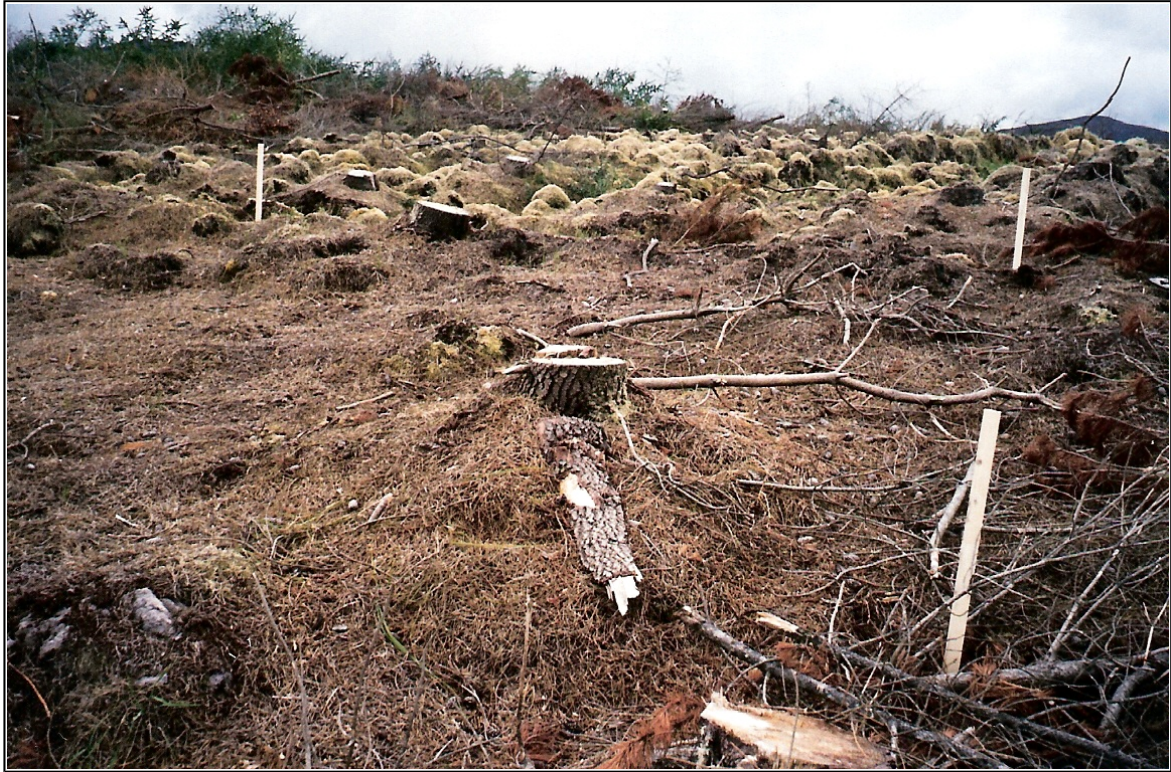
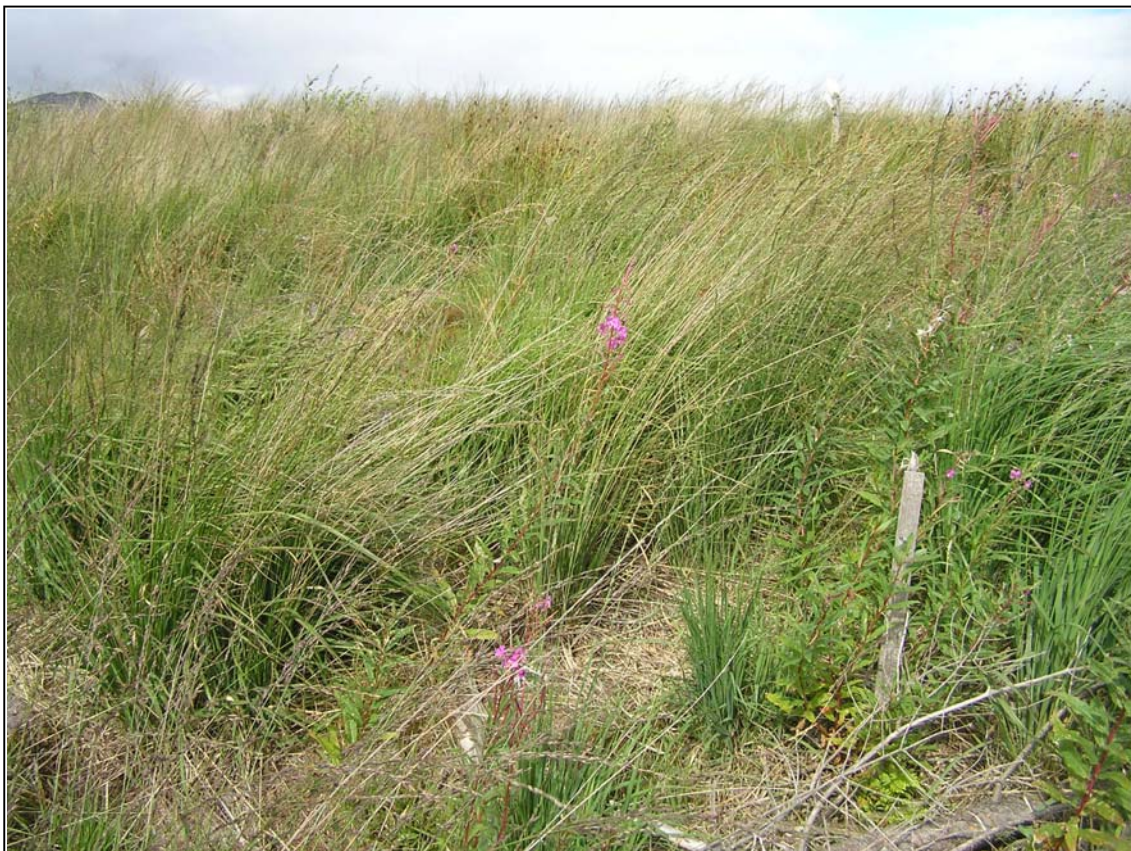
Permanent quadrat 2 – October 2003

Permanent quadrat 2 – August 2006

Site - Drumalohurt			
Code - PQ2			
GPS - V 69708 81461			
Near Walrag? - No			
Size (m) - 5 x 5			
Slope (Degrees) – 20 to 30			
Vegetation cover (%)	5	8	80
Dwarf shrub cover (%)	0	1	5
Herb cover (%)	3	5	60
Bryophyte cover (%)	3	5	50
Needle litter cover (%)	85	80	3
Brash cover (%)	10	5	5
No of species present	5	14	21
Date of survey	10/10/03	29/8/04	22/8/06
<i>Hypnum cupressiforme</i>	2	2	2
<i>Molinia caerulea</i>	2	3	5
<i>Dryopteris dilatata</i>	1	1	1
<i>Thuidium tamariscinum</i>	1	1	-
<i>Rhytidiadelphus loreus</i>	1	-	-
<i>Polytrichum</i> sp.		2	3
<i>Agrostis</i> sp.		1	2
<i>Calluna vulgaris</i>		1	3
<i>Potentilla erecta</i>		1	-
<i>Luzula multiflora</i>		1	1
<i>Epilobium</i> sp.		1	1
<i>Pinus contorta</i> (seedlings)		1 (2 counted)	-
<i>Rubus fruticosus</i>		1	1
<i>Sorbus aucuparia</i> (seedlings)		1	1
<i>Juncus</i> sp.		1	-
<i>Campylopus introflexus</i>			5
<i>Juncus effusus</i>			3
<i>Epilobium angustifolium</i>			2

<i>Juncus bulbosus</i>			2
<i>Carex echinata</i>			2
<i>Digitalis purpurea</i>			1
<i>Erica tetralix</i>			1
<i>Juncus squarrosus</i>			1
<i>Betula pubescens</i> (saplings)			1
<i>Eriophorum angustifolium</i>			1
<i>Juncus squarrosus</i>			1
<p>History – Area on sloping ground previously dominated by Lodgepole pine trees planted in the early 1990's. Trees were generally between 6 and 8 metres tall. Ground vegetation dominated by pine needles. Trees felled in the summer of 2003.</p>

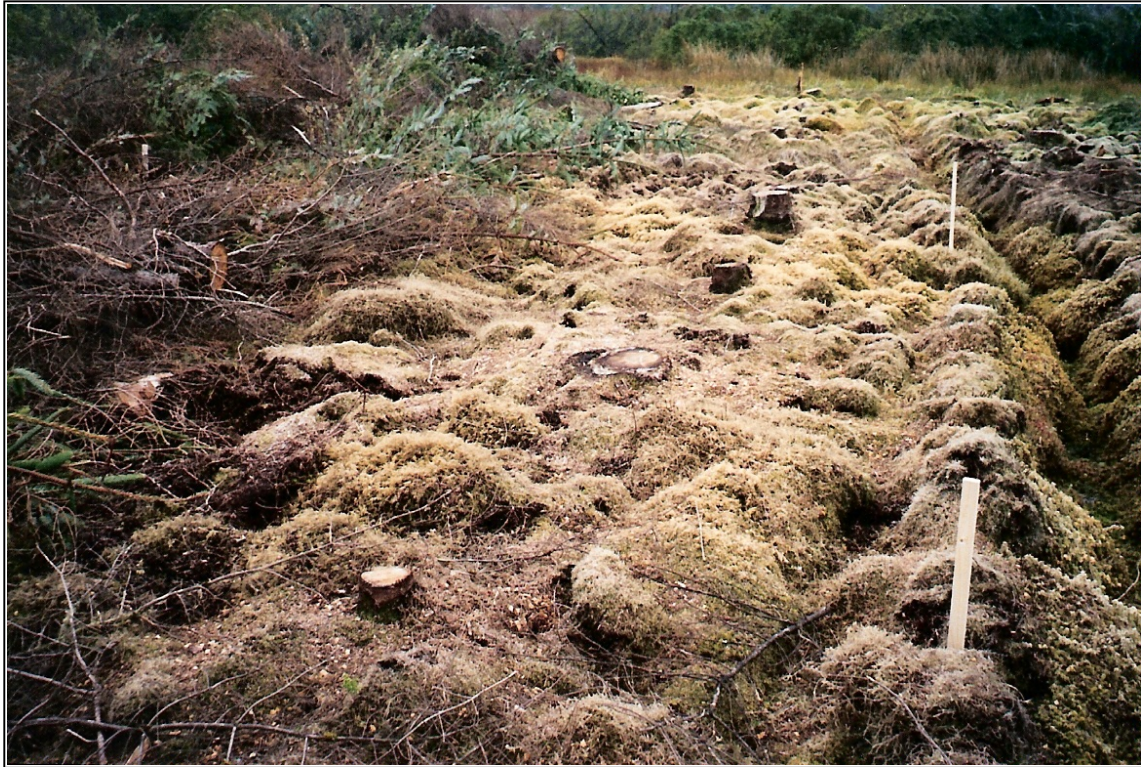
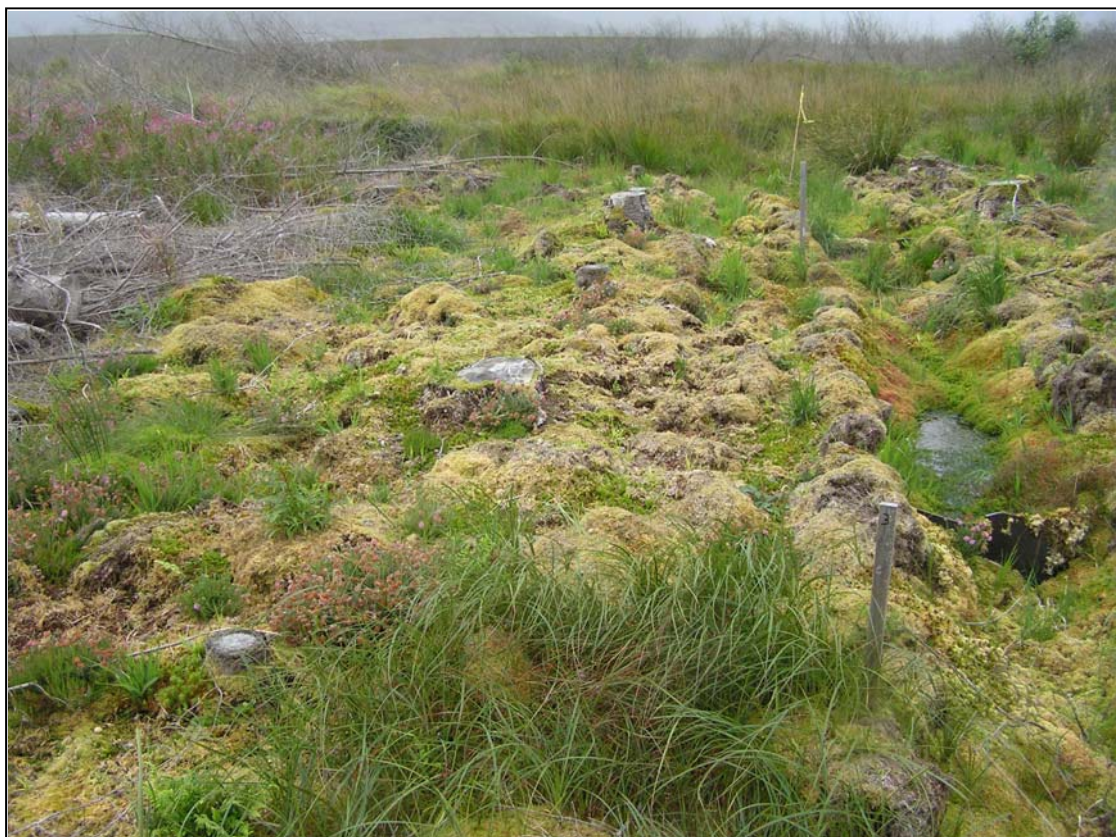
Permanent quadrat 3 – October 2003

Permanent quadrat 3 – August 2006

Site - Drumalohurt			
Code - PQ3			
GPS - V 69769 81282			
Near Walrag? - No			
Size (m) - 6 x 6			
Slope (Degrees) - 5 - 10			
Vegetation cover (%)	35	45	75
Dwarf shrub cover (%)	1	1	3
Herb cover (%)	1	1	15
Bryophyte cover (%)	35	45	65
Needle litter cover (%)	20	10	0
Brash cover (%)	40	35	25
Bare ground cover (%)	0	5	5
No of species present	10	16	26
Date of survey	10/10/03	29/8/04	22/8/06
<i>Thuidium tamariscinum</i>	4	4	3
<i>Hypnum cupressiforme</i>	4	4	5
<i>Rhytiadelphus loreus</i>	3	3	4
<i>Polytrichum commune</i>	2	2	4
<i>Dicranum scoparium</i>	2	2	2
<i>Plagiothecium undulatum</i>	1	2	-
<i>Sphagnum capillifolium</i>	1	2	1
<i>Sphagnum palustre</i>	1	1	2
<i>Dryopteris dilatata</i>	1	1	2
<i>Ilex aquifolium</i> (seedlings)	1	1	1
<i>Calluna vulgaris</i>		1	2
<i>Rhytiadelphus triquetrus</i>		1	-
<i>Molinia caerulea</i>		1	2
<i>Erica tetralix</i>		1	2
<i>Juncus</i> sp.		1	-
<i>Hylocomium splendens</i>		1	3
<i>Campylopus introflexus</i>			5

<i>Eriophorum angustifolium</i>			2
<i>Juncus effusus</i>			1
<i>Carex echinata</i>			1
<i>Epilobium</i> sp.			1
<i>Rubus fruticosus</i>			1
<i>Epilobium angustifolium</i>			1
<i>Drosera rotundifolia</i>			1
<i>Juncus bulbosus</i>			1
<i>Potentilla erecta</i>			1
<i>Blechnum spicant</i>			1
<i>Sphagnum cuspidatum</i>			1
<i>Rhynchospora alba</i>			1
History – Previously dominated by fairly well-grown Sitka spruce planted in the early 1980's. Trees were generally between 6 and 8 metres tall. Ground vegetation dominated by mosses. Trees felled in the summer of 2003. The southern half of the quadrat is dominated by a thick brash mat. Drains blocked in Spring 04.

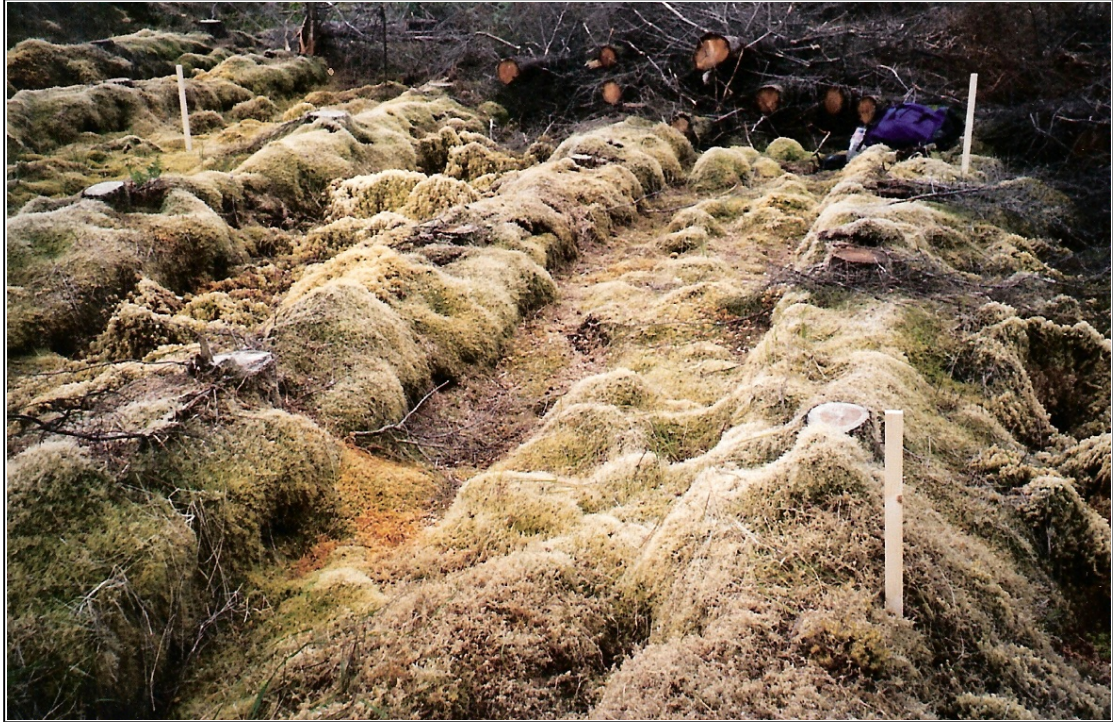
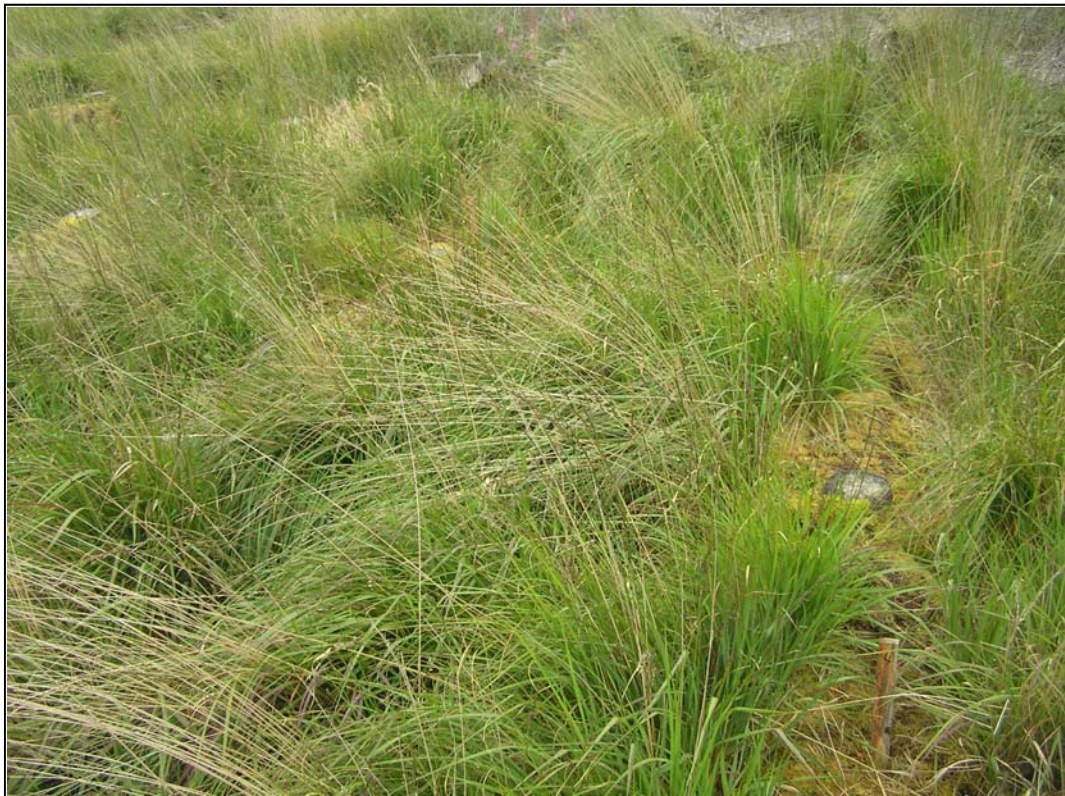
Permanent quadrat 4 – October 2003

Permanent quadrat 4 – August 2006

Site - Drumalohurt			
Code - PQ4			
GPS - V 69853 81249			
Near Walrag? - No			
Size (m) - 6 x 6			
Slope (Degrees) - 3 to 5			
Vegetation cover (%)	90	90	100
Dwarf shrub cover (%)	0	1	3
Herb cover (%)	5	15	70
Bryophyte cover (%)	90	90	90
Needle litter cover (%)	3	3	1
Bare ground cover (%)	3	1	0
No of species present	14	25	27
Date of survey	10/10/03	29/8/04	22/8/06
<i>Hypnum cupressiforme</i>	5	6	5
<i>Eurhynchium praelongum</i>	4	3	3
<i>Sphagnum capillifolium</i>	4	4	4
<i>Thuidium tamariscinum</i>	3	3	2
<i>Sphagnum palustre</i>	3	3	3
<i>Molinia caerulea</i>	3	4	5
<i>Rhytidiadelphus loreus</i>	3	3	-
<i>Polytrichum</i> spp.	2	2	3
<i>Plagiothecium undulatum</i>	2	2	-
<i>Dicranum scoparium</i>	1	1	1
<i>Potentilla erecta</i>	1	1	2
<i>Blechnum spicant</i>	1	-	-
<i>Dryopteris dilatata</i>	1	1	1
<i>Sphagnum cuspidatum</i>	1	1	1
<i>Campylopus</i> sp.		3	4
<i>Agrostis</i> spp.		1	3
<i>Betula pubescens</i> (seedlings)		1	1
<i>Calluna vulgaris</i>		1	2

<i>Carex echinata</i>		1	3
<i>Hylocomium splendens</i>		1	-
<i>Juncus bufonius</i>		1	-
<i>Juncus bulbosus</i>		1	2
<i>Luzula multiflora</i>		1	1
<i>Pseudoscleropodium purum</i>		1	-
<i>Rubus fruticosus</i>		1	1
<i>Sorbus aucuparia</i> (seedling)		1	1
<i>Sphagnum papillosum</i>			3
<i>Holcus lanatus</i>			2
<i>Juncus effusus</i>			2
<i>Erica tetralix</i>			1
<i>Eriophorum angustifolium</i>			1
<i>Epilobium angustifolium</i>			1
<i>Campylopus atrovirens</i>			1
History – Previously dominated by fairly well-grown Sitka spruce planted in the early 1980's. Trees were generally between 6 and 8 metres tall. Ground vegetation dominated by mosses (esp. <i>Hypnum</i>). Trees felled in the summer of 2003.

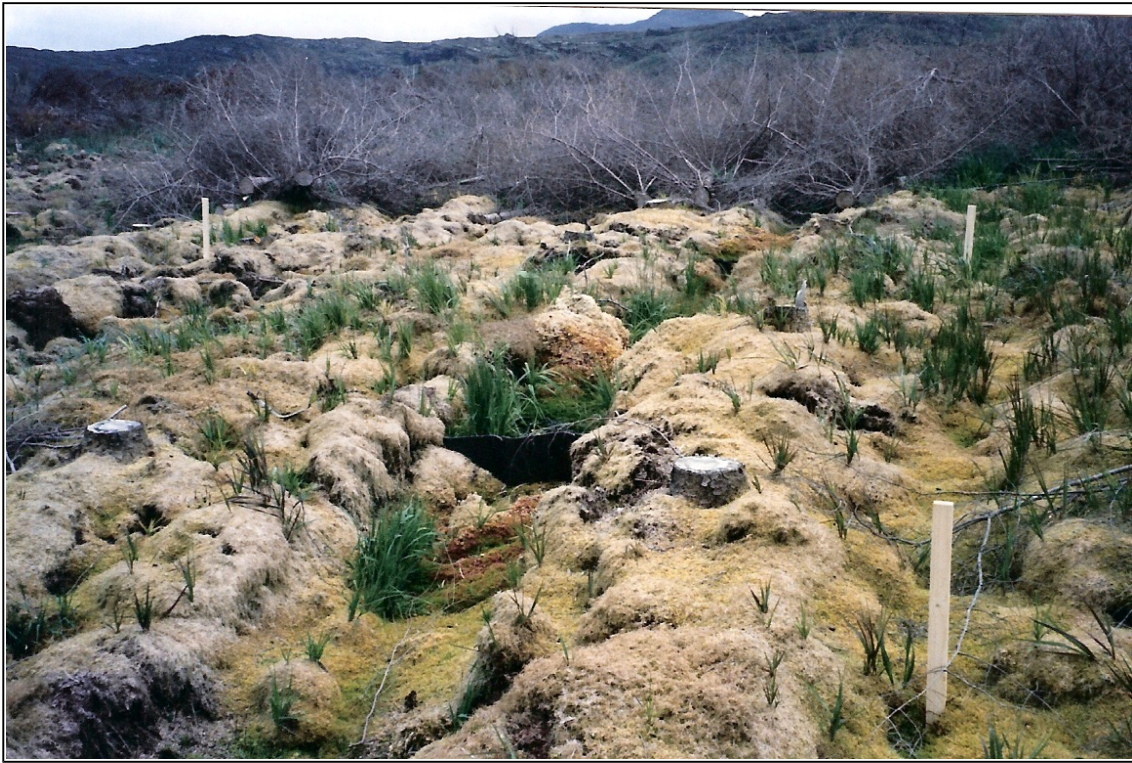
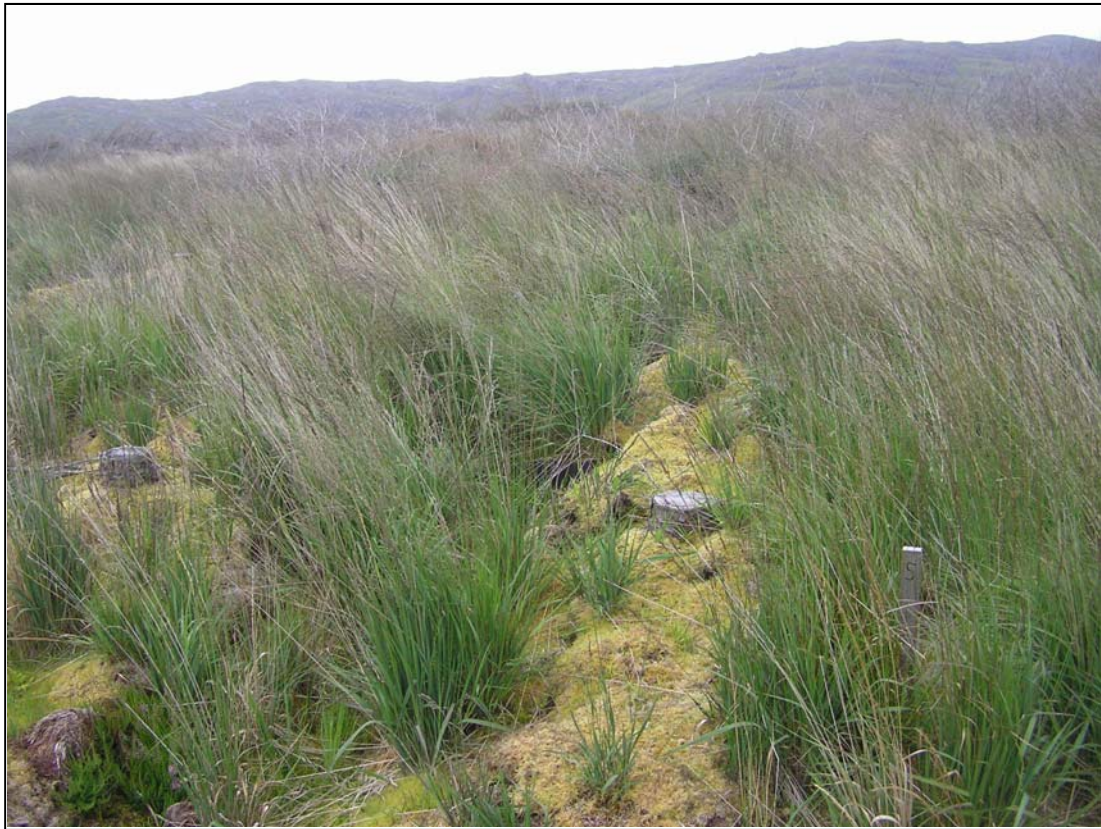
Permanent quadrat 5 – September 2004

Permanent quadrat 5 – August 2006

Site - Drumalohurt		
Code - PQ5		
GPS - V 69956 81116		
Near Walrag? - No		
Size (m) - 7x7		
Slope (Degrees) - 10 to 15		
Vegetation cover (%)	80	95
Dwarf shrub cover (%)	1	5
Herb cover (%)	15	70
Bryophyte cover (%)	75	80
Needle litter cover (%)	5	0
Surface water in drains cover (%)	3	-
Brash cover (%)	5	2
No of species present	14	23
Date of survey	29/8/04	22/8/06
<i>Hypnum cupressiforme</i>	5	5
<i>Molinia caerulea</i>	4	5
<i>Rhytiadelphus loreus</i>	4	3
<i>Sphagnum capillifolium</i>	4	4
<i>Dicranum scoparium</i>	2	2
<i>Hylocomium splendens</i>	2	3
<i>Polytrichum commune</i>	2	3
<i>Thuidium tamariscinum</i>	2	2
<i>Calluna vulgaris</i>	1	2
<i>Dryopteris dilatata</i>	1	2
<i>Erica tetralix</i>	1	2
<i>Ilex aquifolium</i> (seedlings)	1	1
<i>Juncus bulbosus</i>	1	2
<i>Juncus</i> sp.	1	-
<i>Eriophorum angustifolium</i>		2
<i>Campylopus</i> sp.		2
<i>Betula pubescens</i> (Seedlings)		1
<i>Potentilla erecta</i>		1
<i>Pleurozium schreberi</i>		1

Liverwort species		1
<i>Sphagnum palustre</i>		1
<i>Luzula multiflora</i>		1
<i>Juncus effusus</i>		1
<i>Rhytiadelphus squarrosus</i>		1
History - Previously dominated by fairly well-grown Sitka spruce planted in the early 1980's. Trees were generally between 6 and 8 metres tall. Ground vegetation dominated by mosses (esp. <i>Hypnum</i>). Trees felled in the summer of 2003. Quadrat located c. 300 metres south of PQ4.
