RESTORING ACTIVE BLANKET BOG IN IRELAND

Project reference: LIFE02NAT/IRL/8490

A REPORT ON THE RESTORATION OF PROJECT SITE No. 7 ESKERAGH,
CO. MAYO

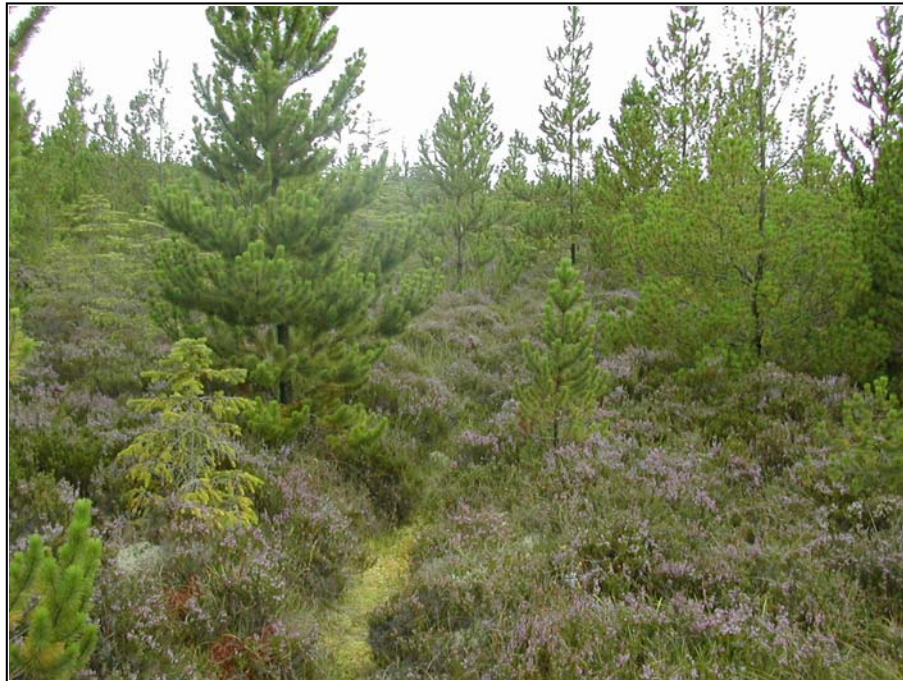
A general view of vegetation on the site prior to the start of restoration activities. Note the stunted nature of the conifers and the high cover of *Calluna vulgaris*. Photograph taken in September 2003.

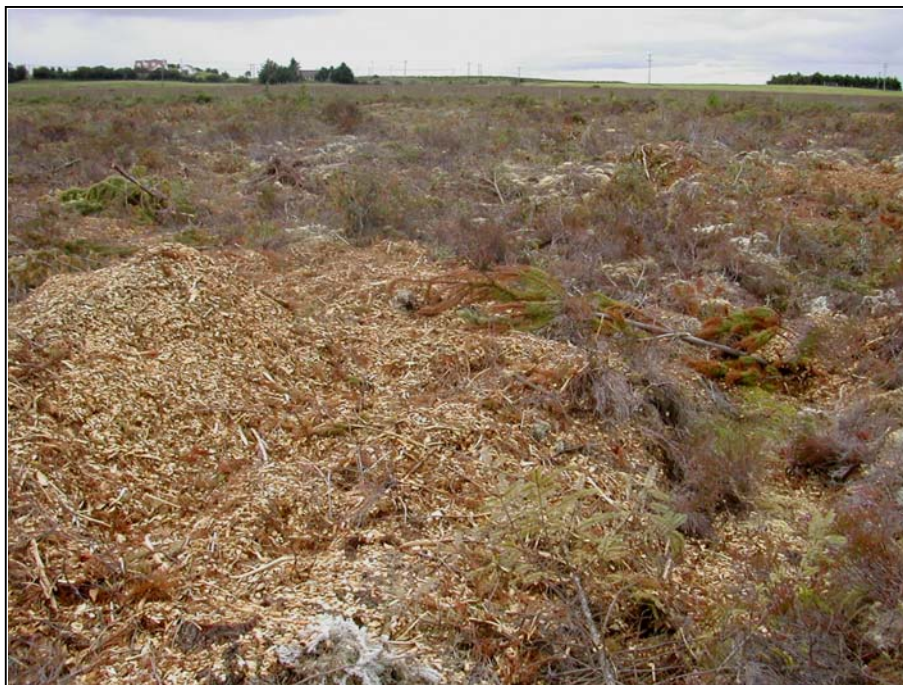
A view of chipped conifers in the west of the site. Note the very clean appearance of the bog surface following chipping. Photograph taken in September 2003.

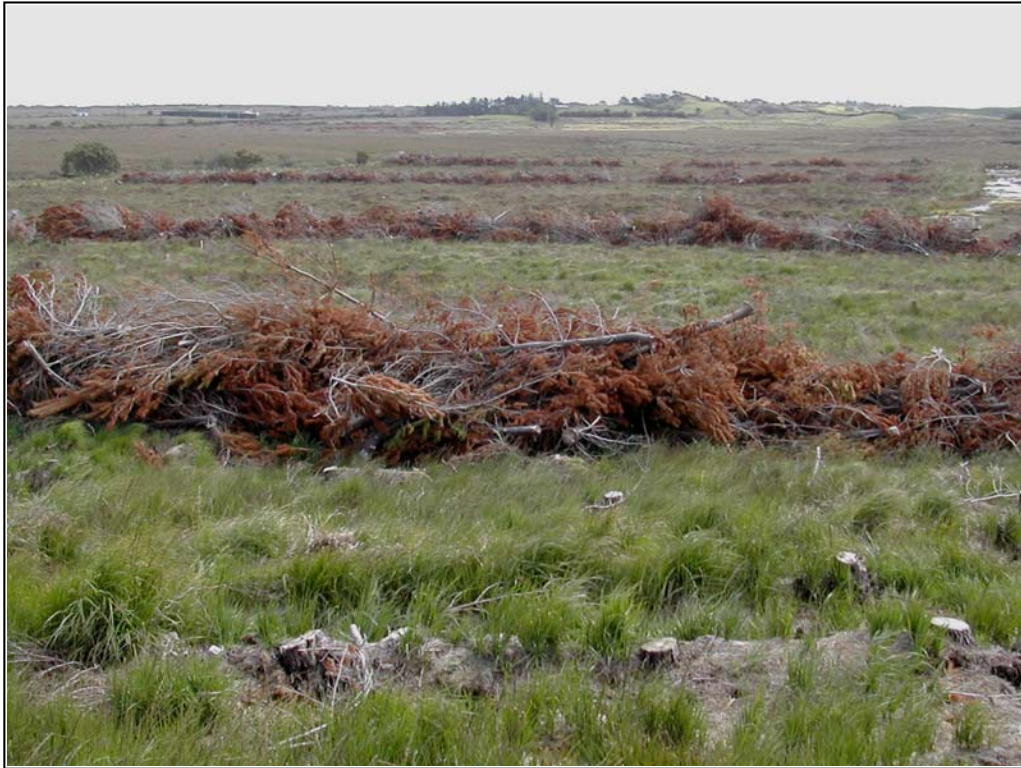
In the western portion of this site the conifer crop was windrowed after felling in order to produce a tidy bog surface. Note the strong regeneration of *Molinia* between the windrows. Photograph taken in August 2004.

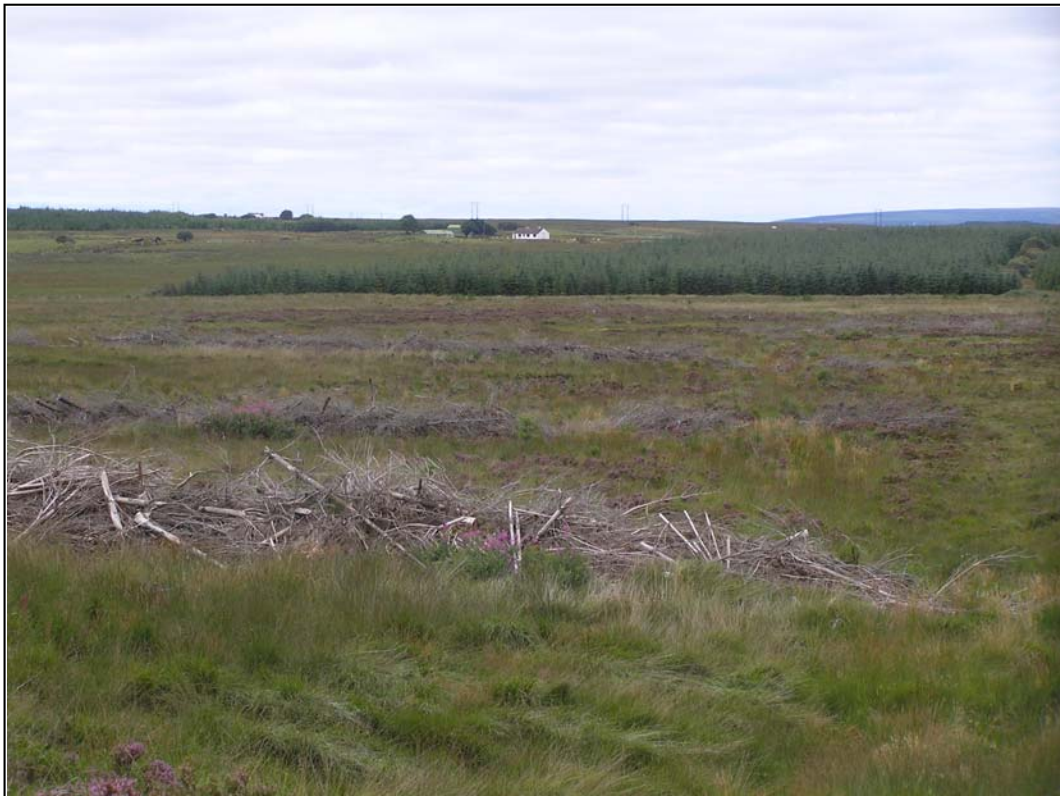
A general view of the western half of the site looking towards the west showing windrowed conifers and regenerating bog vegetation (mostly *Molinia* and *Calluna*). Photograph taken in August 2006.

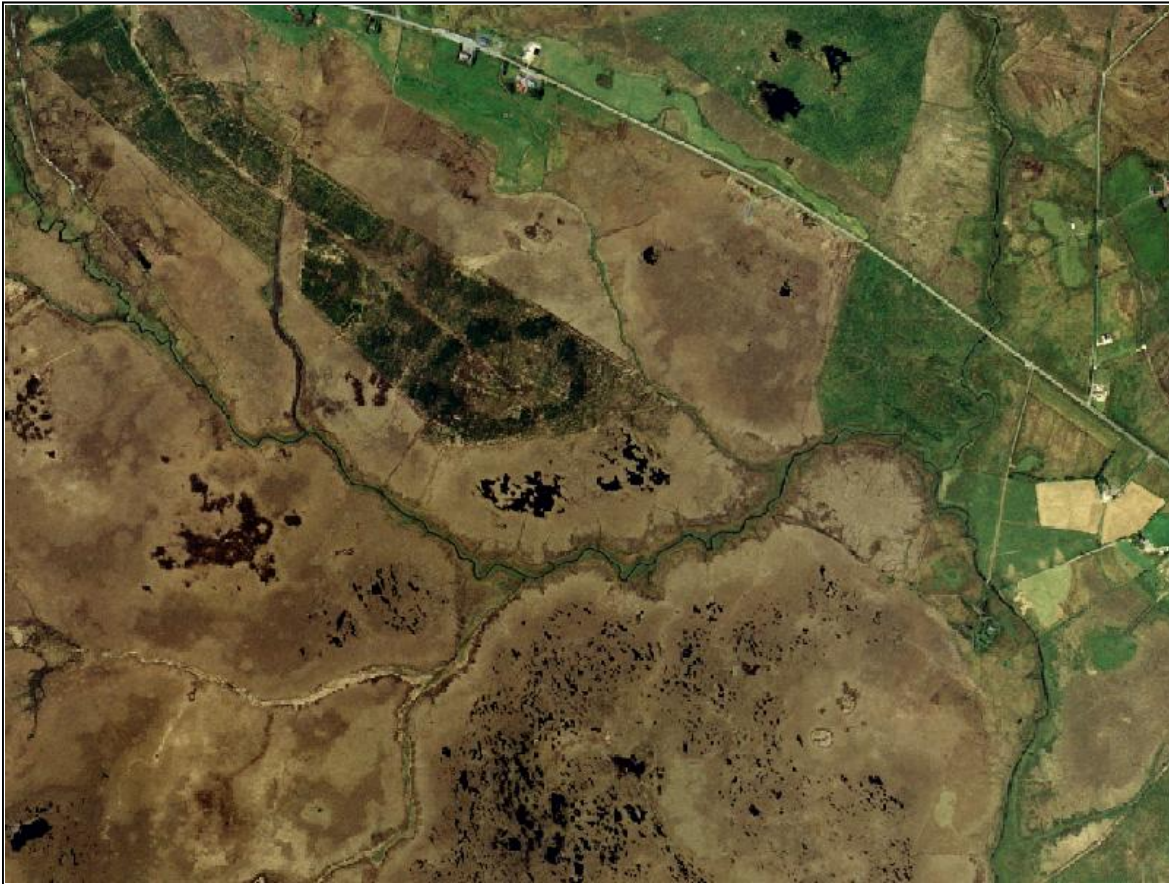
An aerial photograph of the Eskeragh site prior to the start of restoration activities. Aerial photograph taken in the year 2000.

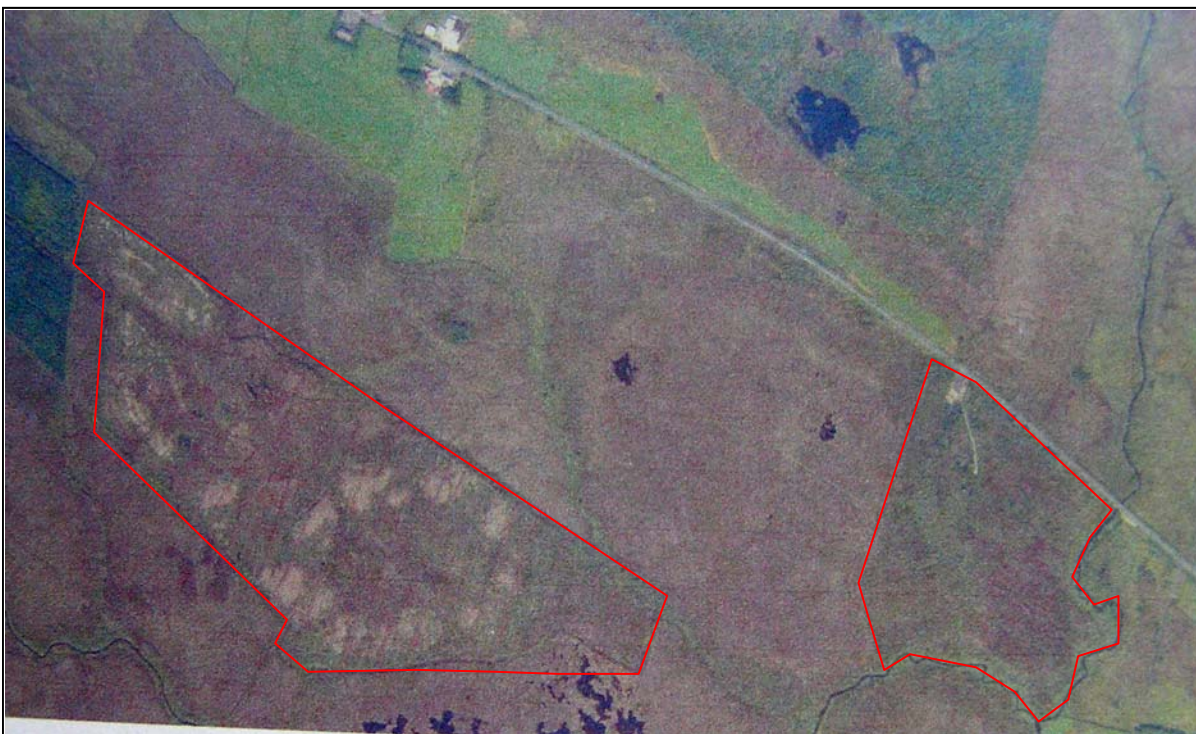
An aerial photograph of the Eskeragh site following restoration activities. Site outline in red. Aerial photograph taken in the year 2004.

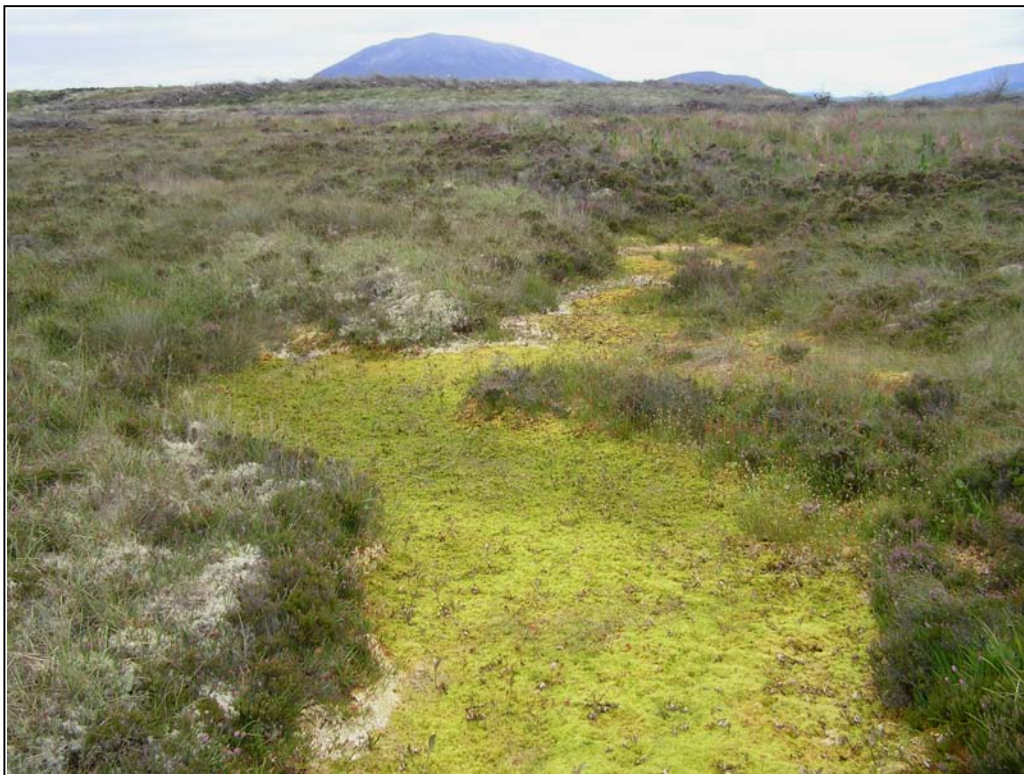
At Eskeragh there are a small number of open bog areas which contain bog pools. This one is dominated by the aquatic bog moss *Sphagnum cuspidatum*.

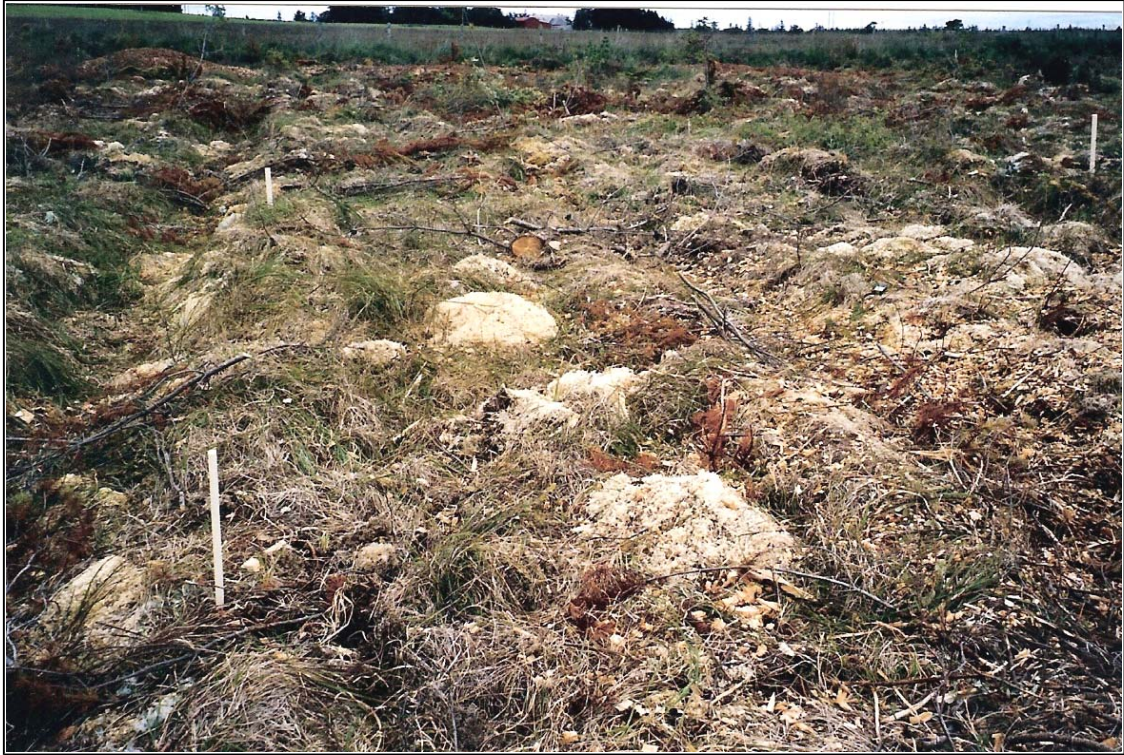
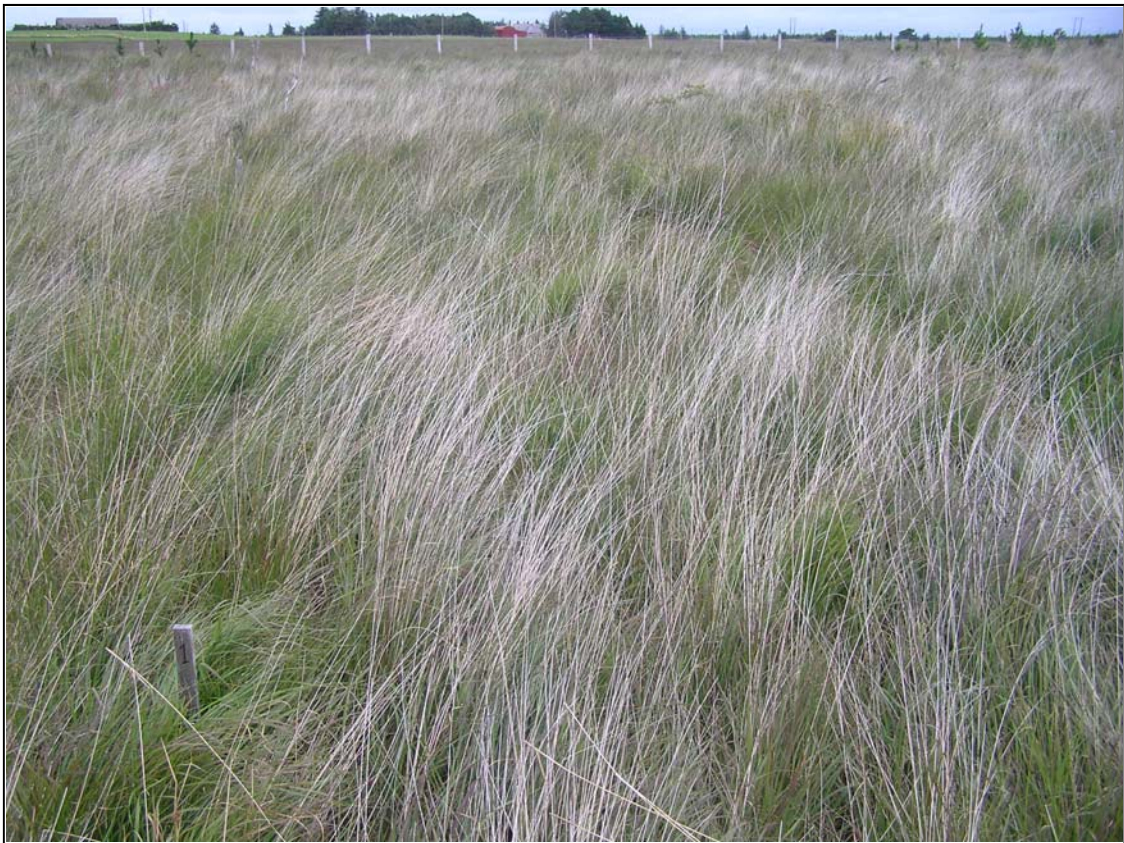
Quadrat 1 – September 2003

The main vegetation change since the start of the project has been the increase in the cover of *Molinia* in most of the permanent quadrats. This increase in cover is particularly pronounced in permanent

quadrats No. 1 and 4 where the species has attained almost 90% cover within three years. Other species which have expanded since the felling of conifers include *Sphagnum capillifolium*, *Campylopus introflexus* and *Polytrichum commune*. On the knoll which dominates the western subsite there has been a spectacular increase in the cover of *Calluna vulgaris*. This is probably due to the shallower peat cover in this part of the site.

Site - Eskeragh			
Code - PQ1			
GPS – G 04803 18319			
Near Walrag? - No			
Size (m) – 8x8			
Slope (Degrees) – 1-3			
Vegetation cover (%)	50	80	95
Dwarf shrub cover (%)	3	8	10
Herb cover (%)	15	50	70
Bryophyte cover (%)	35	50	60
Needle litter cover (%)	10	10	<3
Brush and wood chips cover (%)	30	10	5
No of species present	15	22	23
Date of survey	2/9/03	20/8/04	14/8/06
<i>Molinia caerulea</i>	4	6	6
<i>Sphagnum capillifolium</i>	4	4	5
<i>Hypnum cupressiforme</i>	3	4	4
<i>Calluna vulgaris</i>	2	2	3
<i>Sphagnum palustre</i>	2	2	3
<i>Cladonia portentosa</i>	2	2	2
<i>Potentilla erecta</i>	1	2	2
<i>Dicranum scoparium</i>	1	1	1
<i>Myrica gale</i>	1	1	1
<i>Rhytidiadelphus loreus</i>	1	1	-
<i>Campylopus introflexus</i>	1	1	3
<i>Salix aurita</i>	1	1	1
<i>Pinus contorta</i> seedling	1	1	-
<i>Diplophyllum albicans</i>	1	-	1
<i>Eurhynchium praelongum</i>	1	-	-
<i>Polytrichum</i> sp.		2	3
<i>Sphagnum papillosum</i>		2	2
<i>Aulacomium palustre</i>		1	1

<i>Erica tetralix</i>		1	2
<i>Hylocomium splendens</i>		1	-
<i>Dryopteris dilatata</i>		1	-
<i>Peltigera</i> sp.		1	1
<i>Juncus</i> spp.		1	-
<i>Epilobium angustifolium</i>		1	-
<i>Cladonia</i> sp.			1
<i>Rubus fruticosus</i>			1
<i>Rhytidiadelphus squarrosus</i>			1
<i>Plagiothecium undulatum</i>			1
<i>Juncus effusus</i>			1
<i>Sphagnum cuspidatum</i>			1
History – Previously dominated by a young Lodgepole pine plantation planted in 1990. Trees were generally between 4 and 6 metres tall. Trees felled in the summer of 2003 and trees in this area were chipped.

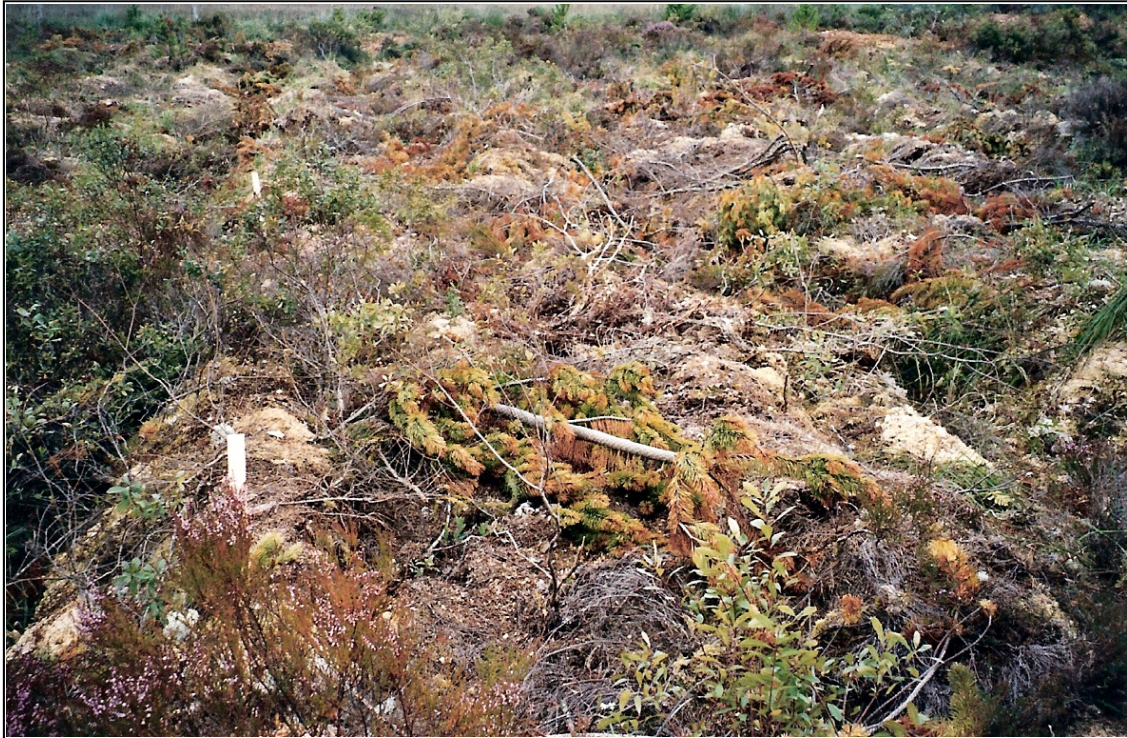
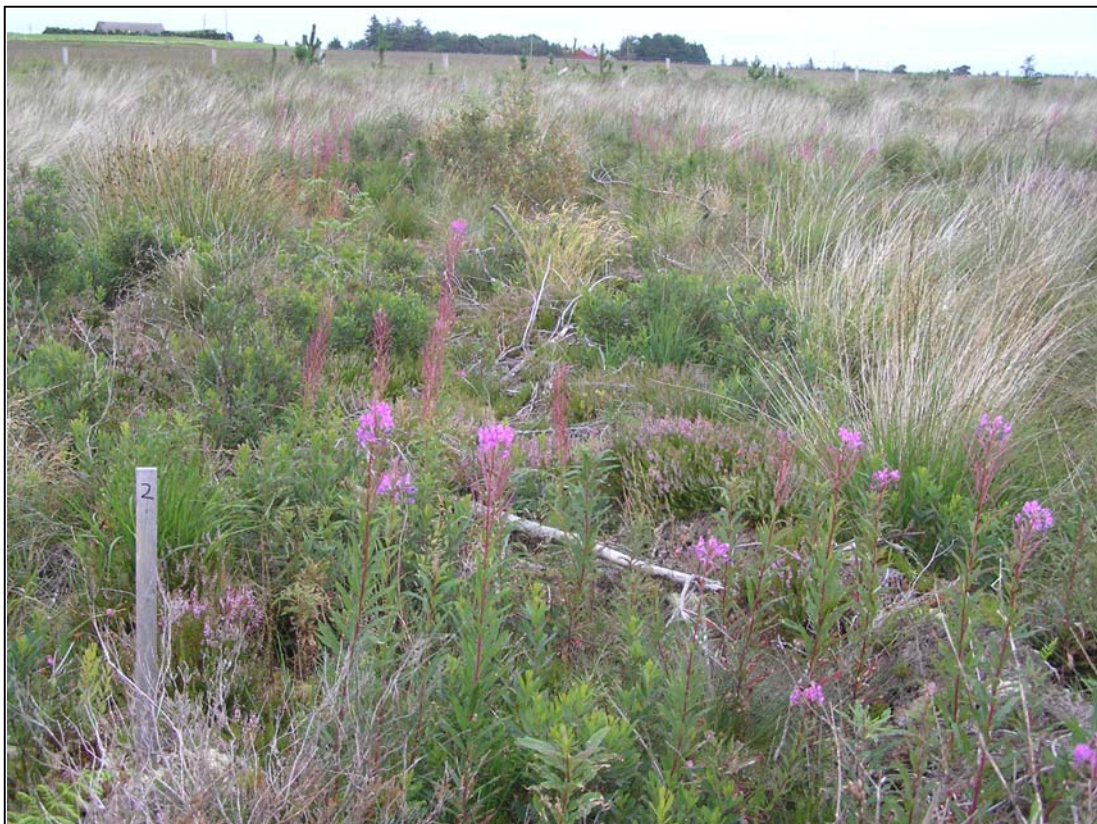
Quadrat 2 – September 2003

Site - Eskeragh			
Code - PQ2			
GPS - G 04777 18350			
Near Walrag? - No			
Size (m) - 7x7			
Slope (Degrees) - 1-3			
Vegetation cover (%)	70	80	90
Dwarf shrub cover (%)	20	30	40
Herb cover (%)	20	35	35
Bryophyte cover (%)	60	60	60
Needle litter cover (%)	10	5	<3
Brash cover (%)	20	15	10
Water cover (%)	0	5	0
No of species present	24	27	30
Date of survey	2/9/03	20/8/04	14/8/06
<i>Hypnum cupressiforme</i>	5	5	4
<i>Sphagnum capillifolium</i>	4	4	5
<i>Molinia caerulea</i>	4	4	5
<i>Myrica gale</i>	4	4	4
<i>Calluna vulgaris</i>	3	4	5
<i>Sphagnum palustre</i>	3	3	-
<i>Campylopus introflexus</i>	3	3	1
<i>Dicranum scoparium</i>	2	2	2
<i>Pseudoscleropodium purum</i>	2	1	1
<i>Pleurozium schreberi</i>	2	3	3
<i>Potentilla erecta</i>	2	3	3
<i>Rhytiadelphus loreus</i>	2	3	2
<i>Eriophorum vaginatum</i>	2	2	3
<i>Cladonia portentosa</i>	2	2	2
<i>Aulacomium palustris</i>	2	-	1
<i>Peltigera</i> sp.	1	2	-
<i>Juncus bulbosus</i>	1	2	1
<i>Dryopteris dilatata</i>	1	1	1

<i>Rubus fruticosus</i>	1	1	1
<i>Erica tetralix</i>	1	2	2
<i>Rhytiadelphus squarrosus</i>	1	-	1
<i>Pinus contorta</i> seedlings	1	1 (3 counted)	1 (1 counted)
<i>Sorbus aucuparia</i>	1	1	1
<i>Luzula multiflora</i>	1	-	-
<i>Epilobium angustifolium</i>		1	3
<i>Polytrichum</i> sp.		2	3
<i>Eriophorum angustifolium</i>		1	2
<i>Epilobium</i> sp.		1	1
<i>Sphagnum cuspidatum</i>		1	-
<i>Sphagnum papillosum</i>		1	1
<i>Agrostis canina</i>			3
<i>Juncus effusus</i>			2
<i>Anthoxanthum odoratum</i>			1
<i>Rumex acetosella</i>			1
History – Previously dominated by a young Lodgepole pine plantation planted in 1990. Trees

were generally between 4 and 6 metres tall. Ground vegetation dominated by a bog vegetation in which *Molinia* was dominant. Trees felled in the summer of 2003 and trees in this area were chipped. Drains blocked at the beginning of 2004.

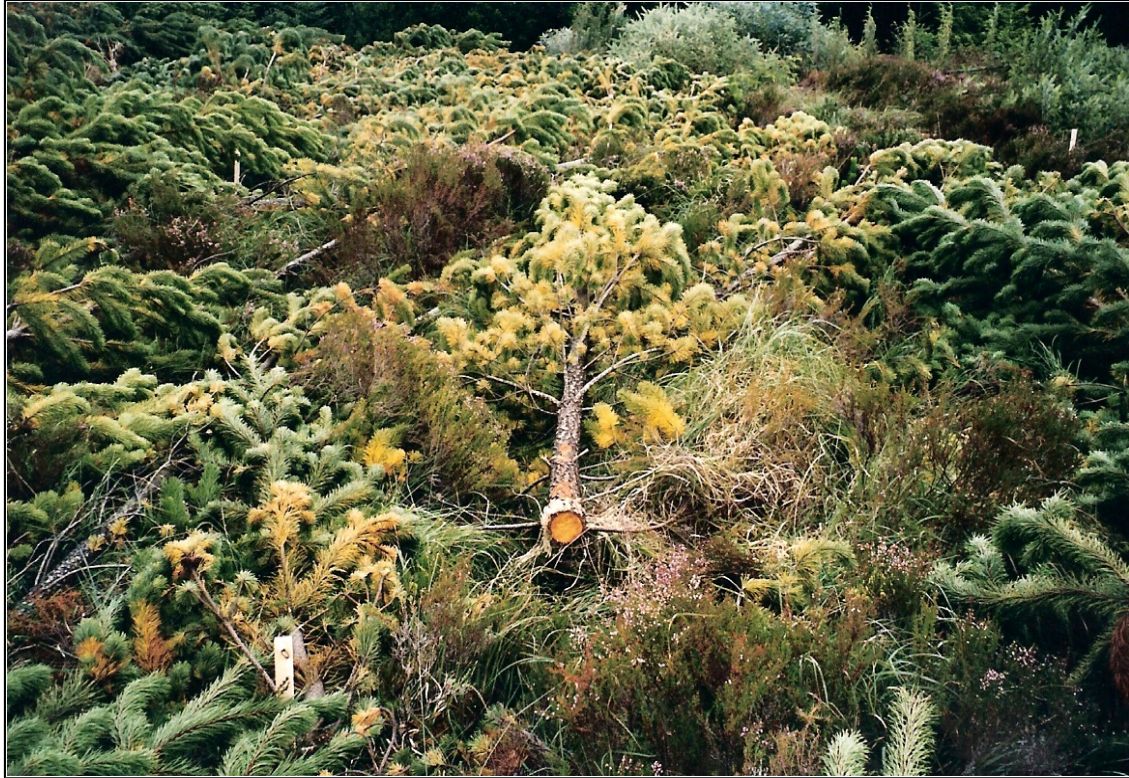
Quadrat 3 – September 2003

Site - Eskeragh		
Code - PQ3		
GPS - G 05016 18009		
Near Walrag? - No		
Size (m) - 7x7		
Slope (Degrees) - 0, but undulating		
Vegetation cover (%)	40 +	90
Dwarf shrub cover (%)	25	80
Herb cover (%)	20	25
Bryophyte cover (%)	30	40
Needle litter cover (%)	0	0
Felled tree cover (%)	60	20
Water cover (%)	0	0
No of species present	11	14
Date of survey	2/9/03	14/8/06
<i>Calluna vulgaris</i>	5	6
<i>Hypnum cupressiforme</i>	4	4
<i>Molinia caerulea</i>	4	4
<i>Sphagnum capillifolium</i>	4	4
<i>Pleurozium schreberi</i>	2	2
<i>Hylocomium splendens</i>	2	2
<i>Rhytidiadelphus loreus</i>	2	2
<i>Eriophorum vaginatum</i>	2	2
<i>Cladonia portentosa</i>	2	1
<i>Thuidium tamariscinum</i>	1	1
<i>Potentilla erecta</i>	1	1
<i>Dicranum scoparium</i>		1
<i>Erica tetralix</i>		1
<i>Plagithecium undulatum</i>		1

History – Previously dominated by a young Lodgepole pine plantation planted in 1990. Trees were generally between 6 and 8 metres tall. Ground vegetation dominated by vegetation in which *Calluna vulgaris* was dominant. Trees felled in the summer of 2003 and subsequently windrowed. Peat in area <1 metre in depth.

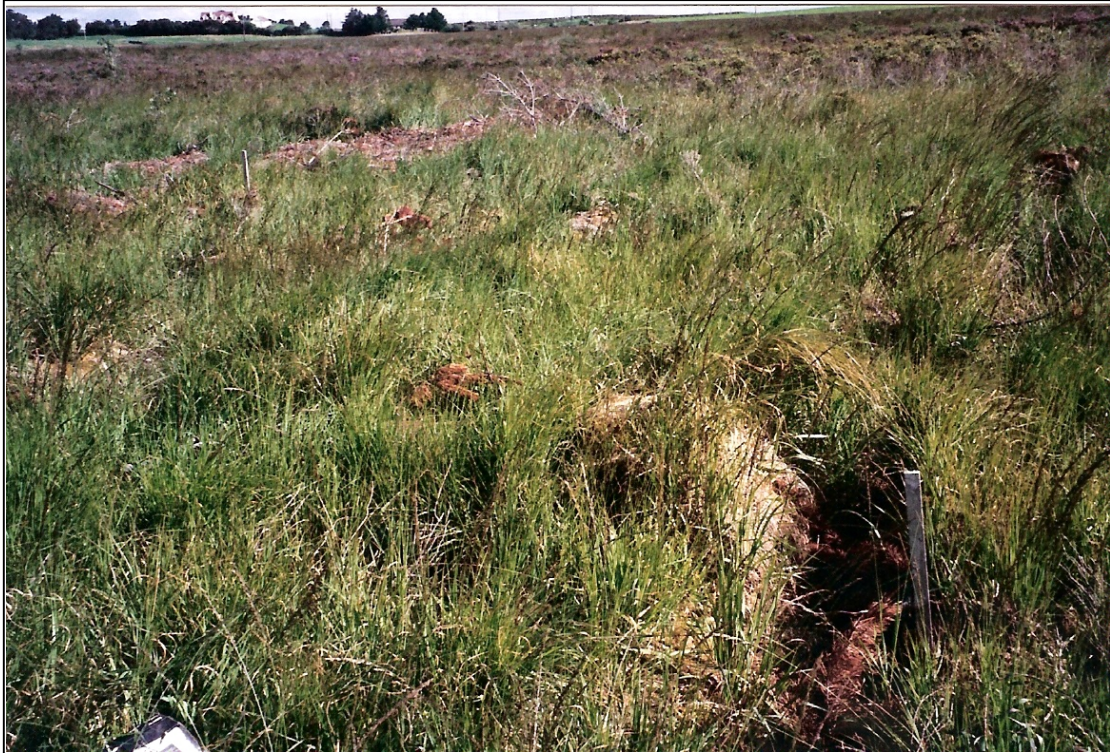
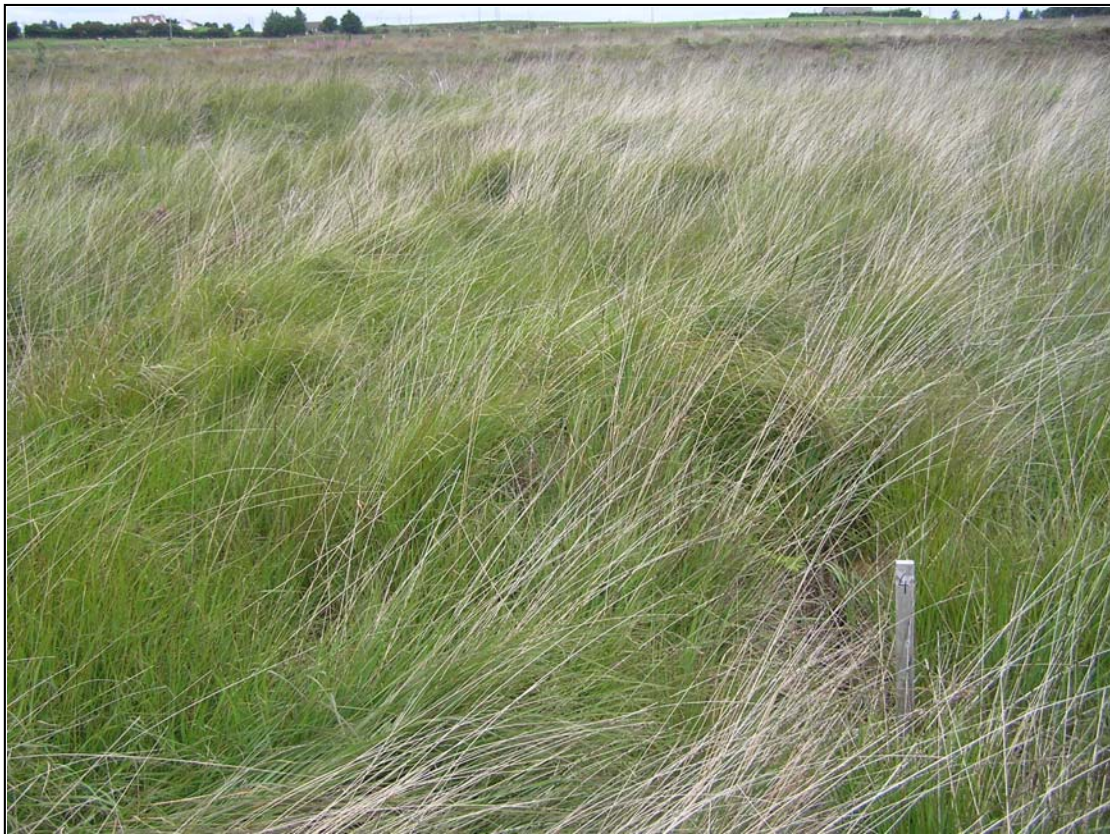
Quadrat 4 – August 2004

Site - Eskeragh			
Code - PQ4			
GPS – G 04752 18248			
Near Walrag? - No			
Size (m) - 6 x 6			
Slope (Degrees) - 0			
Vegetation cover (%)	70	90	100
Dwarf shrub cover (%)	15	25	15
Herb cover (%)	40	80	95
Bryophyte cover (%)	25	50	50
Needle litter cover (%)	20	10	0
Brash cover (%)	10	5	<3
Water cover (%)	0	0	0
No of species present	17	21	24
Date of survey	8/10/03	20/8/04	14/8/06
<i>Molinia caerulea</i>	5	6	7
<i>Calluna vulgaris</i>	4	4	4
<i>Hypnum cupressiforme</i>	4	4	5
<i>Myrica gale</i>	3	2	2
<i>Sphagnum capillifolium</i>	3	4	4
<i>Sphagnum cuspidatum</i>	2	2	2
<i>Aulacomium palustris</i>	2	2	1
<i>Erica tetralix</i>	2	2	2
<i>Hylocomium splendens</i>	2	3	3
<i>Polytrichum commune</i>	2	2	3
<i>Rhytidiadelphus squarrosus</i>	2	-	1
<i>Sphagnum palustre</i>	2	2	3
<i>Blechnum spicant</i>	1	1	1
<i>Cladonia portentosa</i>	1	2	3
<i>Dicranum scoparium</i>	1	-	-
<i>Dryopteris dilatata</i>	1	1	1
<i>Potentilla erecta</i>	1	2	2
<i>Sphagnum papillosum</i>		1	-

<i>Juncus bulbosus</i>		1	1
<i>Rhytidiadelphus loreus</i>		1	-
<i>Peltigera sp.</i>		1	1
<i>Epilobium angustifolium</i>		1	1
<i>Campylopus introflexus</i>		1	-
<i>Drosera rotundifolia</i>			1
<i>Racomitrium lanuginosum</i>			1
<i>Eriophorum vaginatum</i>			1
<i>Salix aurita</i>			1
<i>Sphagnum magellanicum</i>			1
History – Previously dominated by a young Lodgepole pine plantation planted in 1990. Trees were generally between 4 and 6 metres tall. Ground vegetation dominated by vegetation in which <i>Molinia caerulea</i> was dominant. Trees felled in the summer of 2003 and trees in this area were chipped. Drains blocked at the beginning of 2004.

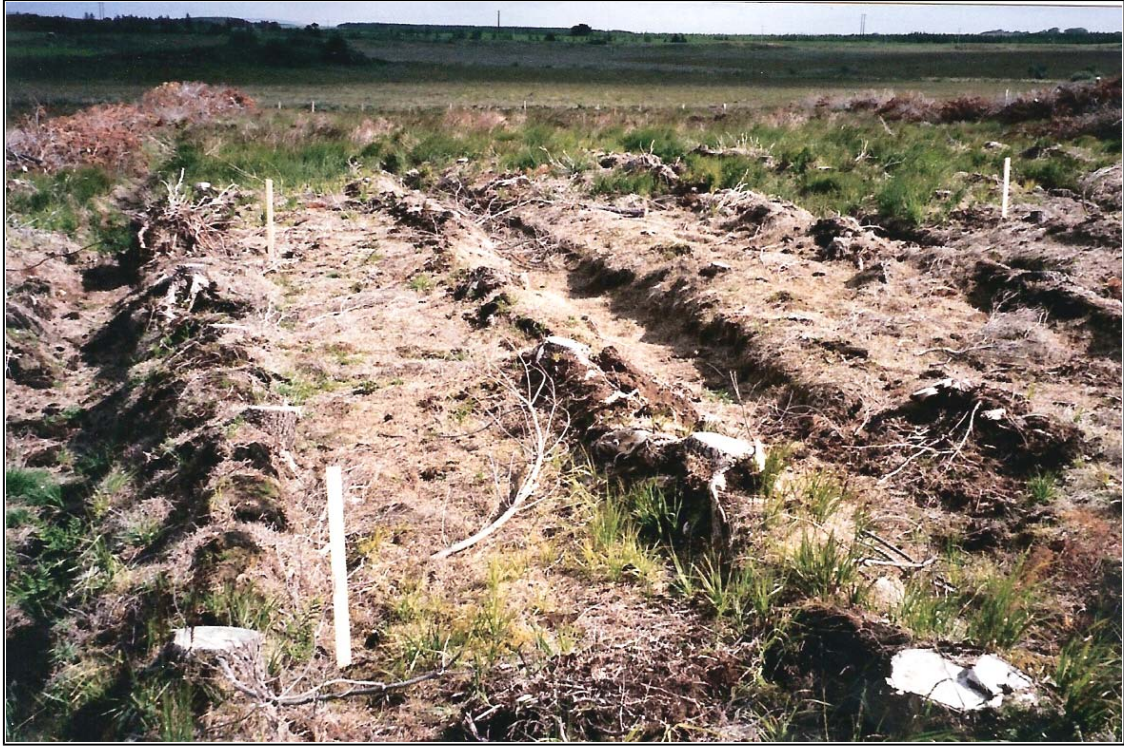
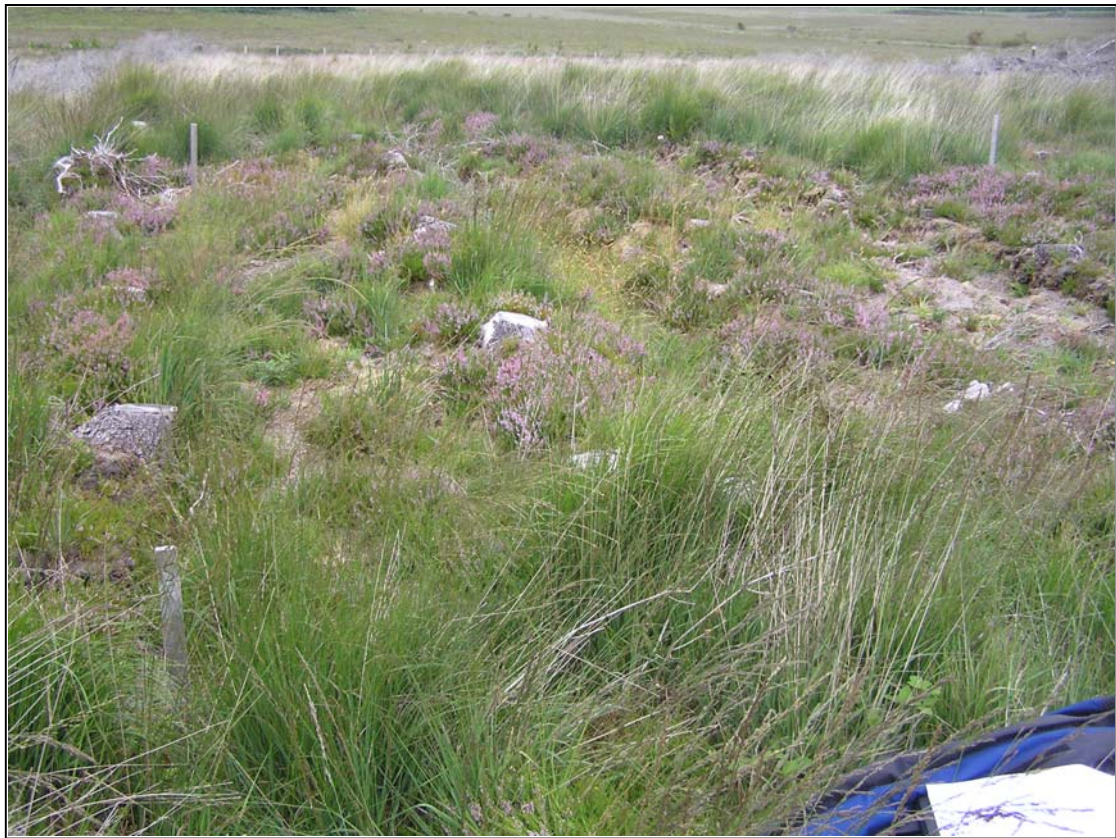
Quadrat 5 – August 2004

Site - Eskeragh		
Code - PQ5		
GPS – G 05110 18054		
Near Walrag? - No		
Size (m) – 8x8		
Slope (Degrees) - 0		
Vegetation cover (%)	15	70
Dwarf shrub cover (%)	3	35
Herb cover (%)	8	40
Bryophyte cover (%)	10	40
Needle litter cover (%)	70	15
Brash cover (%)	3	5
Bare ground cover (%)	10	10
No of species present	15	16
Date of survey	20/8/04	14/8/06
<i>Hypnum cupressiforme</i>	3	4
<i>Molinia caerulea</i>	3	3
<i>Calluna vulgaris</i>	2	5
<i>Carex</i> sp.	2	3
<i>Luzula multiflora</i>	2	3
<i>Cladonia portentosa</i>	1	2
<i>Dryopteris dilatata</i>	1	1
<i>Pseudoscleropodium purum</i>	1	-
<i>Pleurozium schreberi</i>	1	-
<i>Potentilla erecta</i>	1	2
<i>Cerastium fontanum</i>	1	-
<i>Epilobium angustifolium</i>	1	2
<i>Anthoxanthum odoratum</i>	1	4
<i>Agrostis</i> sp.	1	3
<i>Hypochoeris radicata</i>	1	-
<i>Pinus contorta</i> seedling	1 (1 counted)	-
<i>Campylopus</i> sp.		4
<i>Polytrichum commune</i>		4
<i>Rubus fruticosus</i>		1
<i>Erica tetralix</i>		1

<i>Carex panicea</i>		1
<p>History – Previously dominated by a young Lodgepole pine plantation planted in 1990. Trees were generally between 6 and 8 metres tall. Ground vegetation dominated by pine needle litter. Trees felled in the autumn of 2003 and subsequently windrowed. Peat only c. 1 metre deep in this area.</p>

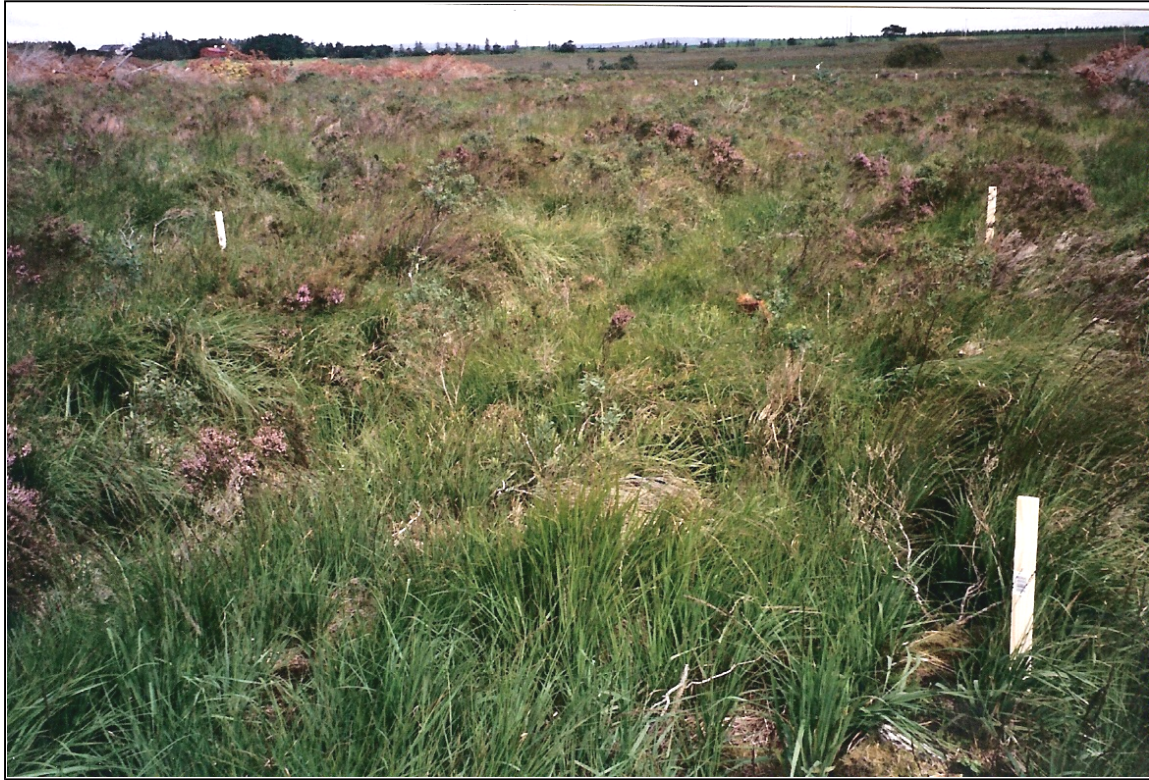
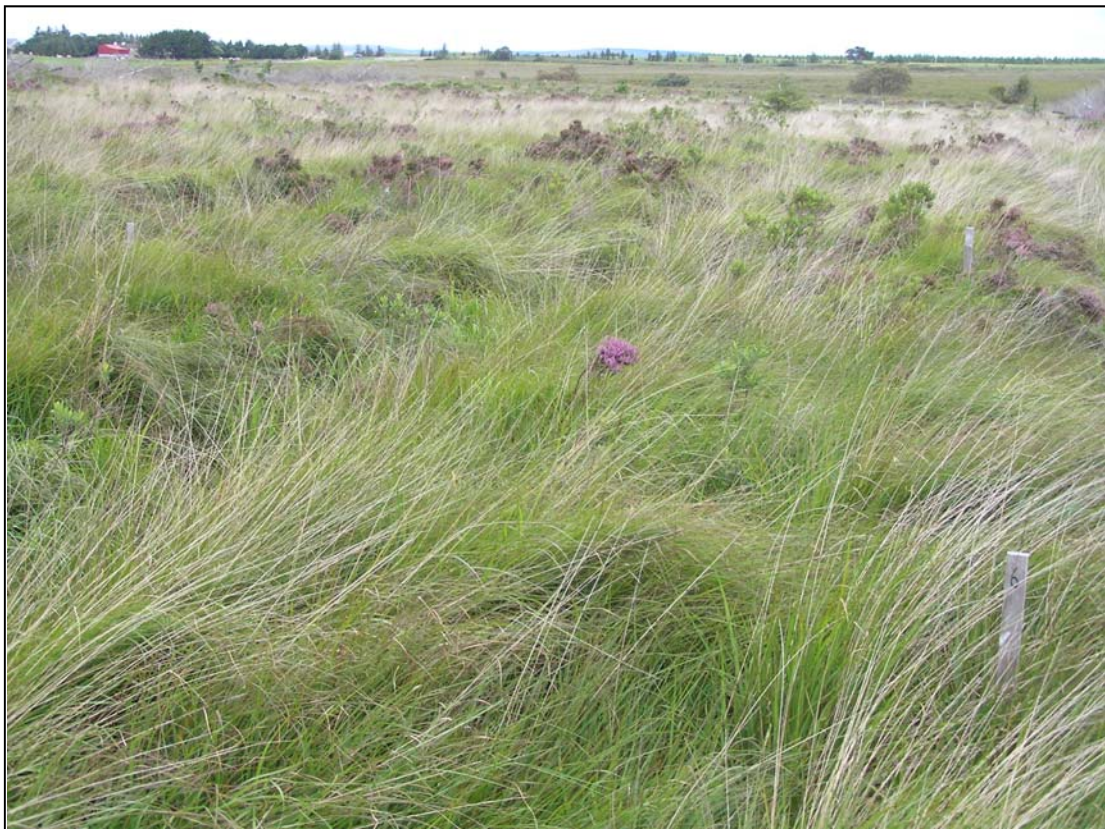
Quadrat 6 – August 2004

Site - Eskeragh		
Code – PQ6		
GPS – G 05337 17927		
Near Walrag? - No		
Size (m) - 7 x 7		
Slope (Degrees) - 0		
Vegetation cover (%)	98	100
Dwarf shrub cover (%)	25	25
Herb cover (%)	85	95
Bryophyte cover (%)	50	50
Needle litter cover (%)	0	0
Brash cover (%)	5	<3
Water cover (%)	5	0
No of species present	13	12
Date of survey	20/8/04	14/8/06
<i>Molinia caerulea</i>	7	7
<i>Hypnum cupressiforme</i>	5	5
<i>Sphagnum capillifolium</i>	4	4
<i>Calluna vulgaris</i>	4	4
<i>Myrica gale</i>	4	4
<i>Cladonia portentosa</i>	3	2
<i>Hylocomium splendens</i>	2	-
<i>Potentilla erecta</i>	2	2
<i>Dicranum scoparium</i>	1	-
<i>Dryopteris dilatata</i>	1	-
<i>Erica tetralix</i>	1	1
<i>Pleurozium scheberi</i>	1	3
<i>Polytrichum commune</i>	1	1
<i>Campylopus</i> sp.		2
<i>Sphagnum palustre</i>		1
<p>History – Previously dominated by a young and poor mixed Sitka/Lodgepole plantation planted in 1990. Trees were generally between 4 and 6 metres tall. Ground vegetation dominated by <i>Molinia caerulea</i>. Trees felled in the autumn of 2003 and subsequently windrowed.</p>
