RESTORING ACTIVE BLANKET BOG IN IRELAND

Project reference: LIFE02NAT/IRL/8490

A REPORT ON THE RESTORATION OF PROJECT SITE No. 15.
SESSUEGUILROY, CO. SLIGO

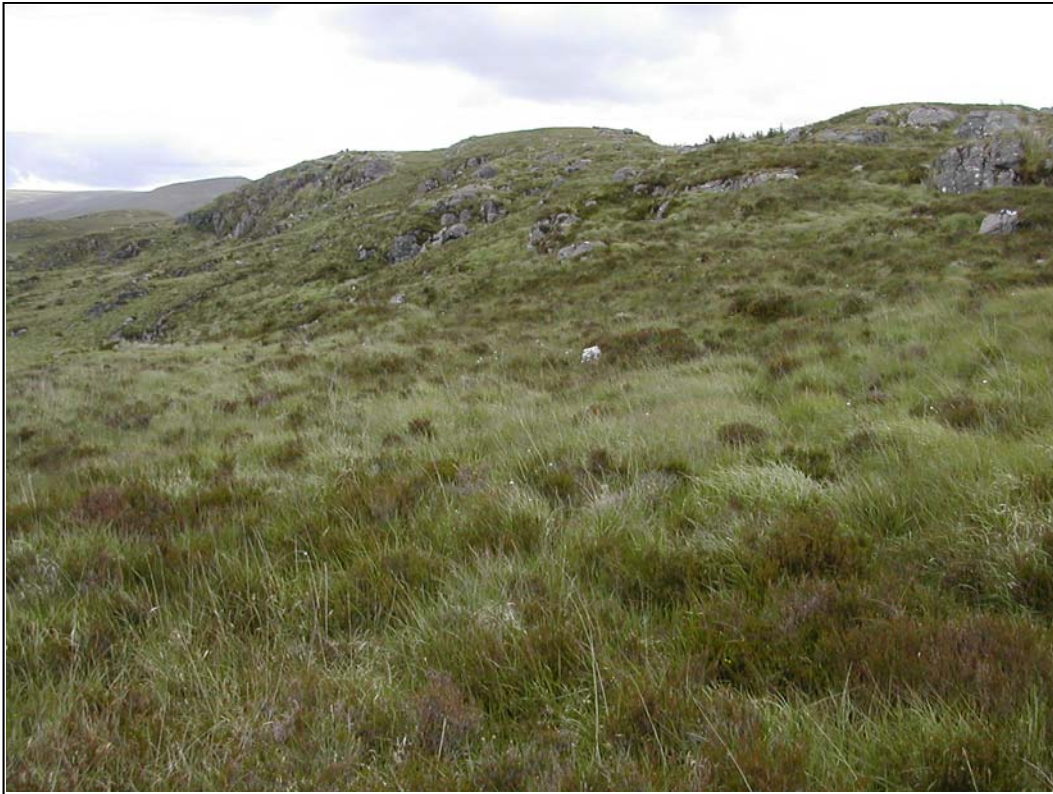
The unplanted parts of this site are dominated by relatively shallow blanket bog and wet heath vegetation with conspicuous *Calluna vulgaris*, *Molinia caerulea* and *Eriophorum vaginatum*. Areas of outcropping rock are also frequent. Photograph taken in September 2003.

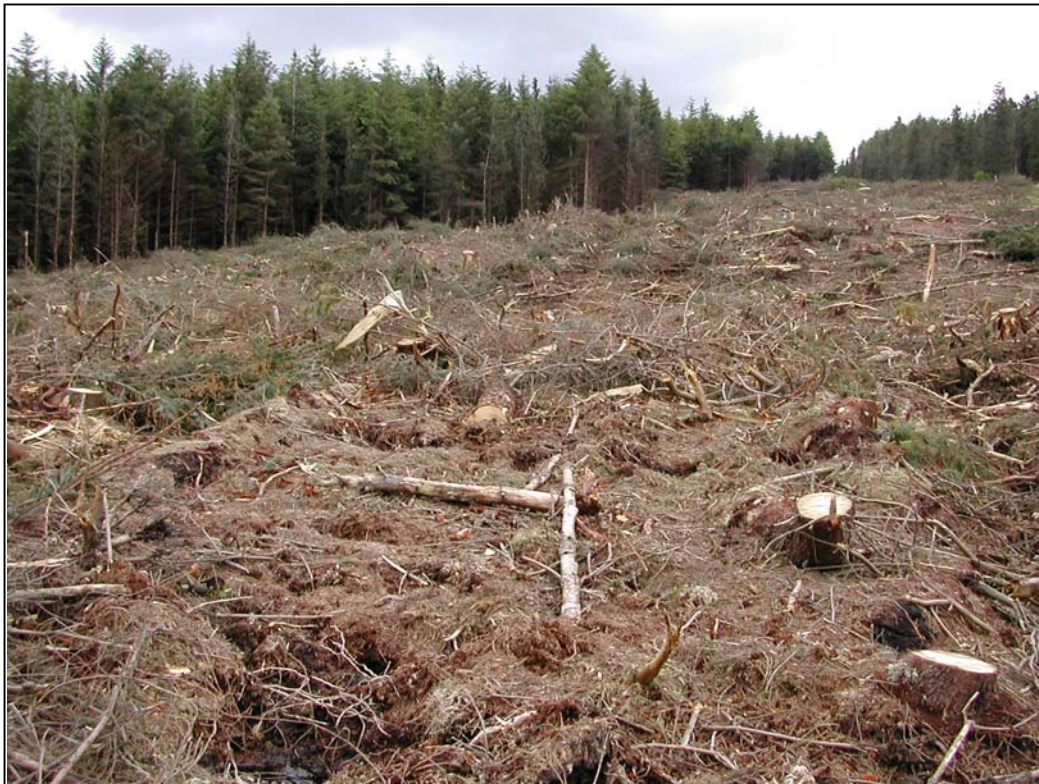
On the afforested portions of this site the conifer plantation had grown relatively well and the existing bog vegetation was largely killed off by tree growth. This photograph, taken in September 2003, shows the

dominance of brash and needle litter following commercial tree removal.

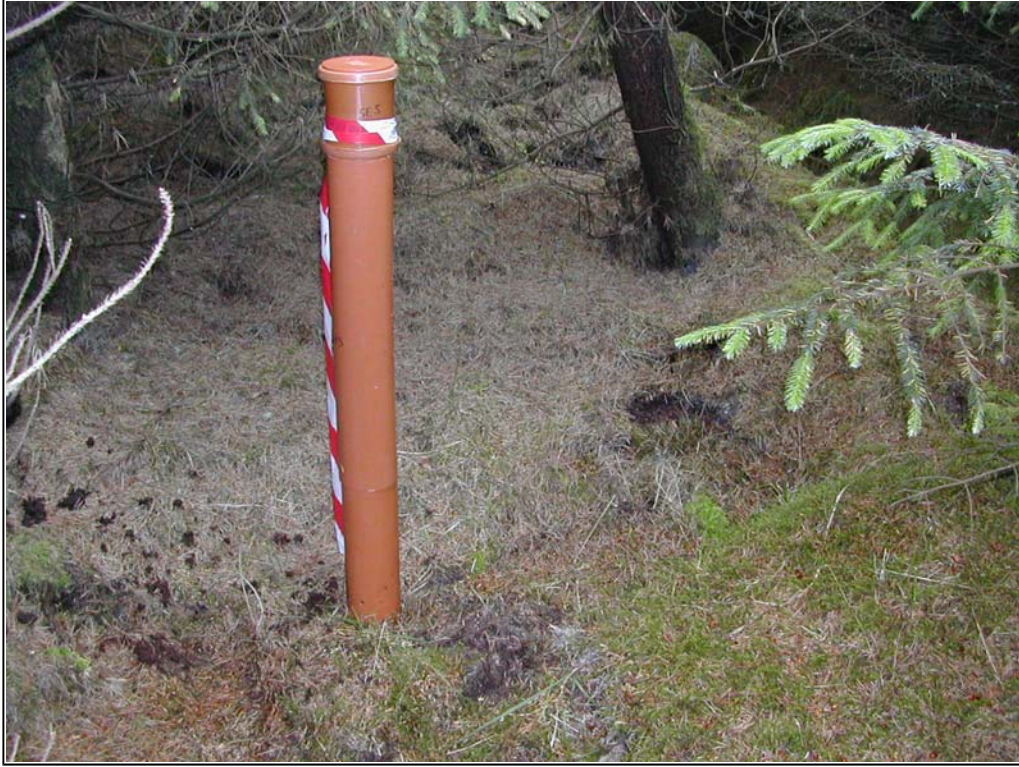
A photograph of the typical ground vegetation underneath the tall conifer crop. A thick layer of pine needles dominates with a sparse layer of mosses also present. Photograph taken in June 2003.

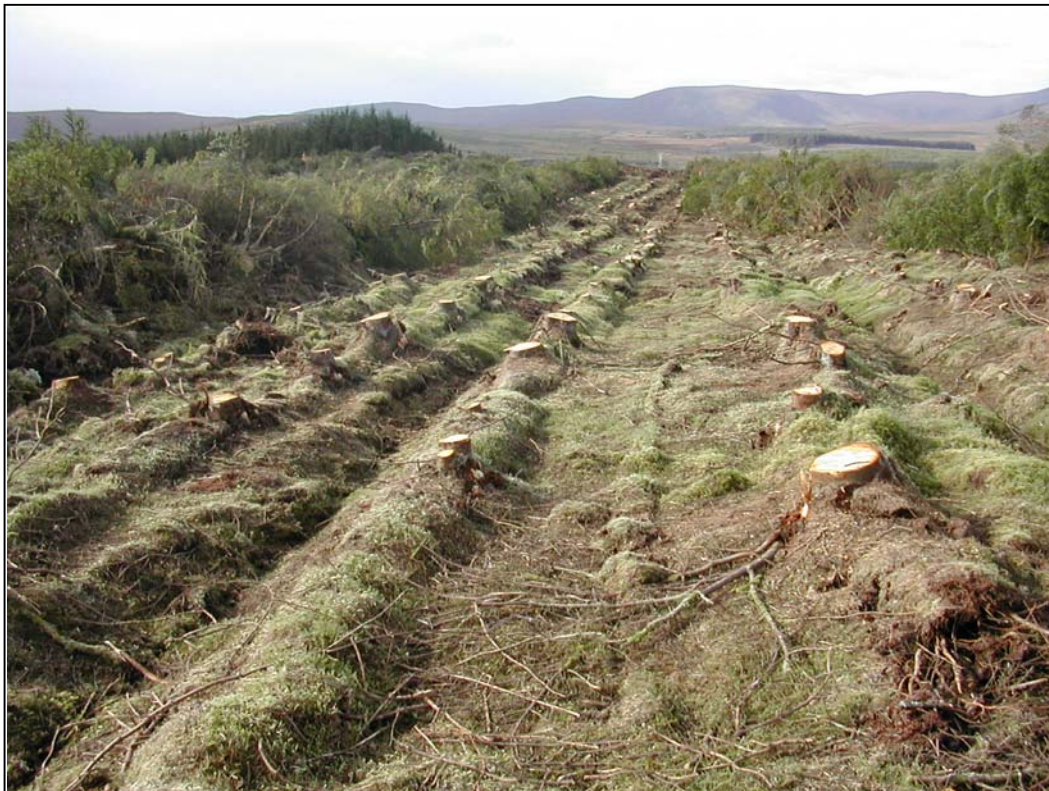
On a portion of this site the conifer crop was not large enough for commercial harvest. These conifers were felled with chainsaw and windrowed by machine. Photograph taken October 2003.

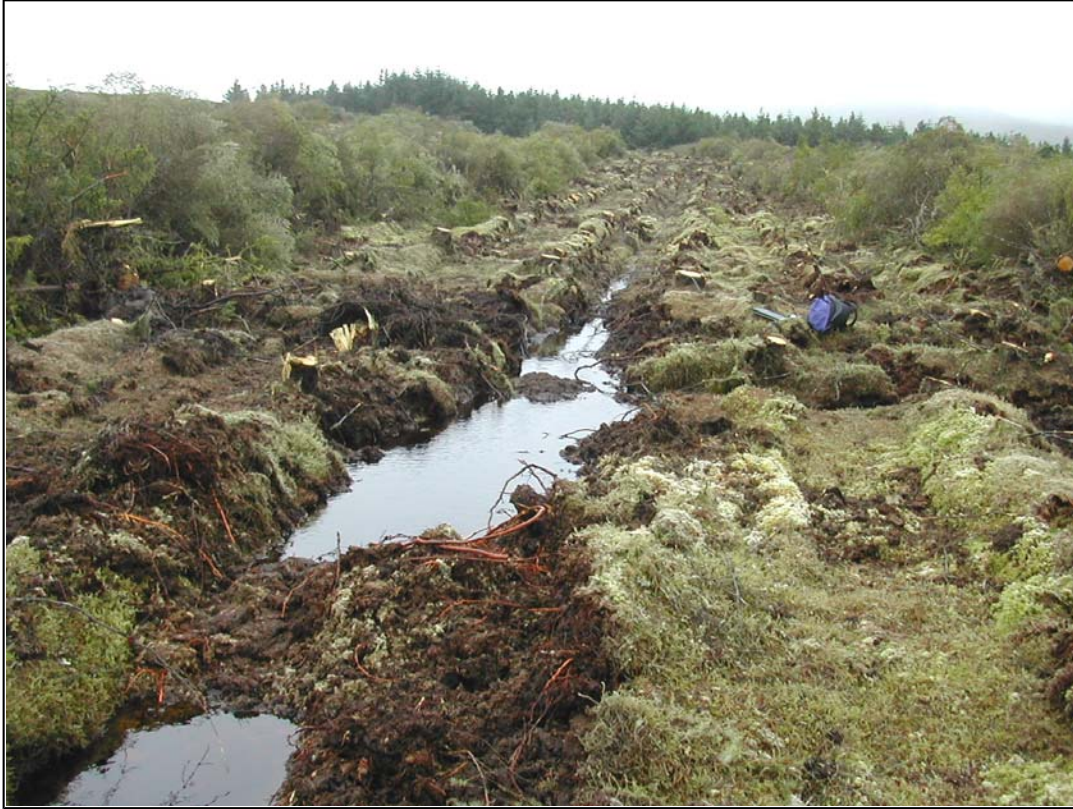
A view of windrowed conifer crop with a peat dam in place. It was generally difficult to put good dams in this site due to the well developed root systems of trees. Photograph taken October 2003.

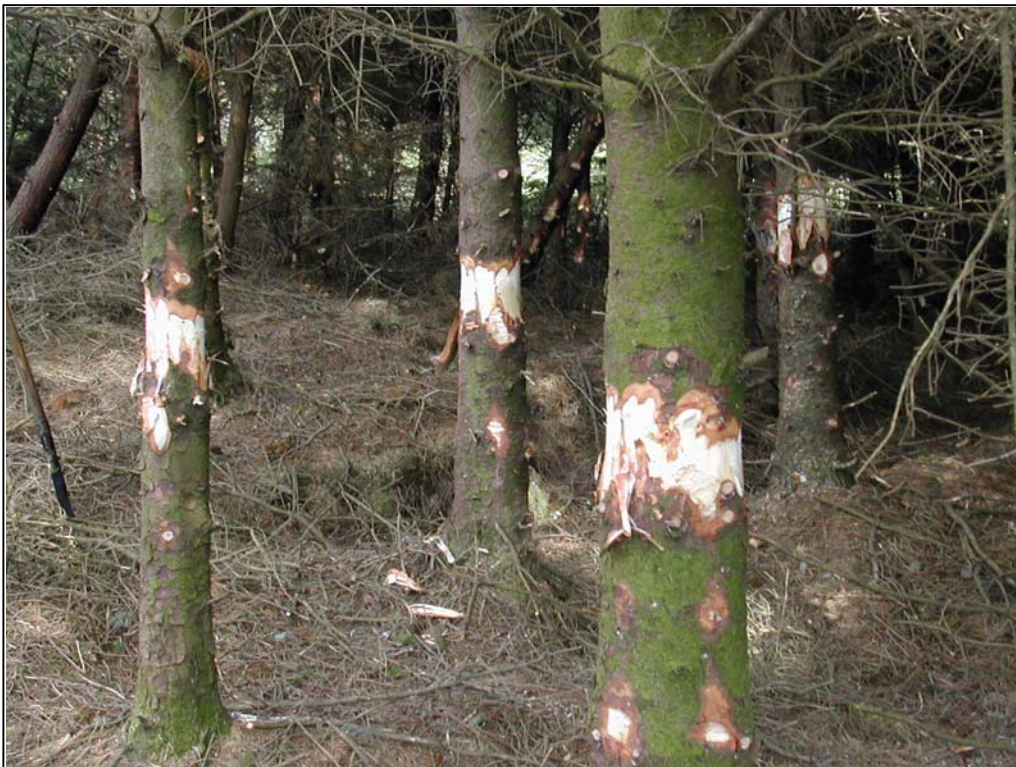
Ring-barked trees at the northern end of the site. At this site it took a couple of seasons for the trees to completely

die off and the regeneration of bog vegetation underneath the tree canopy is slow. Photograph taken August 2004.

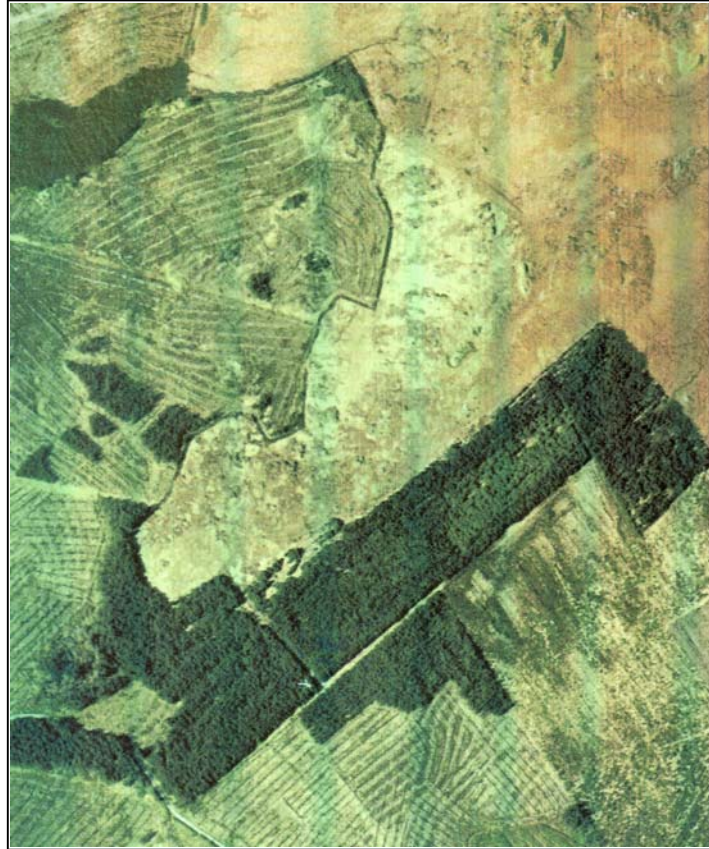
An aerial photograph of the Sessuegilroy site prior to the start of restoration activities. Aerial photograph taken in the year 2000.

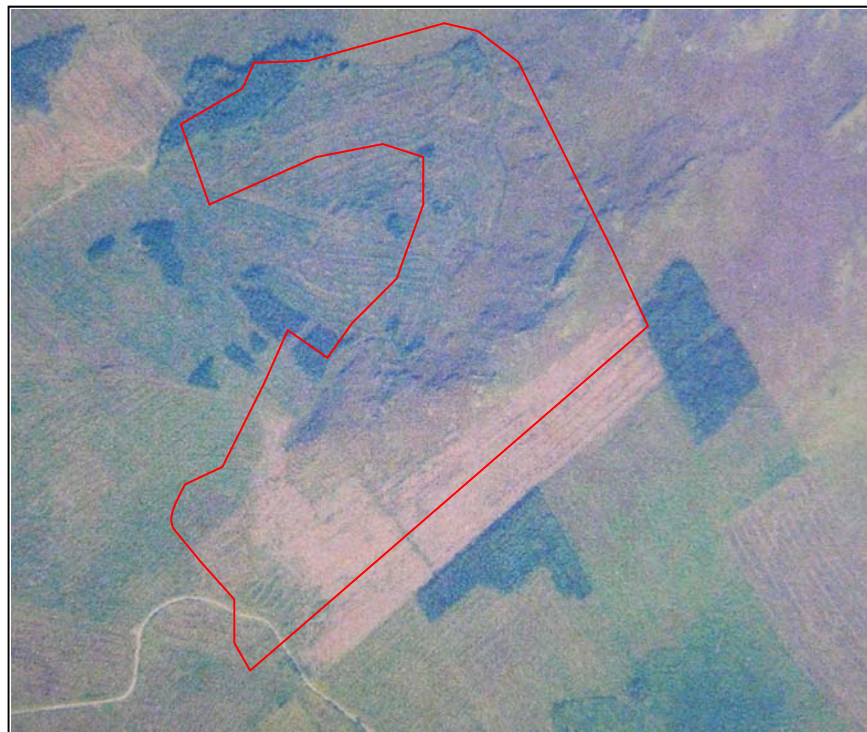
An aerial photograph of the Sessuegilroy site following restoration activities. Site outline in red. Aerial photograph

taken in the year 2004.

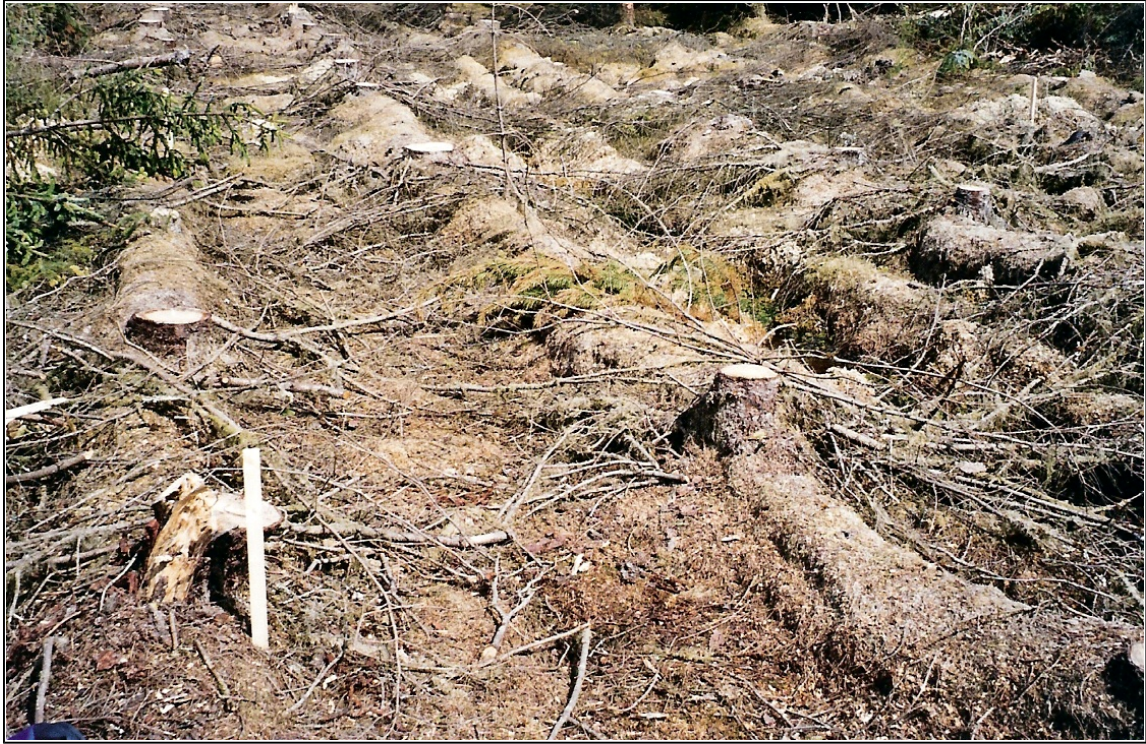
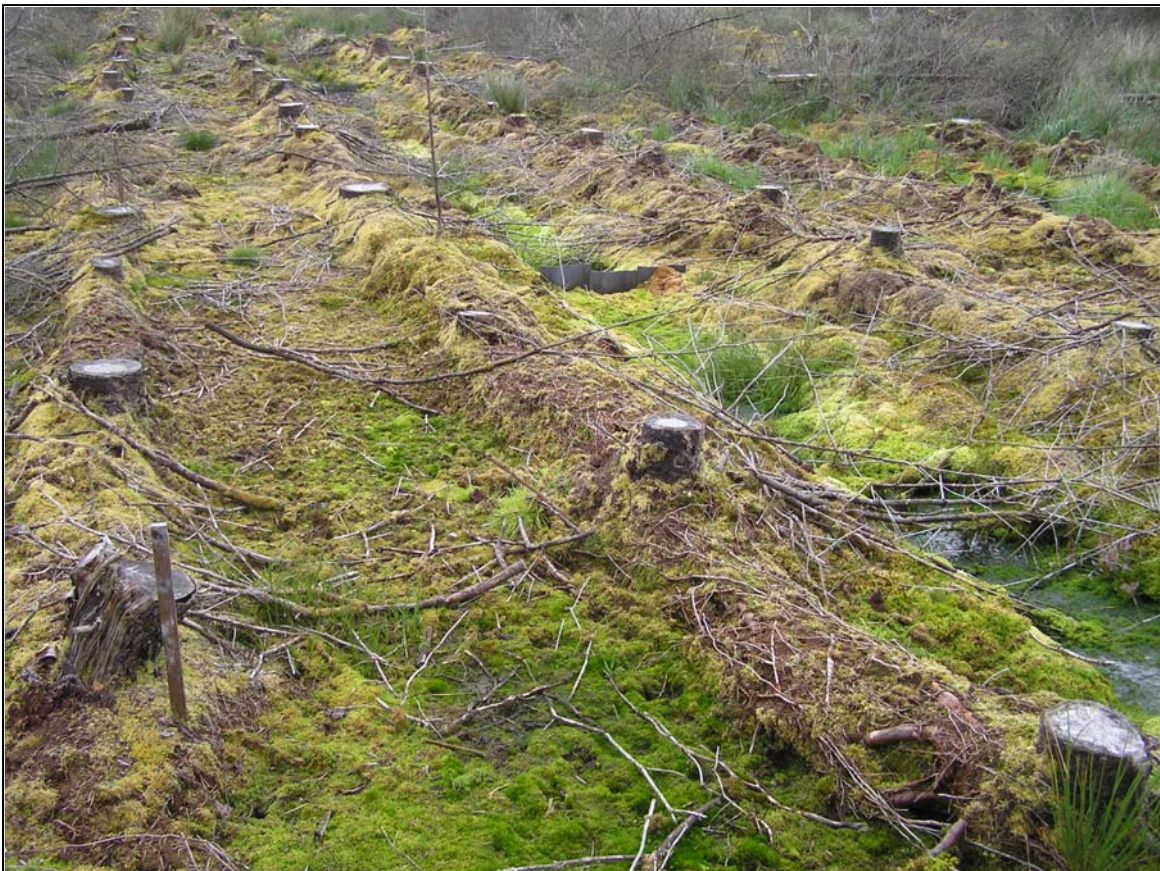
Quadrat No. 1 – August 2003

Site - Sessuegilroy			
Quadrat code - PQ1			
GPS - G 43206 18337			
Near Walrag? - 40 m S.E. of W.7			
Size (m) - 7x7			
Slope (Degrees) - 1 to 3			
Vegetation cover (%)	40	60	80
Needle litter cover (%)	50	50	3
Brash cover (%)	15	10	10
Bare ground cover (%)	0	0	10
Surface water cover (%)	0	0	5
Dwarf shrub cover (%)	0	1	3
Herb cover (%)	0	1	10
Bryophyte cover (%)	40	60	75
No of species present	7	14	25
Date of survey	11/8/2003	4/8/2004	9/8/2006
<i>Rhytidiadelphus loreus</i>	4	4	4
<i>Hypnum cupressiforme</i>	4	4	5
<i>Sphagnum capillifolium</i>	3	4	4
<i>Thuidium tamariscinum</i>	3	3	3
<i>Plagiothecium undulatum</i>	3	4	3
<i>Sphagnum palustre</i>	3	3	3
<i>Sphagnum cuspidatum</i>	3	3	3
<i>Polytrichum</i> sp.		2	4
<i>Calluna vulgaris</i>		1	1
<i>Pinus contorta</i> seedlings		1 (9 counted)	1 (1 counted)
<i>Dryopteris dilatata</i>		1	1
<i>Molinia caerulea</i>		1	1
<i>Sphagnum subnitens</i>		1	-
<i>Hylocomium splendens</i>		1	1

<i>Campylopus introflexus</i>			4
<i>Eriophorum angustifolium</i>			2
<i>Cladonia portentosa</i>			2
<i>Erica tetralix</i>			1
<i>Nardus stricta</i>			1
<i>Pseudoscleropodium purum</i>			1
<i>Dicranum scoparium</i>			1
<i>Cladonia</i> sp.			1
<i>Vaccinium myrtillus</i>			1
<i>Agrostis canina</i>			1
<i>Potentilla erecta</i>			1
<i>Drosera rotundifolia</i>			1
History – Previously dominated by a Sitka spruce plantation planted in the late 1970's. Trees were generally between 6 and 8 metres tall. Ground vegetation dominated by conifer needles and scattered mosses (mainly <i>Hypnum cupressiforme</i> and <i>Rhytidiadelphus loreus</i> . Trees felled and removed for sale in summer of 2003. In 2003 much of the moss cover was either dead or dying.

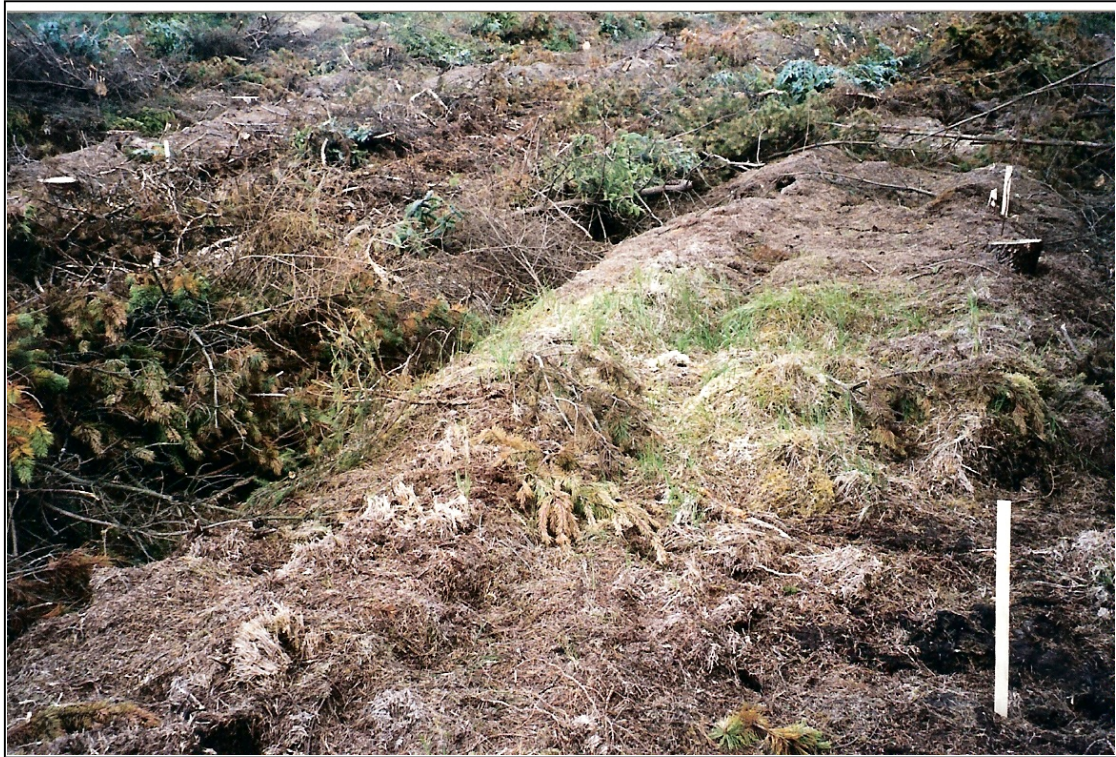
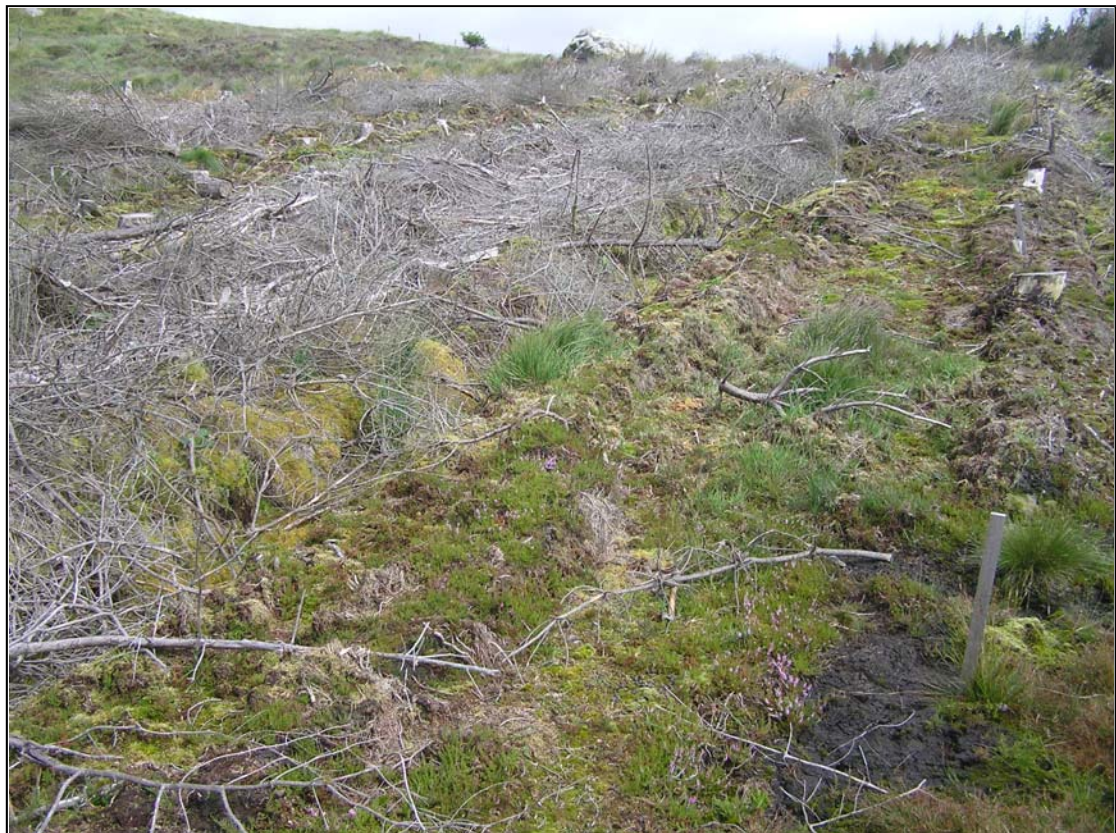
Quadrat No. 2 – August 2003

Site - Sessuegilroy			
Code - PQ2			
GPS - G 43236 18394			
Near Walrag? - No			
Size (m) - 8x8			
Slope (Degrees) – 5 to 10			
Vegetation cover (%)	20	25	50
Needle litter cover (%)	20	20	5
Brash cover (%)	60	60	40
Dwarf shrub cover (%)	0	2	5
Herb cover (%)	10	10	15
Bryophyte cover (%)	15	20	50
No of species present	6	14	22
Date of survey	11/8/03	4/8/04	9/8/2006
<i>Molinia caerulea</i>	4	4	4
<i>Hypnum cupressiforme</i>	3	3	4
<i>Rhytidiadelphus loreus</i>	3	3	3
<i>Hylocomium splendens</i>	3	3	1
<i>Thuidium tamariscinum</i>	2	2	-
<i>Sphagnum capillifolium</i>	2	2	3
<i>Campylopus introflexus</i>		2	4
<i>Calluna vulgaris</i>		2	3
<i>Juncus bulbosus</i>		1	1
<i>Potentilla erecta</i>		1	1
<i>Luzula multiflora</i>		1	1
<i>Pleurozium schreberi</i>		1	2
<i>Agrostis</i> sp.		1	1
<i>Pinus contorta</i> seedlings		1 (8 counted)	-
<i>Polytrichum commune</i>			4
<i>Digitalis purpurea</i>			2
<i>Erica cinerea</i>			1
<i>Juncus effusus</i>			1

<i>Juncus squarrosus</i>			1
<i>Eriophorum vaginatum</i>			1
<i>Epilobium angustifolium</i>			1
<i>Carex echinata</i>			1
<i>Epilobium</i> sp.			1
<i>Galium saxatile</i>			1
<p>History – Previously dominated by a Lodgepole pine/Sitka spruce plantation planted in the late 1970's. Trees were generally between 6 and 8 metres tall. Ground vegetation dominated by conifer needles and scattered mosses (mainly <i>Hypnum cupressiforme</i> and <i>Rhytidiadelphus loreus</i>). Trees felled and removed for sale in summer of 2003. Approx. 60% of quadrat (western half) is dominated by a thick brash mat.</p>

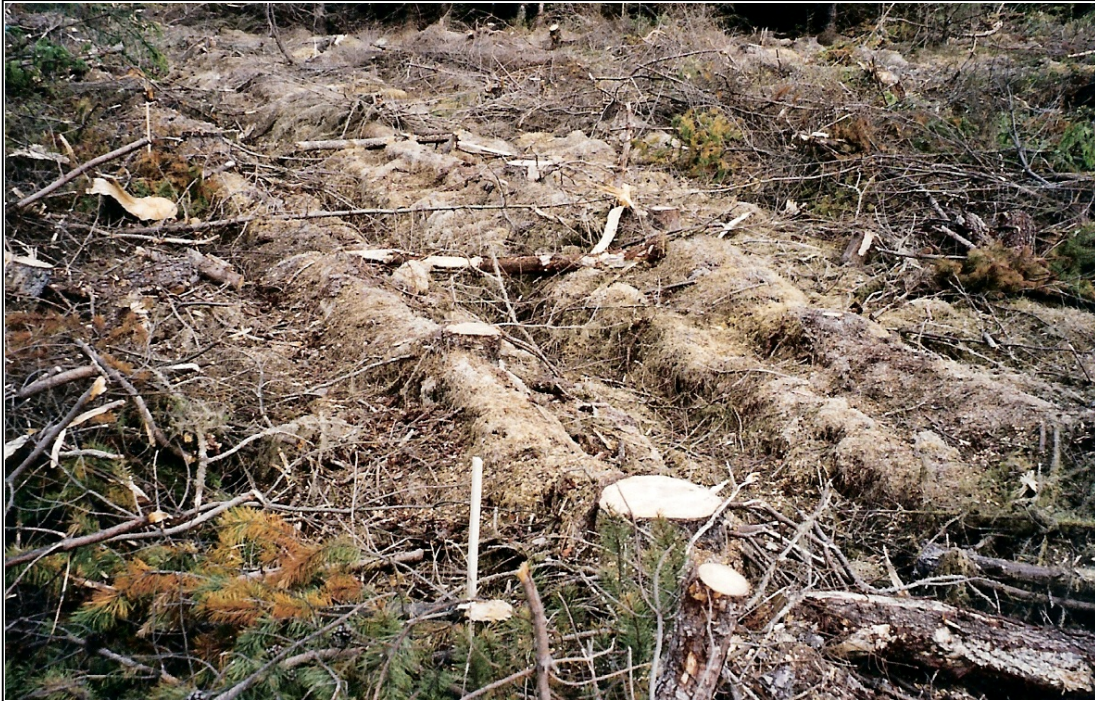
Quadrat No. 3 – August 2003

Not possible to refind this quadrat due to ground disturbance.

Site	Sessuegilroy	
Code	PQ3	
GPS		
Near Walrag?	C. 80 metres west of Walrag 2	
Size (m)	8x8	
Slope (Degrees)	5 - 15	
Date of survey	11/8/03	
Vegetation cover (%)	10	
Dwarf shrub cover (%)	0	
Herb cover (%)	1	
Bryophyte cover (%)	10	
Needle litter cover (%)	50	
Brash cover (%)	40	
Water cover (%)	0	
No of species present	6	
<i>Rhytidiadelphus loreus</i>	3	
<i>Thuidium tamariscinum</i>	2	
<i>Hypnum cupressiforme</i>	2	
<i>Sphagnum palustre</i>	1	
<i>Dryopteris dilatata</i>	1	
<i>Plagiothecium undulatum</i>	1

History – Previously dominated by a Lodgepole pine/Sitka spruce plantation planted in the late 1970's. Trees were generally between 6 and 8 metres tall. Ground vegetation dominated by conifer needles and scattered mosses (mainly *Hypnum cupressiforme* and *Rhytidiadelphus loreus*). Trees felled and removed for sale in summer of 2003.

Approx. 50% of quadrat is dominated by a thick brash mat.

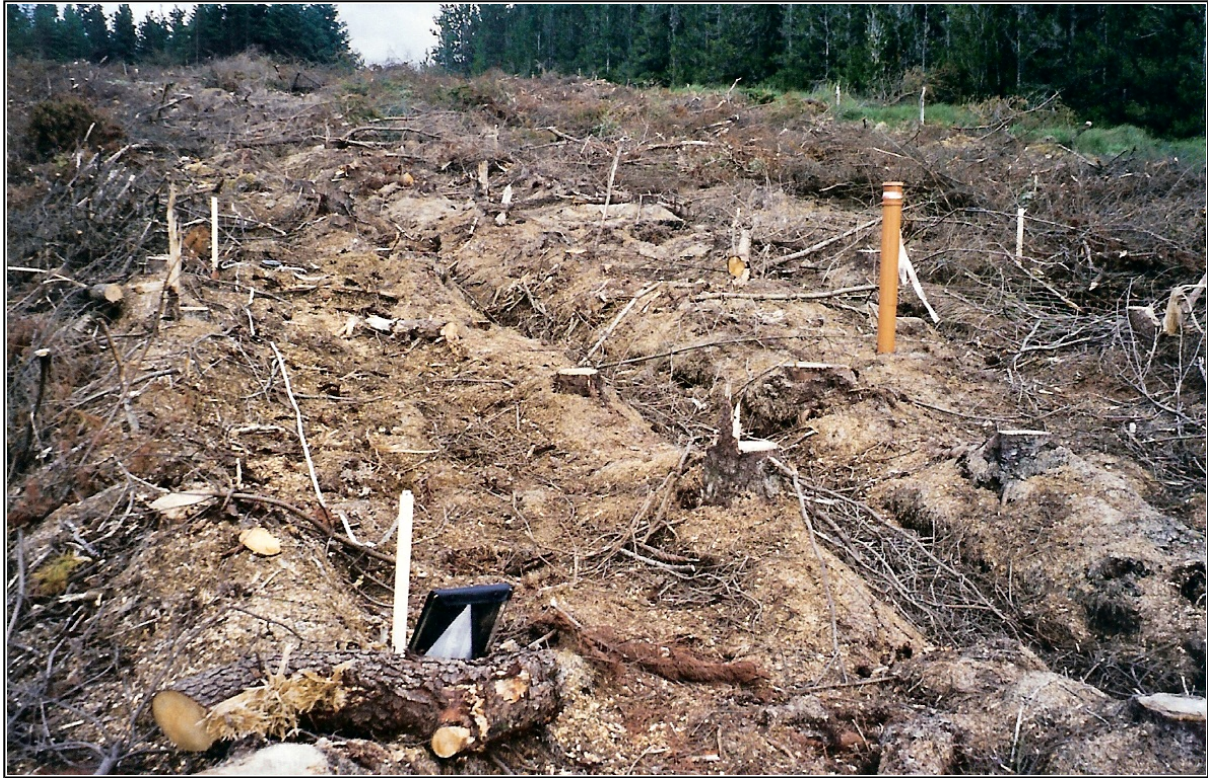
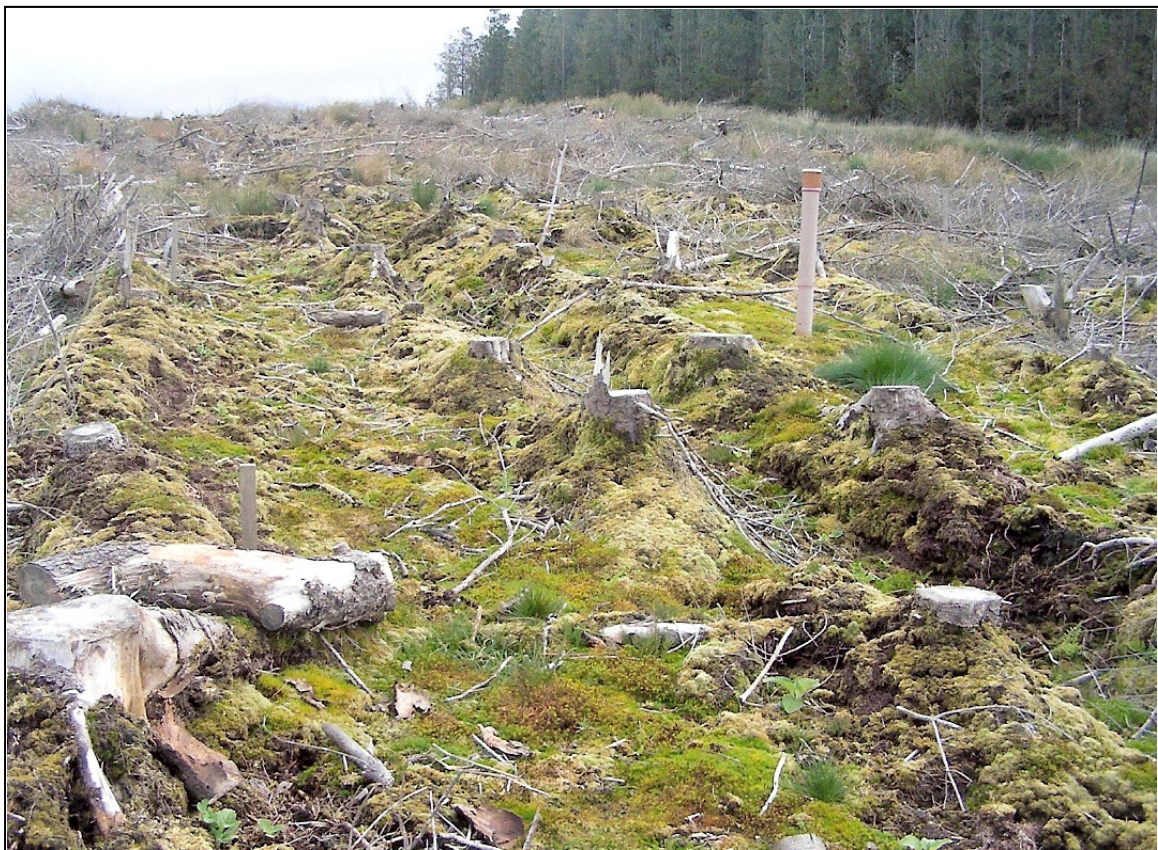
Quadrat No. 4 – August 2003

Site - Sessuegilroy			
Code - PQ4			
GPS – G 43106 18181			
Near Walrag? - W1 in centre of plot			
Size (m) - 8x8			
Slope (Degrees) - 15-20			
Vegetation cover (%)	5	25	80
Dwarf shrub cover (%)	0	1	1
Herb cover (%)	<1	2	10
Bryophyte cover (%)	5	25	75
Needle litter cover (%)	70	60	5
Brash cover (%)	25	20	20
Bare ground cover (%)	0	0	10
No of species present	4	16	22
Date of survey	11/8/03	4/8/04	9/8/06
<i>Hypnum cupressiforme</i>	2	3	5
<i>Thuidium tamariscinum</i>	2	3	1
<i>Plagiothecium undulatum</i>	1	4	3
<i>Dryopteris dilatata</i>	1	1	1
<i>Campylopus introflexus</i>		3	5
<i>Polytrichum commune</i>		3	5
<i>Pinus contorta</i> seedlings		1 (4 counted)	-
<i>Calluna vulgaris</i>		1	2
<i>Juncus squarrosus</i>		1	1
<i>Luzula multiflora</i>		1	1
<i>Digitalis purpurea</i>		1	2
<i>Anthoxanthum odoratum</i>		1	1
<i>Rubus fruticosus</i>		1	-
<i>Molinia caerulea</i>		1	1
<i>Epilobium angustifolium</i>		1	1
<i>Sphagnum recurvum</i>		1	1

<i>Juncus bulbosus</i>			1
<i>Eriophorum vaginatum</i>			1
<i>Sphagnum palustre</i>			1
<i>Vaccinium myrtillus</i>			1
<i>Rhytidiadelphus loreus</i>			1
<i>Blechnum spicant</i>			1
<i>Erica cinerea</i>			1
<i>Carex echinata</i>			1
History – Previously dominated by a mixed Lodgepole pine and Sitka spruce plantation planted in the late 1970's. Trees were generally between 6 and 8 metres tall. Ground vegetation dominated by conifer needles with very low moss cover. Trees felled and removed for sale in summer of 2003.

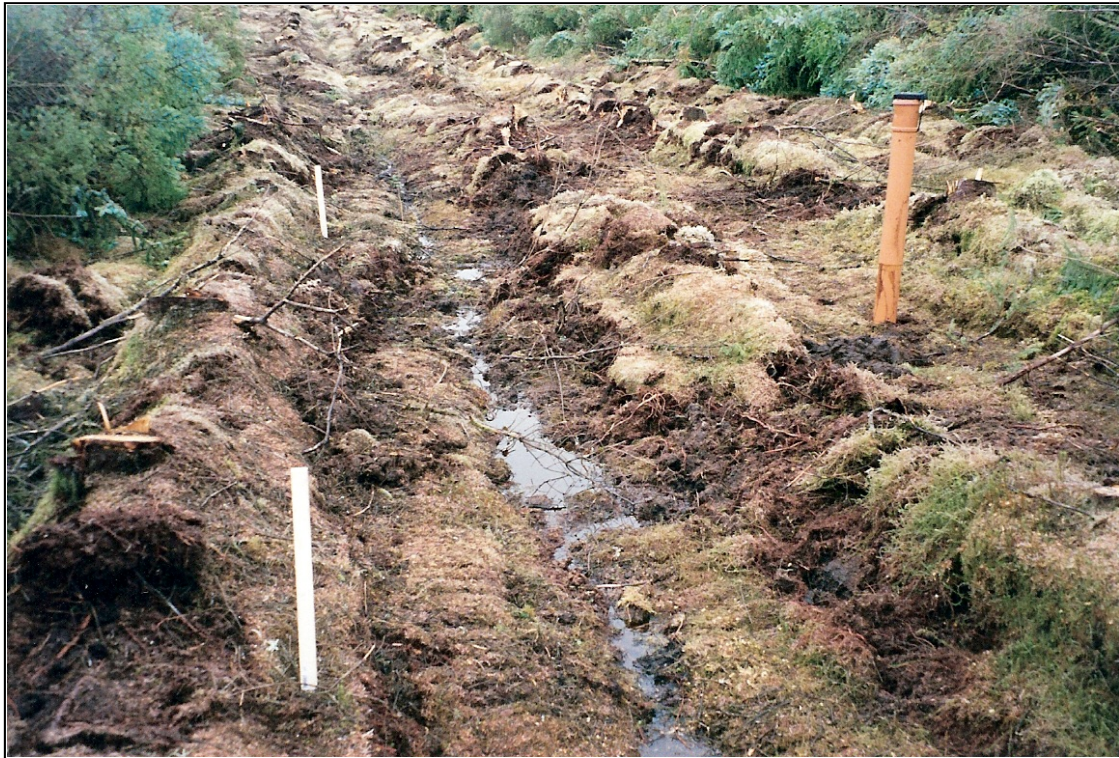
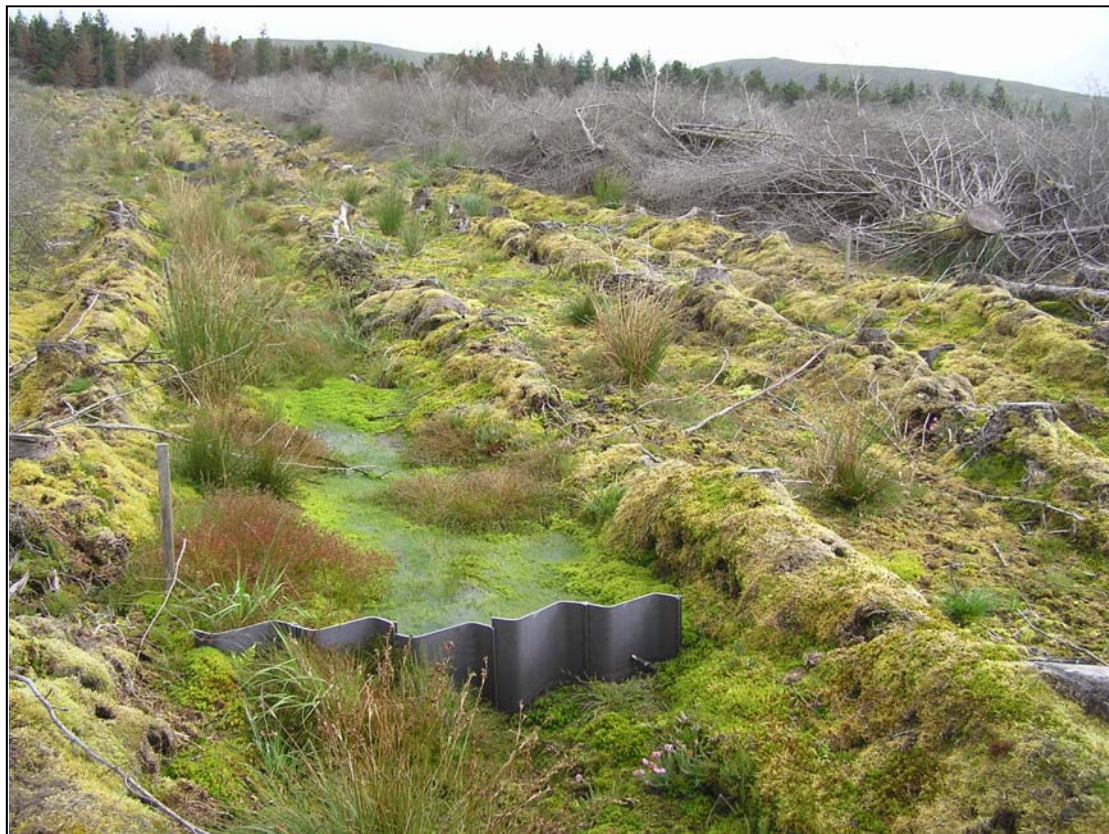
Quadrat No. 5 – August 2003

Site - Sessuegilroy			
Code - PQ5			
GPS - G 43245 18346			
Near Walrag? - No			
Size (m) - 6 x 6			
Slope (Degrees) – 3 to 5			
Vegetation cover (%)	65	60	80
Dwarf shrub cover (%)	0	1	5
Herb cover (%)	<1	1	75
Bryophyte cover (%)	65	60	75
Needle litter cover (%)	60	45	5
Brash cover (%)	5	5	5
Bare soil cover (%)	30	10	10
Water in blocked drains (%)	0	15	15
No. of species present	10	14	27
Date of survey	8/10/03	4/8/04	9/8/06
<i>Hypnum cupressiforme</i>	4	4	4
<i>Sphagnum capillifolium</i>	4	4	4
<i>Rhytidiadelphus loreus</i>	4	4	4
<i>Thuidium tamariscinum</i>	3	3	2
<i>Sphagnum palustre</i>	3	3	3
<i>Plagiothecium undulatum</i>	2	2	2
Liverwort species	2	-	3
<i>Polytrichum commune</i>	2	2	5
<i>Dicranum scoparium</i>	2	-	1
<i>Hylocomium splendens</i>	2	2	-
<i>Pleurozium schreberi</i>		3	-
<i>Calluna vulgaris</i>		1	3
<i>Juncus</i> sp.		1	-
<i>Molinia caerulea</i>		1	2
<i>Erica tetralix</i>		1	3
<i>Sphagnum cuspidatum</i>		1	4
<i>Campylopus introflexus</i>			4

<i>Juncus bulbosus</i>			2
<i>Juncus effusus</i>			2
<i>Agrostis</i> sp.			2
<i>Juncus squarrosus</i>			2
<i>Carex echinata</i>			1
<i>Eriophorum angustifolium</i>			1
<i>Dryopteris dilatata</i>			1
<i>Rubus fruticosus</i>			1
<i>Vaccinium myrtillus</i>			1
<i>Cladonia</i> sp.			1
<i>Sphagnum subnitens</i>			1
<i>Potentilla erecta</i>			1
<i>Anthoxanthum odoratum</i>			1
History – Previously dominated by Sitka spruce plantation planted in the late 1970's. Trees were generally between 6 and 8 metres tall. Ground vegetation dominated by conifer needles with a low cover of mosses (<i>Hypnum</i> , <i>Sphagnum capillifolium</i> and <i>Rhytidiadelphus loreus</i>). Trees felled and windrowed in the summer of 2003.
